INGRAFFIA  
HOME INSPECTIONS

PROPERTY INSPECTION

July 25, 2026

123 Sample Street  
Corona, 92879

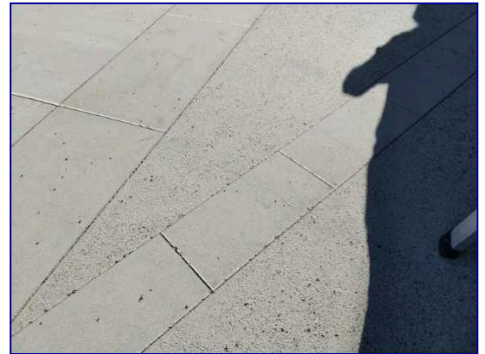
1.1. The walkway had some cracking, but is usable. Recommend a professional contractor seal the cracks to help prevent additional damage.

Cracks front

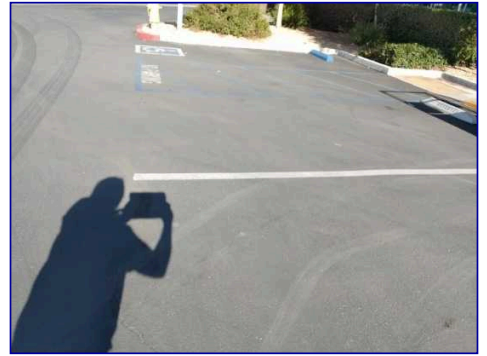
Cracks

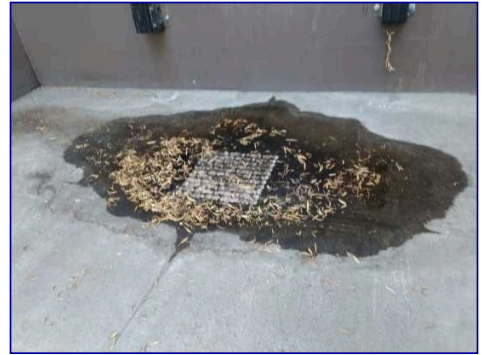
2.4. Standing water at loading dock, drain covered with debris. Recommend monitoring and consulting a professional contractor to repair as needed.

Standing water

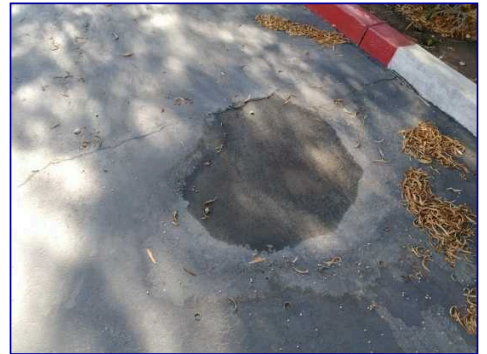
2.1. There are uneven, low spots in parking lot area near planter, which could be a tripping hazard and potential ponding water.. Recommend using additional caution in these areas. Repair or replace as needed.

Cracks, uneven

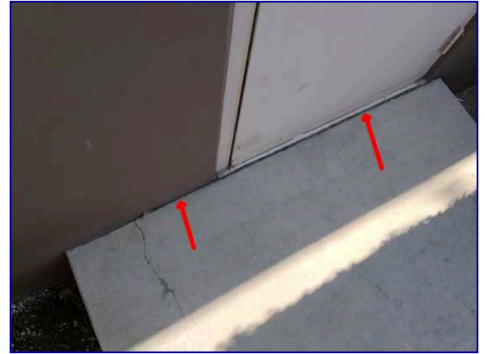
Voids

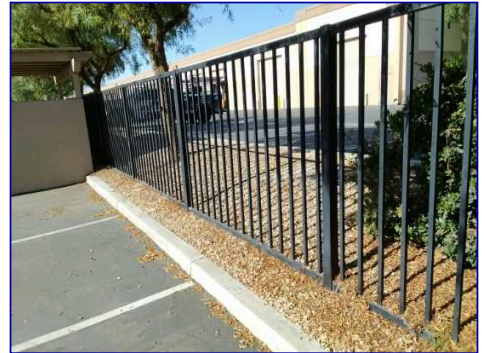
Rusting, weathered

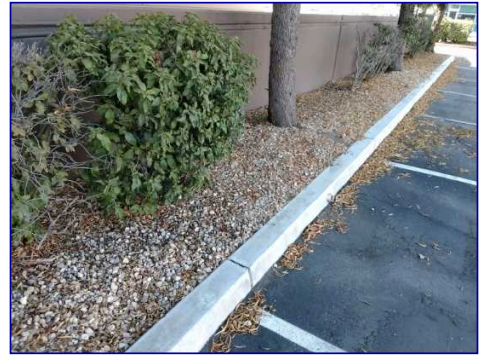
Large tree at foundation

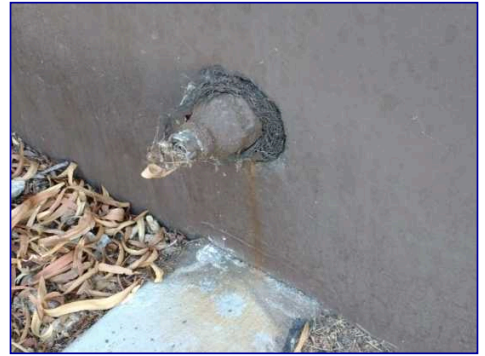
Left rear rusting, weathered

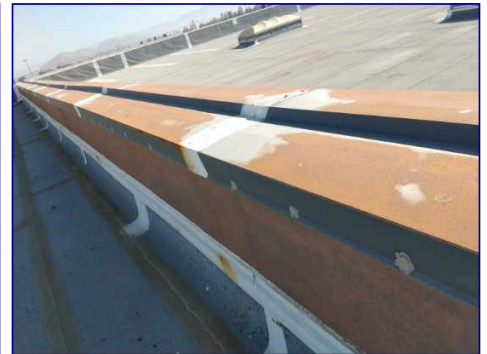
Rusting

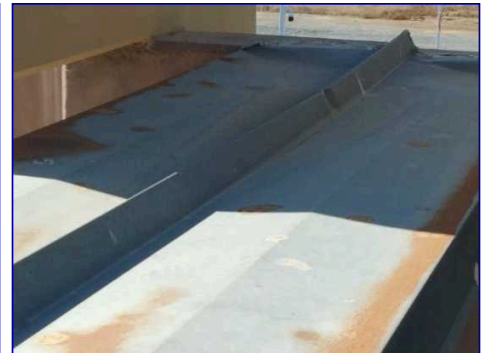
| Grounds | | |
|---|---|---|
| Page 17 Item: 4 | Flashing | 4.1. Cap flashings show signs of rusting. Front flashing apparently bent. Recommend a licensed roofer repair or replace as needed.<br>4.2. There are one or more areas of the roof flashing in need of sealing/repairs. Recommend a licensed contractor evaluate and repair or replace the flashing as needed. |

Bent front

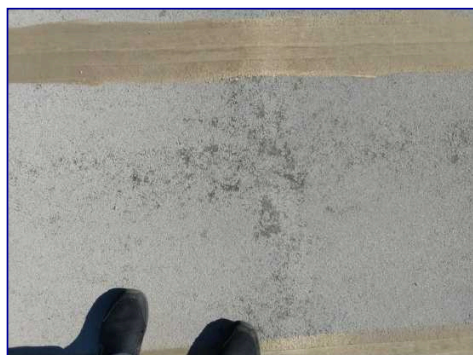
Deterioration of granules

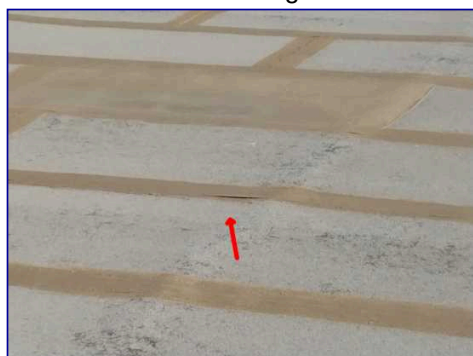
Joint cracks

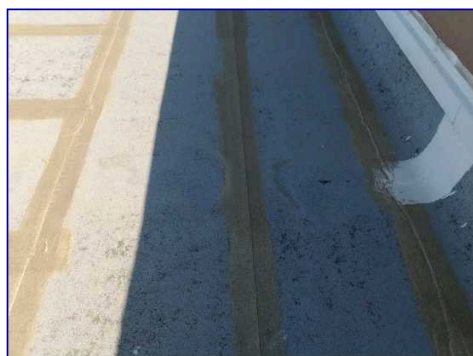
Deterioration of granules

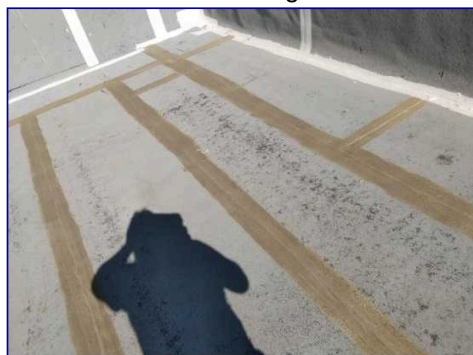
Deterioration of granules

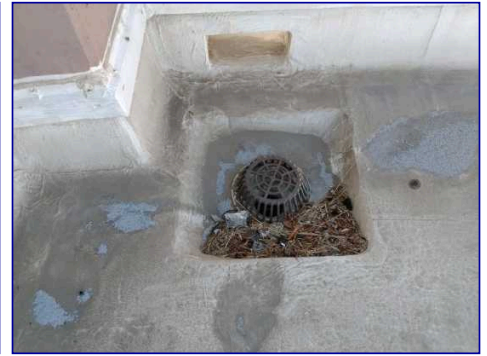
Drain debris

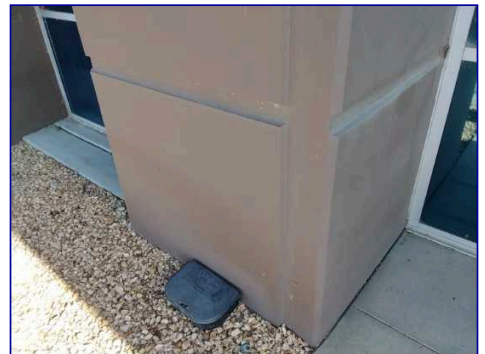
Weathered

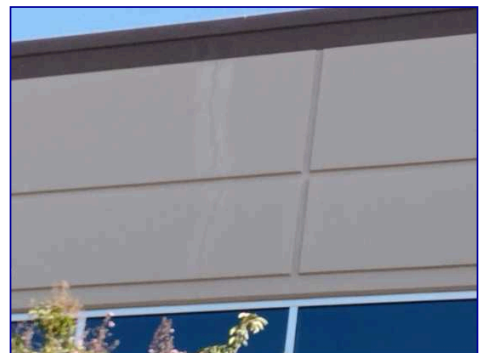
Cracks front

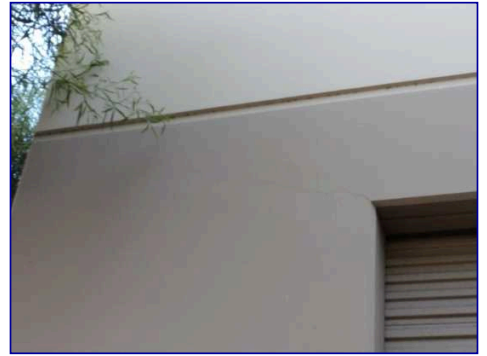
Cracks left

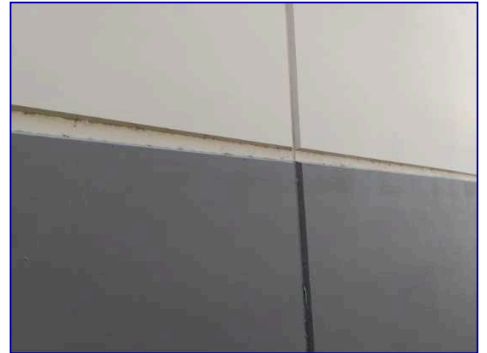
Cracks left

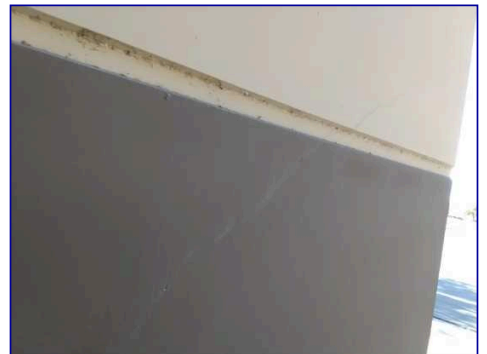
Cracks left

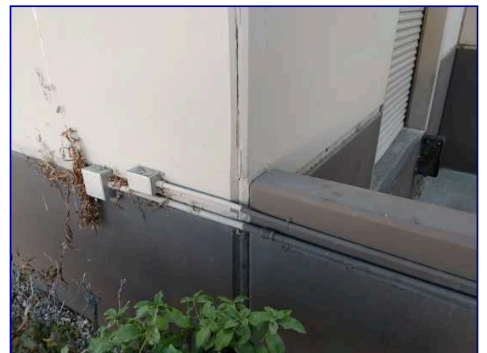
Voids left

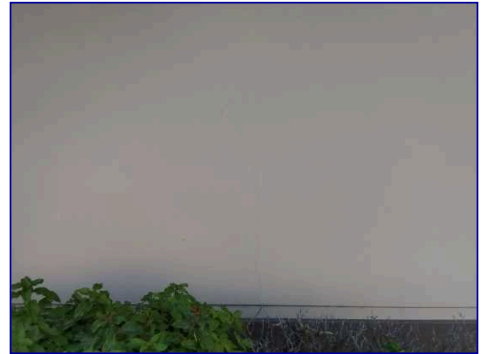
Cracks left

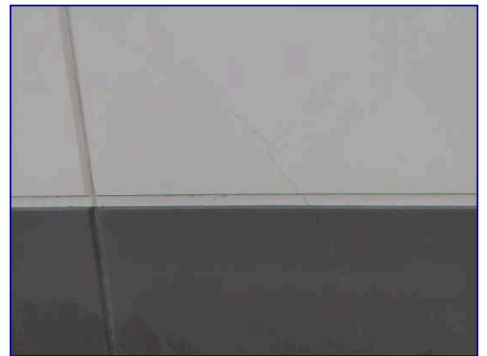
Cracks left

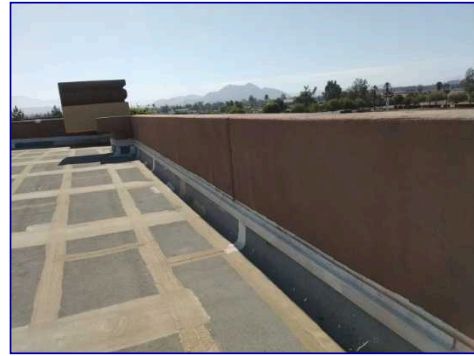
Weathered

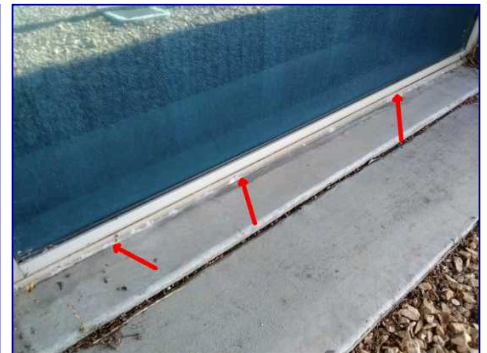
Front rusting

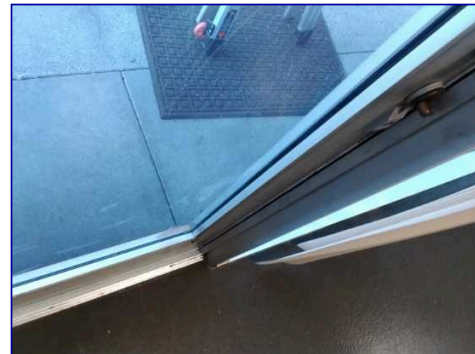
| Page 24 Item: 4 | Exterior Doors | 4.1. The front entry door was uneven, poor weather stripping. Lock/latch was damaged. Recommend a professional contractor repair or replace. |

Main entry uneven

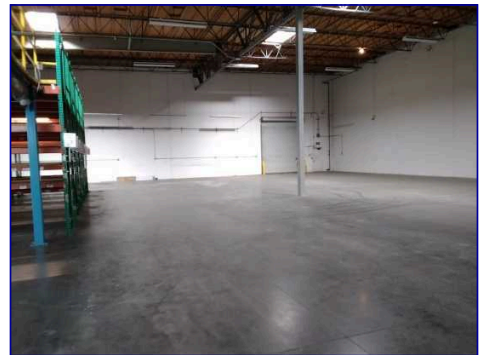
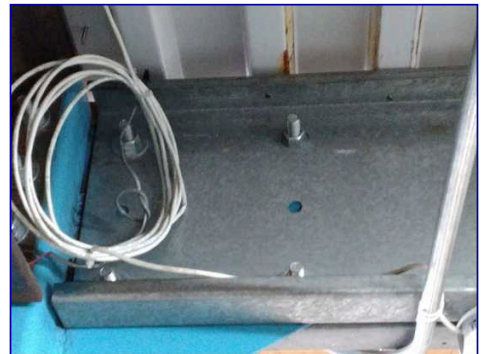
1.1. Mezzanines are not part of the inspection, but items noted should be further evaluated. Missing washers at joist bolts. Staircase stinger bolts not used, lower end welded. Staircase upper riser heights uneven near landing. Recommend evaluation and repair by qualified professional.

Missing washers mezzanine

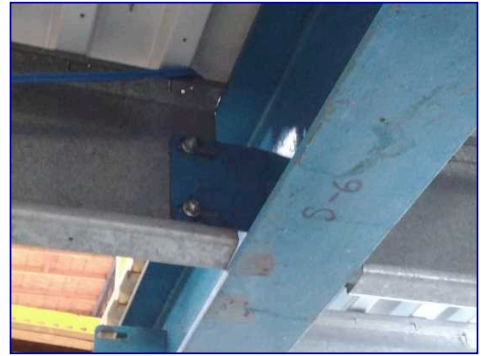
Missing washers

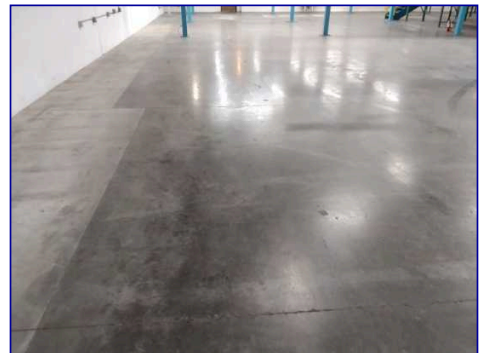
2.2. The garage floor has areas of efflorescence at cut off bolt areas. Monitor and repair or replace as needed by qualified professional.

Efflorescence

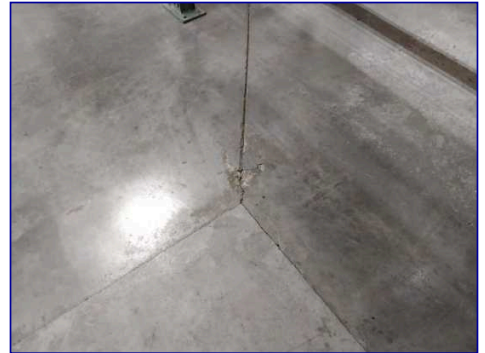
Spalling

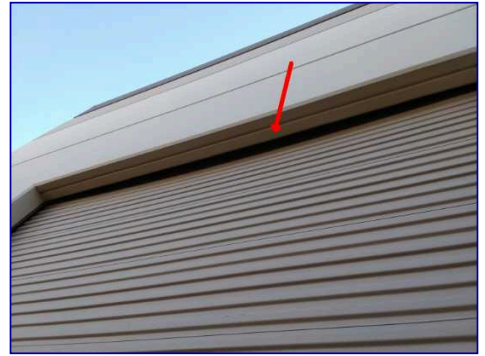
3.2. The rear left door panel(s) bowed at upper wall. Recommend further evaluation and repair by door specialist.

Left bowed

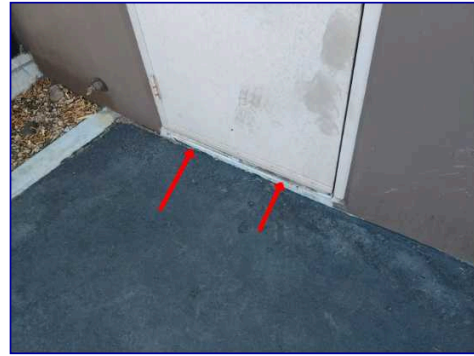
Left swings over step

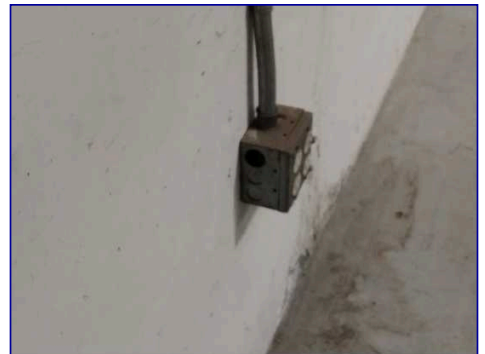
5.3. Several junction boxes were missing knock out plates around warehouse. This is a safety concern. Recommend a licensed electrician repair.

Open knock outs

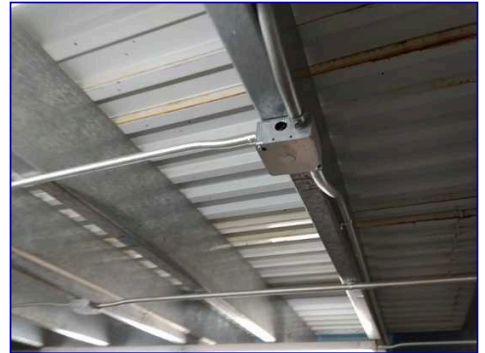
Open knock outs

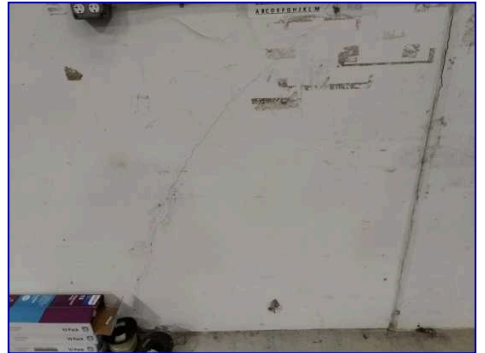
Cracks, efflorescence

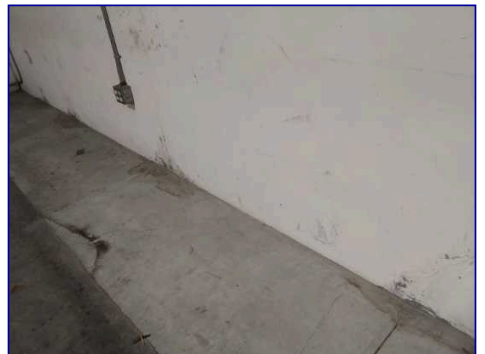
Cracks, efflorescence

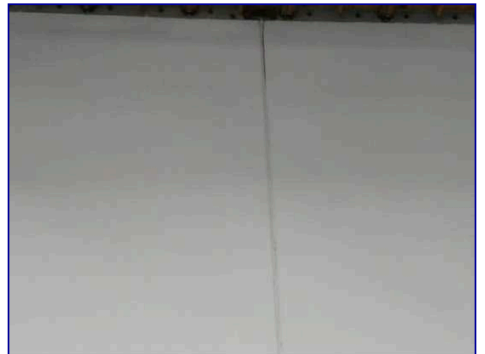
Joints cracks

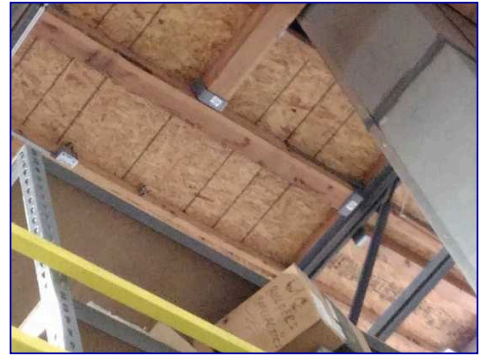
Stains forward roof

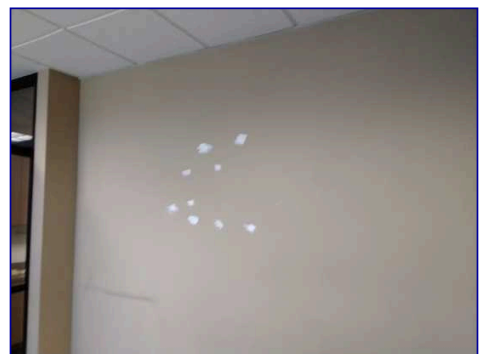
Patches entry

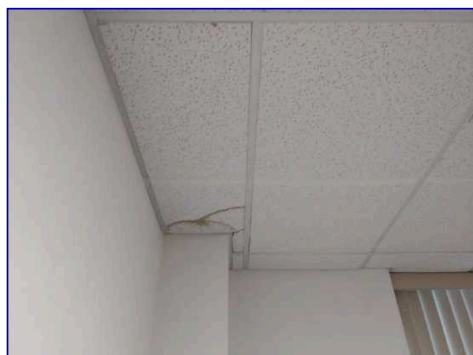
Stains left office

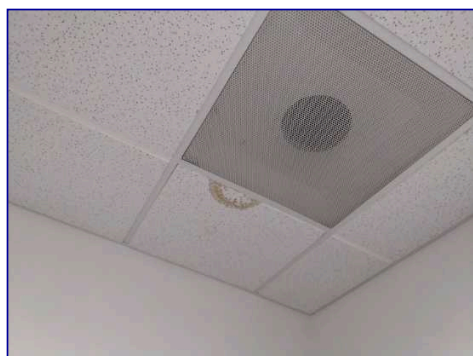
Stains rear right ceiling

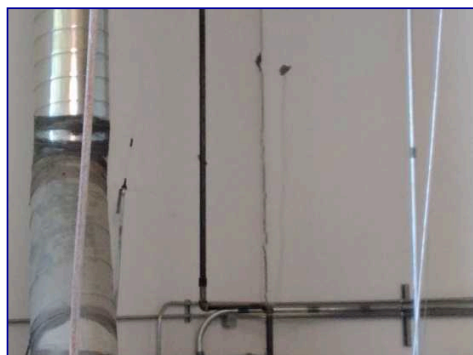
Joints cracks

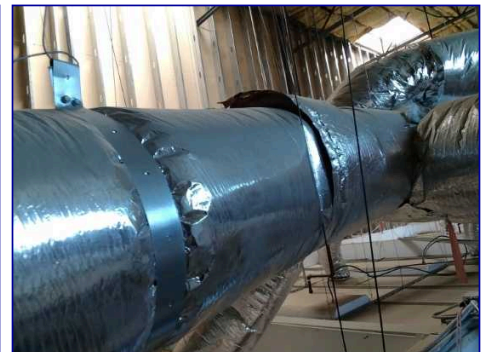
4.1. The HVAC ducts were poorly insulated at joints/connections. Peeling, damage at plenum. Taping around joints poor, peeling. Recommend a qualified professional to repair as needed.

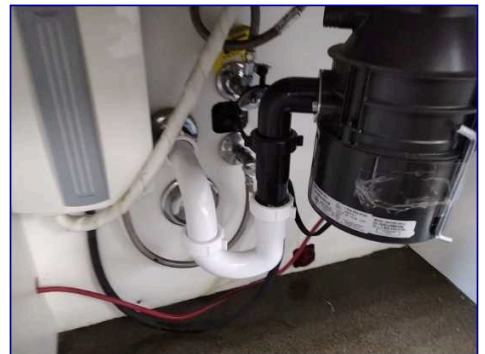
4.2. The kitchen faucet is leaking. Recommend a licensed plumber to evaluate and repair.

Faucet leaks

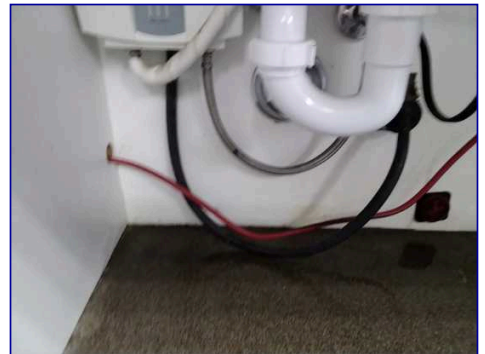
Stains sink

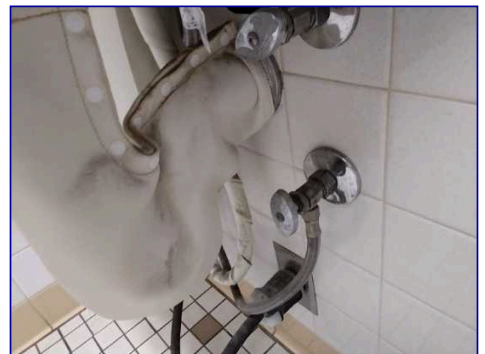
4.1. Apparent corrosion observed at plumbing within vanity. Recommend a licensed plumber repair or replace as necessary.

Corroded plumbing

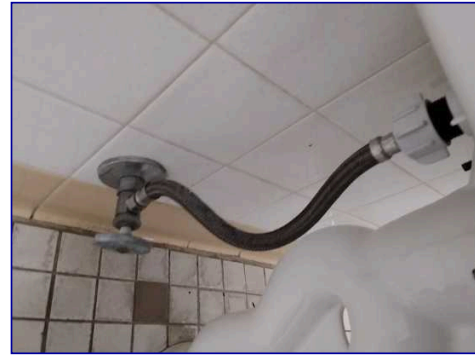
5.1. Toilet plumbing/valve was corroded. Recommend further evaluation from licensed plumber.

Corroded plumbing

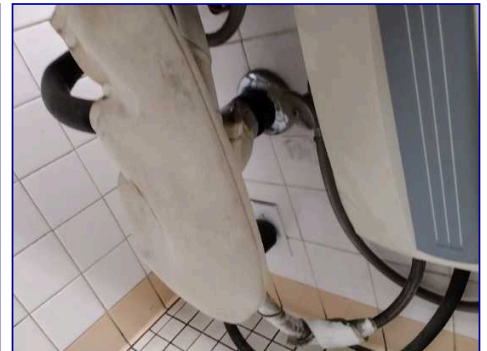
4.1. Apparent corrosion observed at plumbing within vanity. Recommend a licensed plumber repair or replace as necessary.

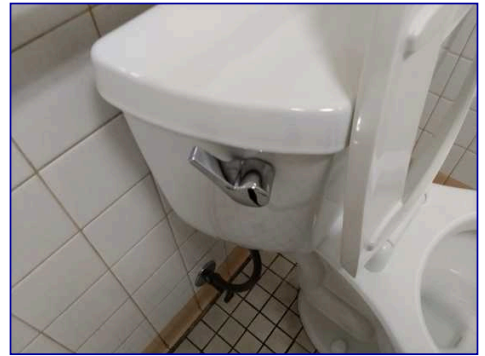
Handle difficult

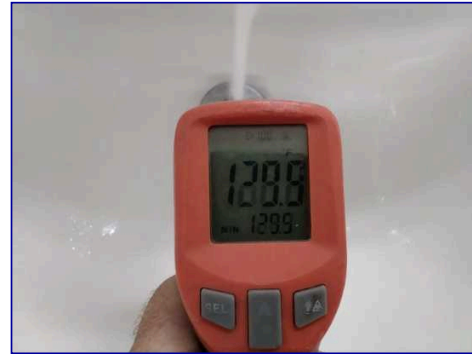
2.2. The water temperature is greater than 120 degrees, which is a scalding concern and safety concern. Recommend reducing the temperature. Consult a professional contractor as needed.

Temp over 120 womens

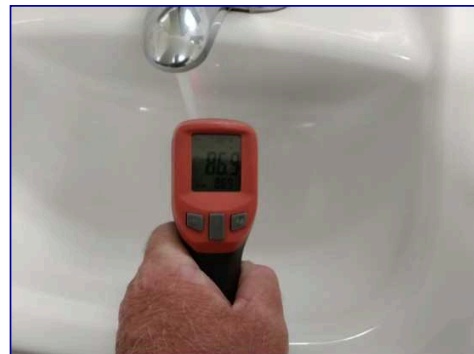
2.1. The water heater was coming into/passing the average theoretical life expectancy of 8-12 years. Recommend budgeting for replacement and having a detailed evaluation from licensed HVAC technician.

2.2. The water heater was not operating. Recommend further evaluation from qualified professional.

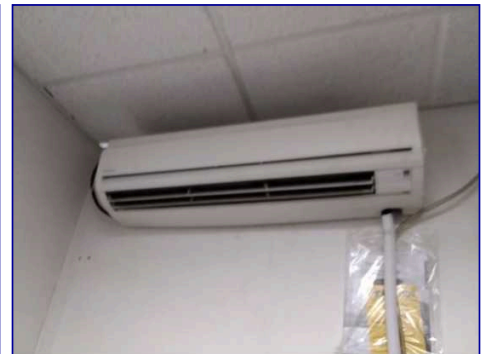
| Page 51 Item: 2 | Operation - Condition | 2.2. Rooftop line set deterioration, electrical conduit damaged. Cabinet enclosure in room was sagging. Recommend evaluation from licensed HVAC technician. |

Bowed

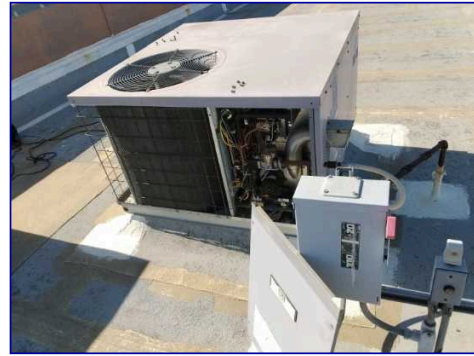
Rusting

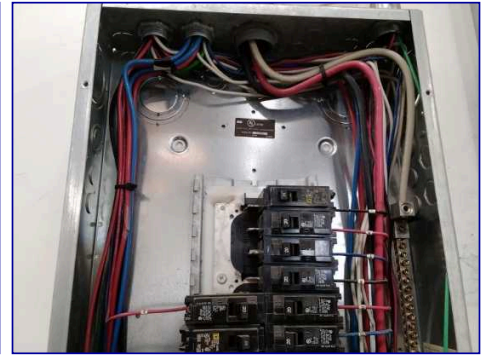
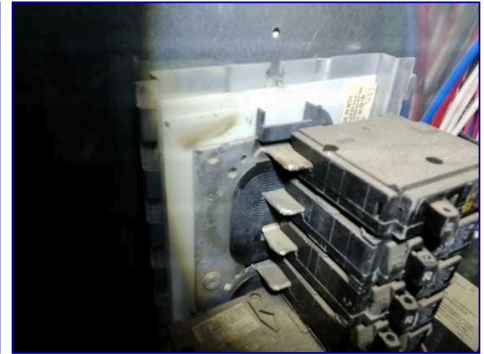
2.2. Upper bus apparent overheating, corrosion, which is a safety concern. Recommend licensed electrician evaluate and make necessary repairs.

Arching

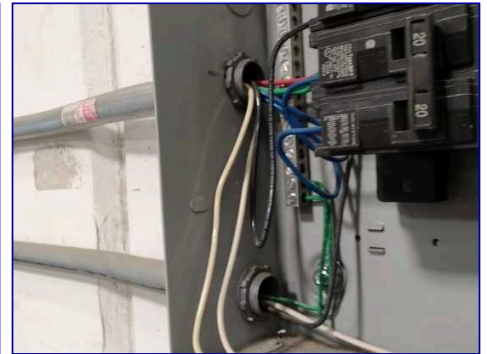
2.1. Conduit bushings missing at entrance to panel, which is a safety concern. Recommend licensed electrician evaluate and make necessary repairs.

Grommets missing
