INGRAFFIA  
HOME INSPECTIONS

PROPERTY INSPECTION

# 123 Sample Street

## Santa Ana, 92701

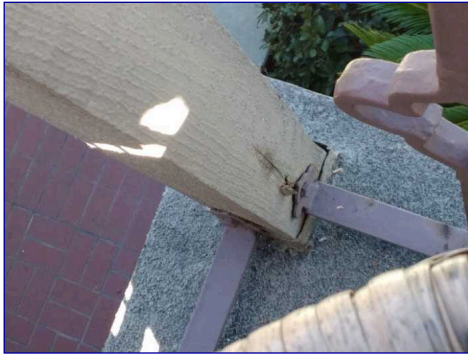
1.3. There is damaged wood observed at railing posts. Post joints at floor open voids. Recommend repair or replacement by a professional contractor.

Damage

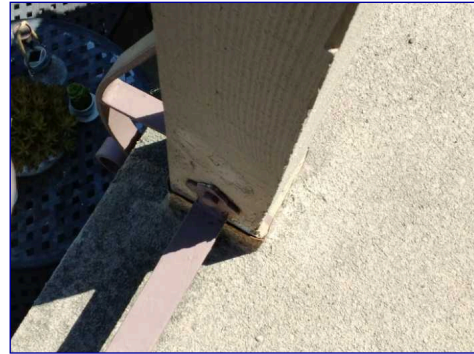
Post voids

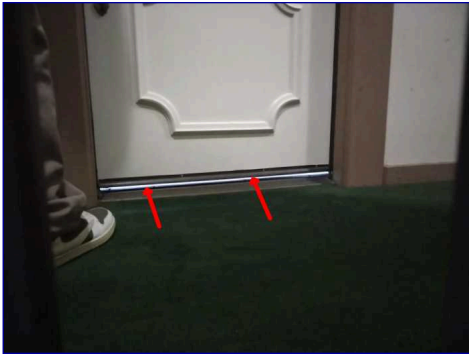
3.3. The weather stripping at bottom door is missing or damaged off front door. Recommend replacing the insulation by qualified professional.

Main entry poor weather stripping

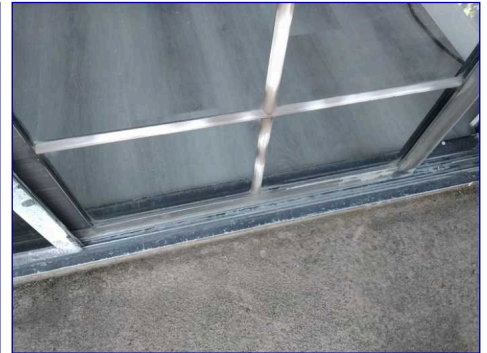
3.1. The balcony entry door is weathered, discolored. Recommend a professional contractor service to protect from further damage.

Balcony weathered

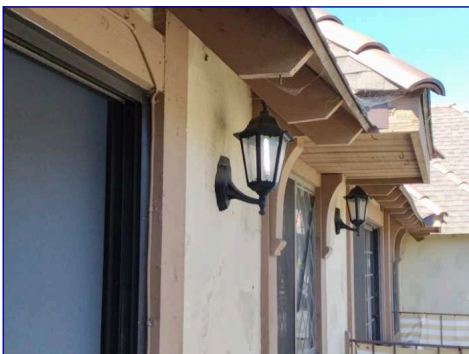
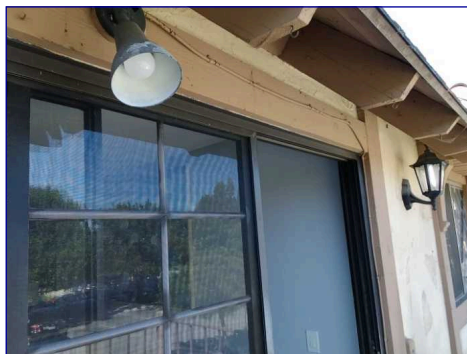
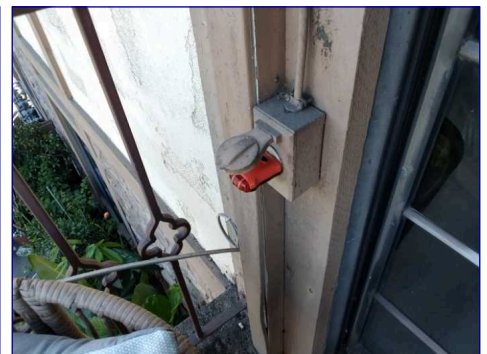
5.1. Extension cord wiring exists off balcony, installed into house which should never be used as permanent wiring, which is a safety concern. Recommend a licensed electrician repair.

Extension

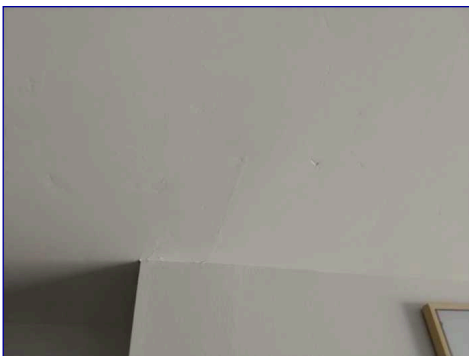
2.1. Cracks on ceiling. Recommend a professional contractor evaluate and repair.

Cracks

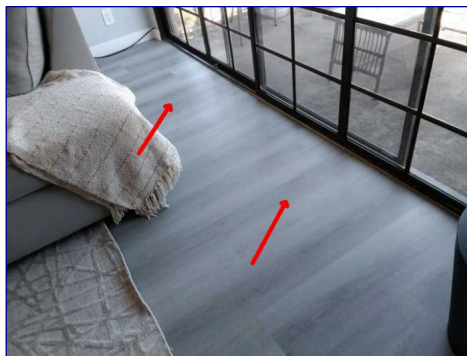
2.2. The flooring system was apparently sloping, uneven. Recommend evaluation from qualified professional and or contractor.

Sloping

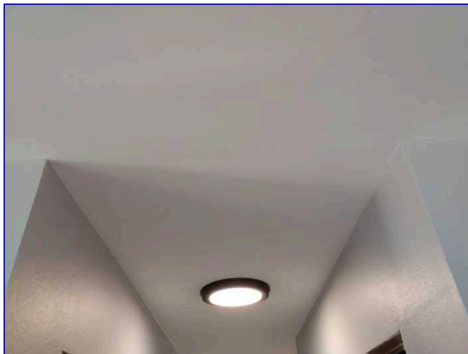
- 2.1. There are cracks present in the ceiling. Recommend a professional contractor evaluate and repair.
- 2.2. The flooring system was apparently sloping, uneven. Recommend evaluation from qualified professional and or contractor.

Cracks

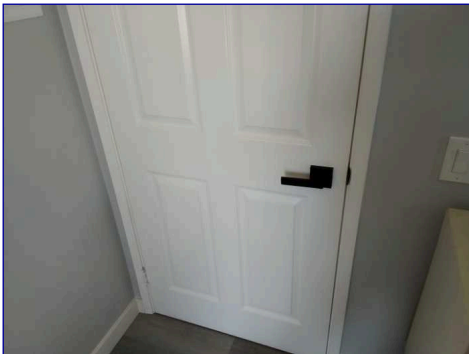
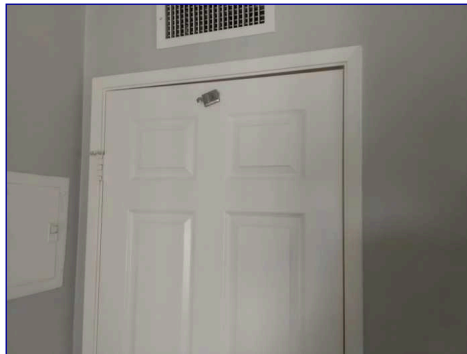
5.1. Entry door uneven at casing. Door npt latching strike plate. Recommend a professional contractor repair or replace the door as needed.

Uneven

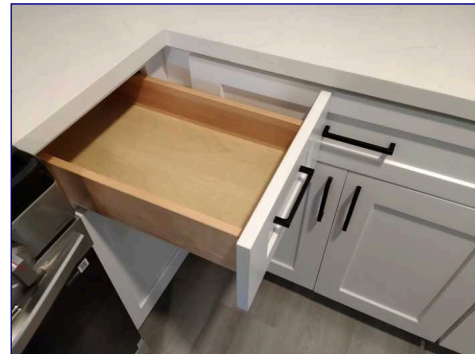
3.1. The kitchen cabinet drawers hit near stove and were in need of repair. Recommend repairing or replacing as needed.

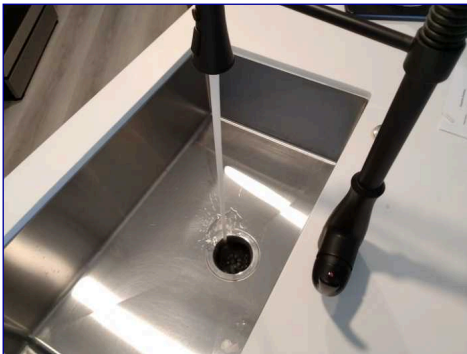
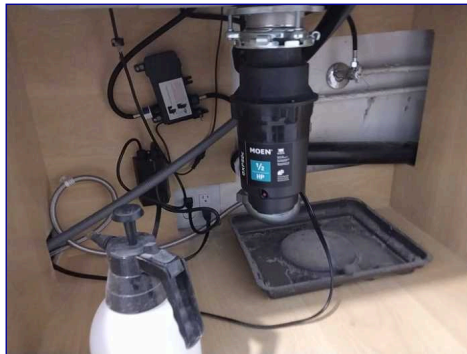
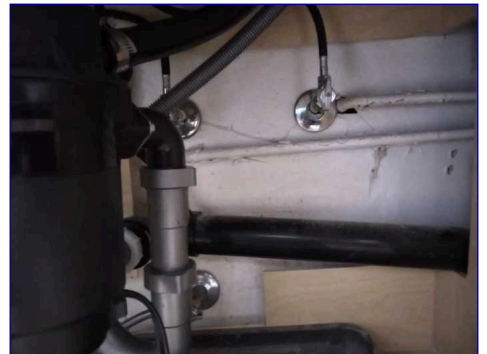
4.1. Sink drain unevenly sloped. Recommend evaluation from licensed plumber to properly install drain.

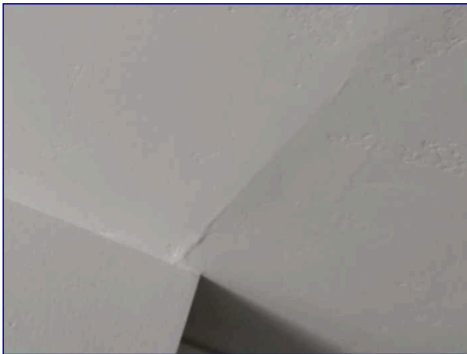
- 5.1. Finished floor apparently sloping, uneven. Recommend further evaluation by qualified professional.
- 5.2. Cracking present in the kitchen ceiling. Recommend monitoring and repair as needed by qualified professional.
- 5.3. Unfinished drywall, holes in sink cabinet. Recommend monitoring and repair as needed by qualified professional.

Cracks

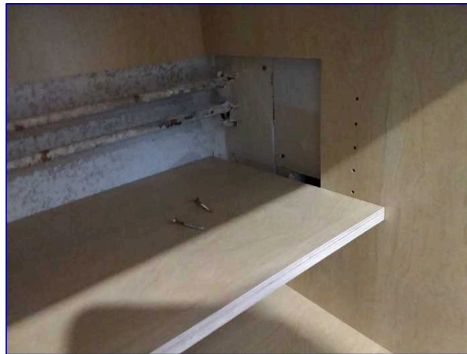
Holes sink wall

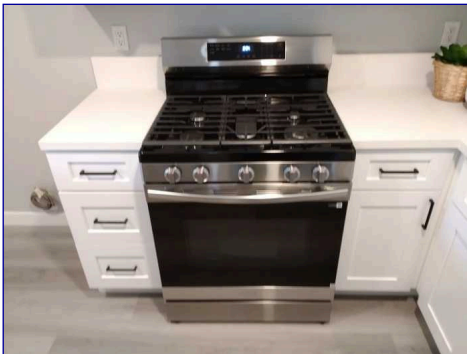
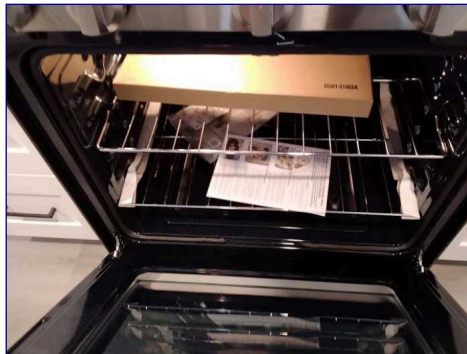
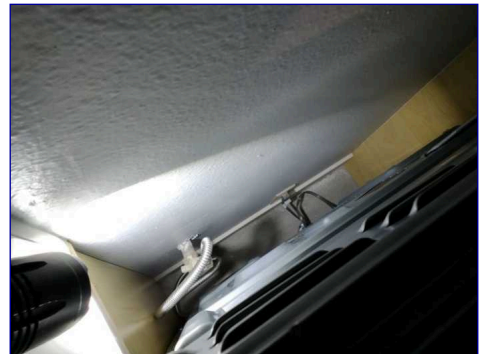
7.1. Unable to push oven back to wall, gas valve restricted clearance. Recommend further evaluation and repair by qualified professional.

7.2. There is no tip guard installed at the oven, which is a safety concern. Recommend a professional contractor install a tip guard.

Gas restricted

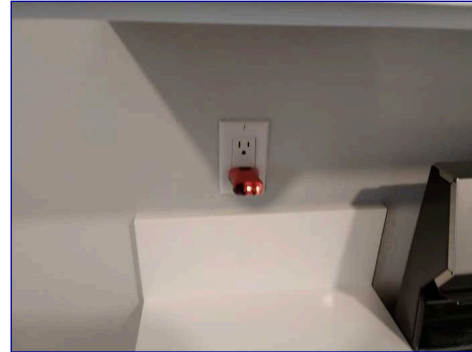
8.1. Missing **GFCI** receptacles observed in the kitchen at required locations, which is a safety concern. Recommend a licensed electrician install GFCI receptacles as required.

No gfci

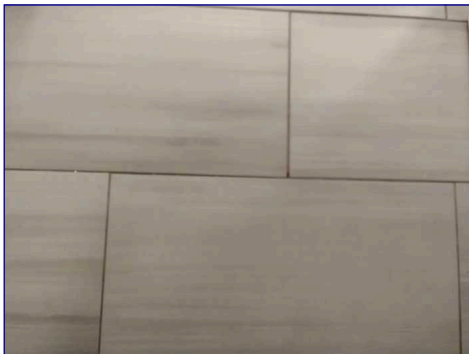
2.2. Floor covering apparent damage, grout cracking, tiles popping loose. Recommend further evaluation from qualified professional.

Loose

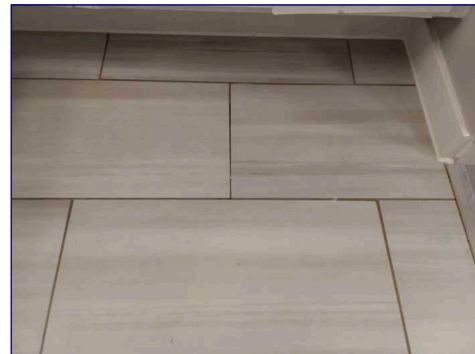
Loose

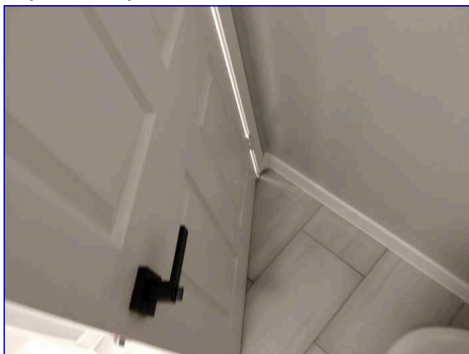
3.3. Door stop missing, recommend repair to prevent damage. Recommend evaluation and repair by qualified professional.

Missing door stop

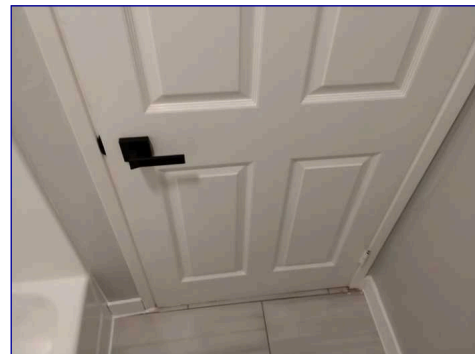
3.2. The entry door rubs/binds at casing. Recommend a professional contractor repair or replace for proper operation.

Door uneven

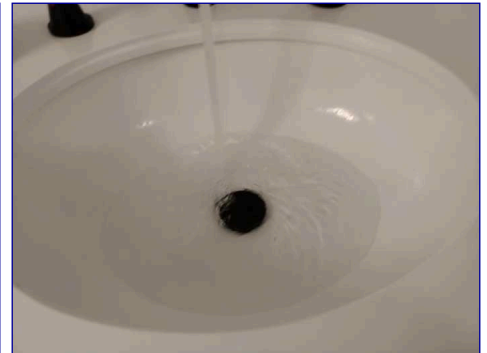
4.1. Sink was draining slowly during operation. Recommend a licensed plumber repair or replace as necessary.

Slow

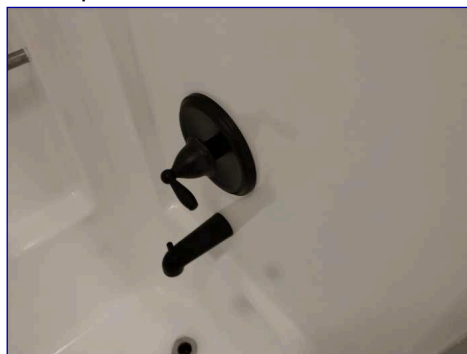
5.4. Faucet handle was difficult to operate. Recommend further evaluation and repair from licensed plumber.

Difficult

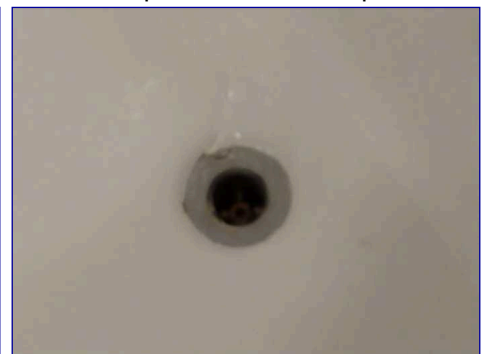
5.3. Plumbing drain corroded. Recommend further evaluation and repair from licensed plumber.

Drain corroded

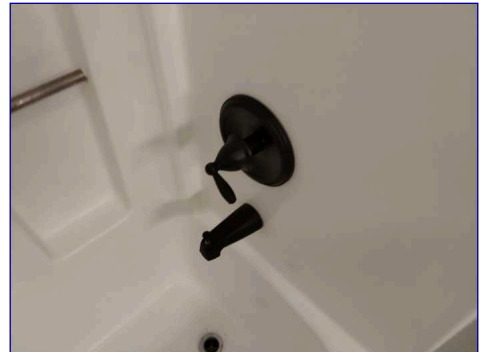
**5.4.** Faucet handle was difficult to operate. Recommend further evaluation and repair from licensed plumber.

Difficult

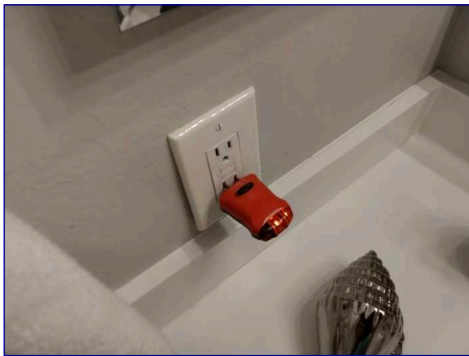
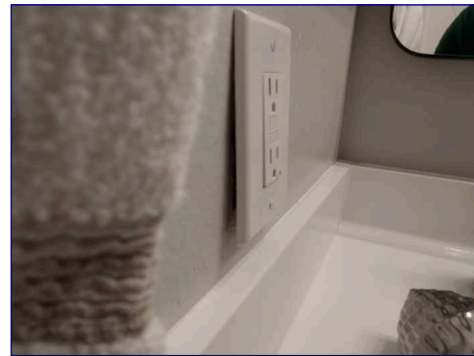
7.1. Wall outlet loose at wall. Recommend a licensed electrician to repair or replace.

Loose

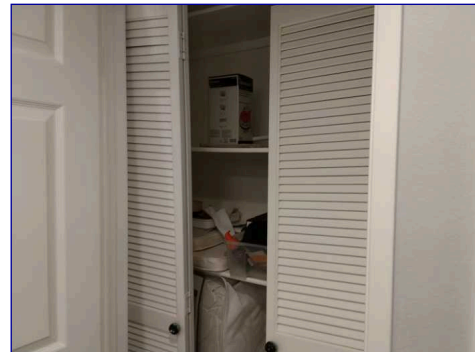
Doors in closet

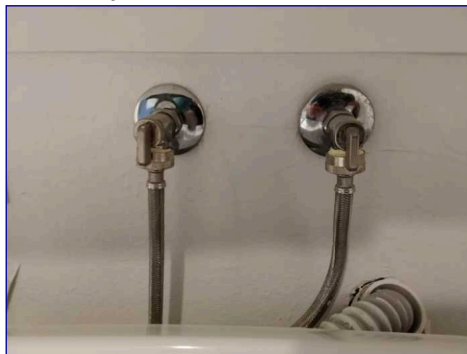
3.1. Washer plumbing valves were not installed with water hammer arresters. Recommend a licensed plumber repair or replace as necessary.

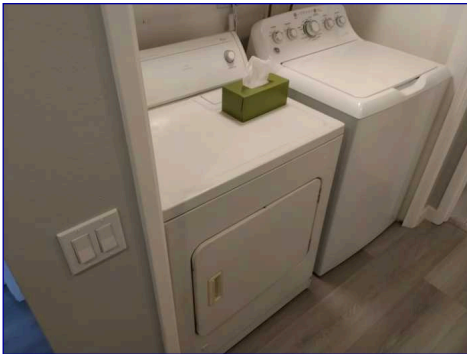
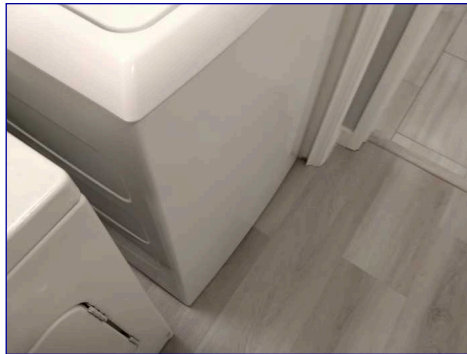
5.1. Washing machine not installed with drip pan. Recommend installation of drip pan by qualified professional.

No pan

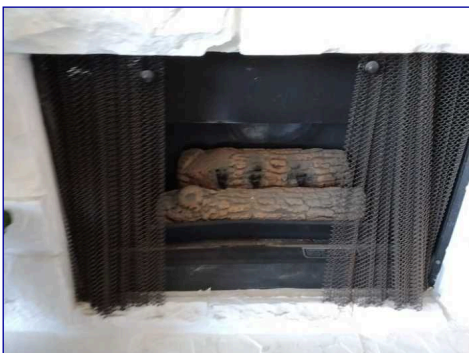
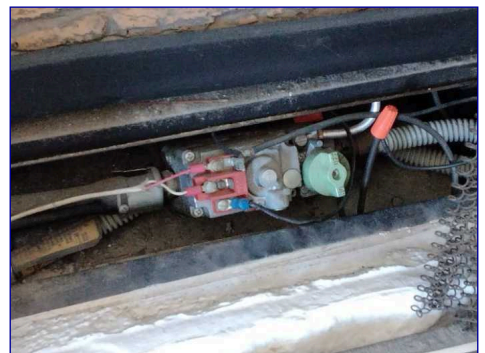
**3.1. Fireplace not operating at time of inspection. Recommend further inspection and repairs by a qualified professional or have seller show operation.**

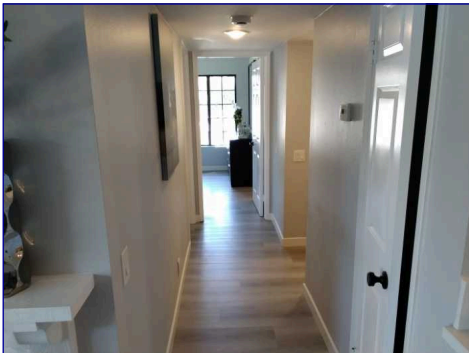
1.2. The hallway floor was apparently sloping, uneven. Recommend further evaluation from qualified professional.

Sloping

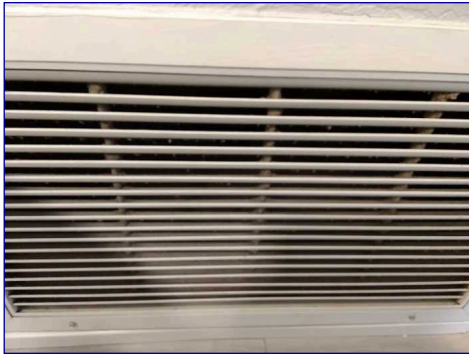
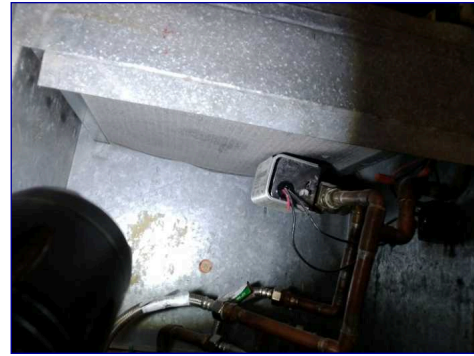
3.1. The furnace filter is dirty, return dirty. Recommend changing the filter per the manufacturer's recommendations and cleaning return.

Dirty

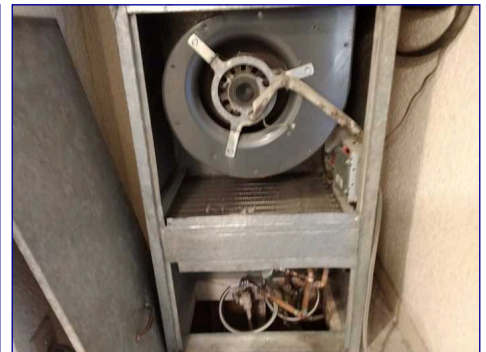
Corroded

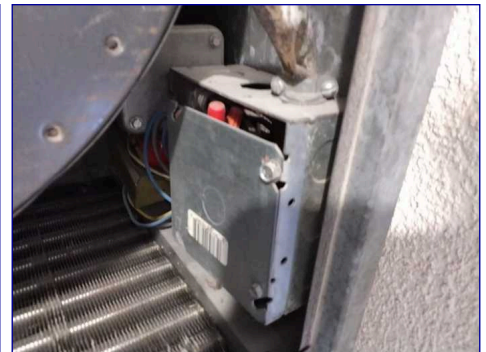
Open junction

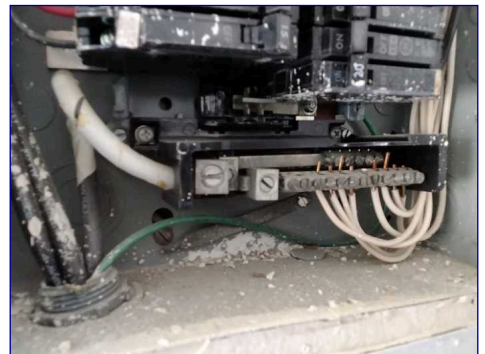
2.1. Panel uneven to wall, open voids around enclosure, which is a safety concern. Recommend licensed electrician evaluate and make necessary repairs.

Uneven, voids
