INGRAFFIA  
HOME INSPECTIONS

PROPERTY INSPECTION

July 25, 2026

123 Sample Street  
Corona Del Mar, 92625

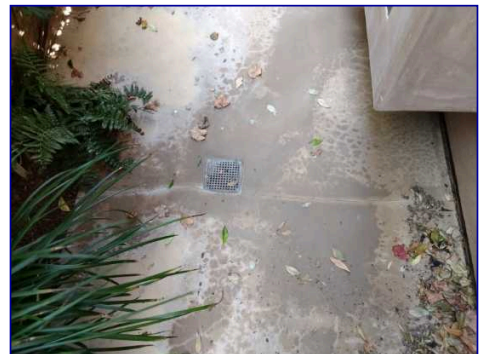
1.1. The walkway had some cracking, but is usable. Recommend a professional contractor seal the cracks to help prevent additional damage.

Cracks left

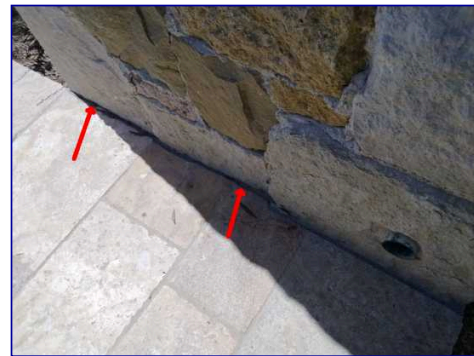
The Service Walk View

Joint cracks right

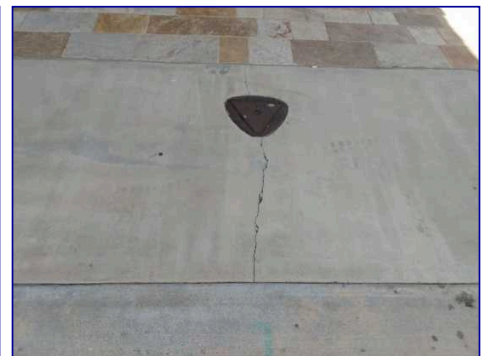
2.1. The driveway is cracked. Recommend sealing the cracks to help prevent additional damage. Consult a professional contractor as needed.

Cracks

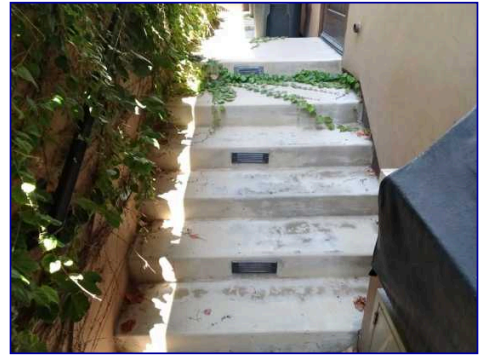
3.1. There are cracks on the front steps. Recommend a professional contractor evaluate to help prevent additional damage.

Cracks front

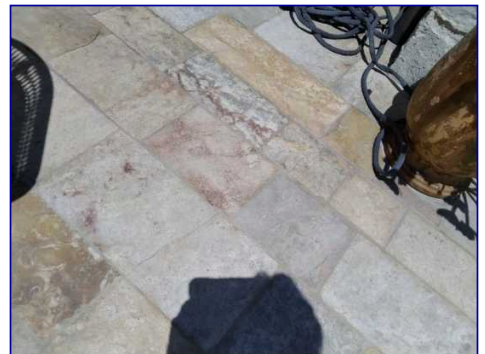
4.1. The patio has typical cracks. Recommend a professional contractor seal the cracks to help protect the cement from damage.

Cracks

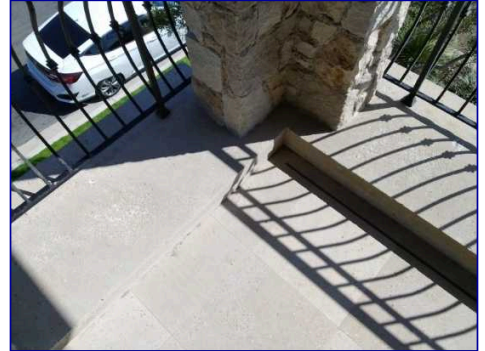
Deterioration front

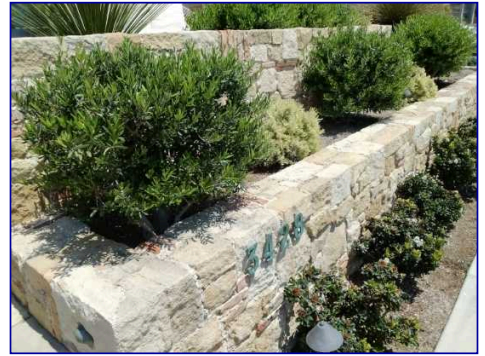
Cracks left

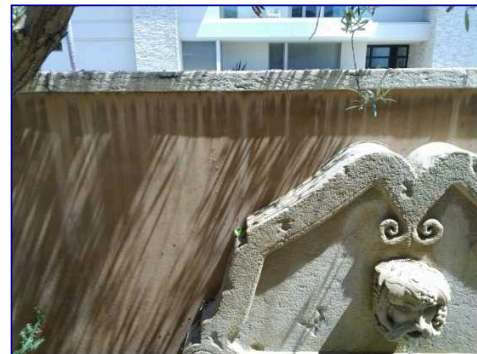
Cracks right

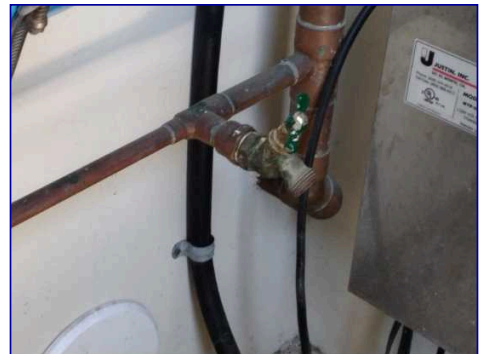
8.2. At least one hose bib is not equipped with an anti-siphon device. A possible cross-contamination can occur, which is a potential safety concern. A licensed plumber should install an anti-siphon/vacuum breaker.

No anti-siphon exterior right

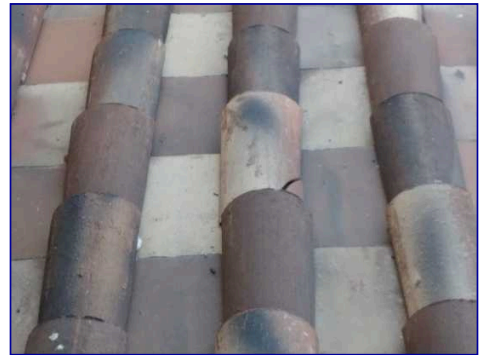
Cracking right

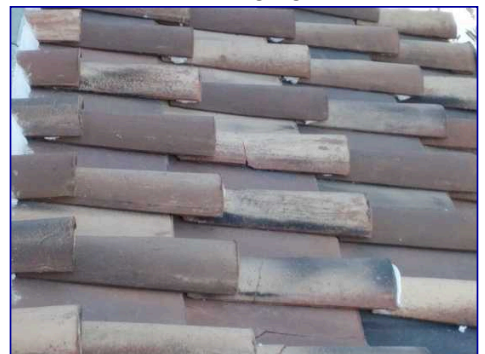
Cracking rear

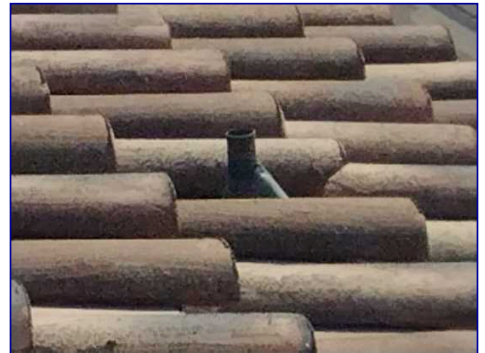
| Roof | | |
|---|---|---|
| Page 20 Item: 5 | Plumbing Vents - Mechanical Vents | <p>5.1. The mastic joint sealer were old and cracked, which can allow water to penetrate and cause damage to the roof coverings. Recommend a licensed roofer evaluate and repair, seal.</p> |

Mastic cracking

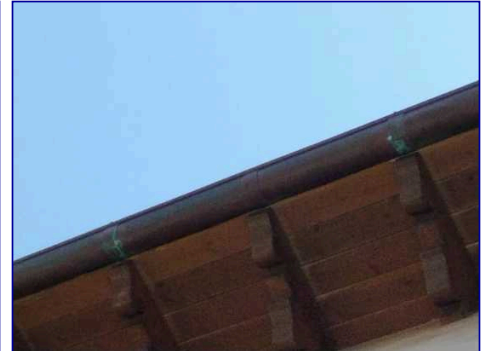
Seams leak left

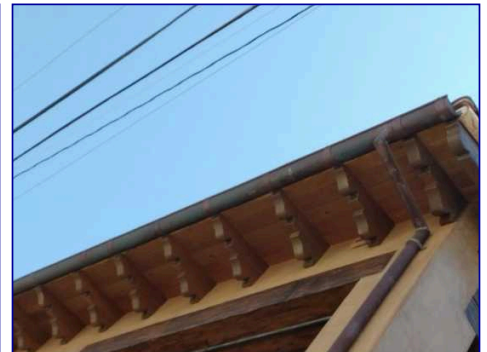
Corroded rear

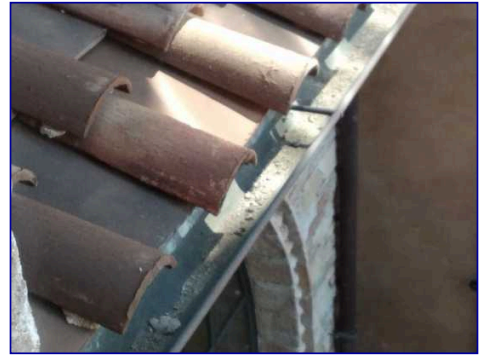
Debris

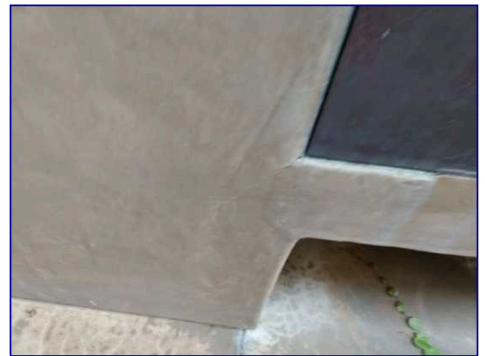
Cracks left

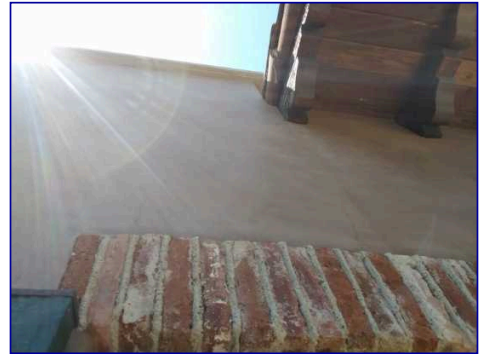
Cracks right

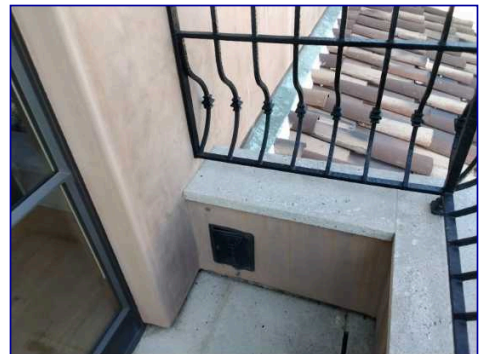
Upper right discoloration

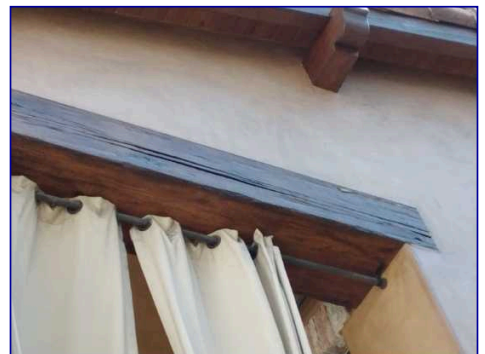
Left rear cracks, voids

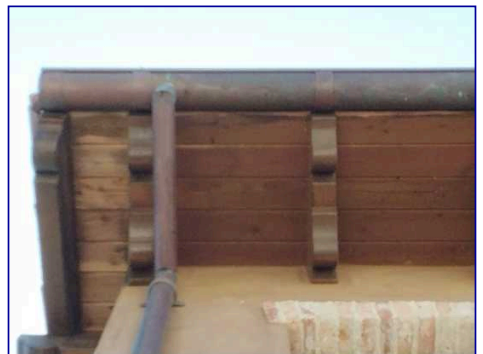
Water stains rear right

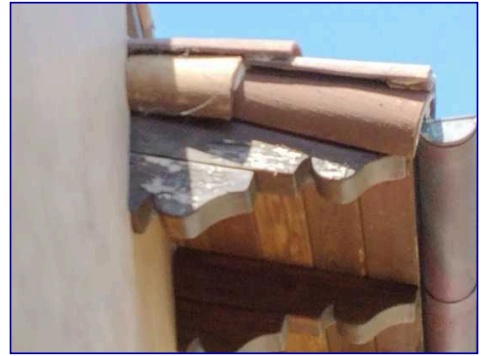
Peeling paint

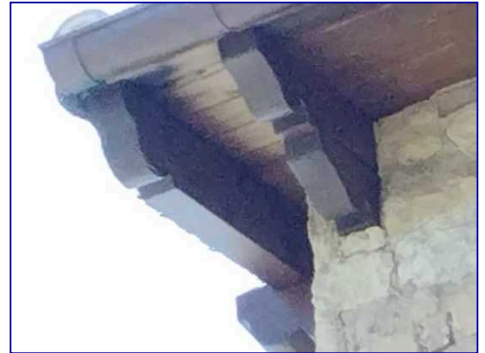
Water stains right

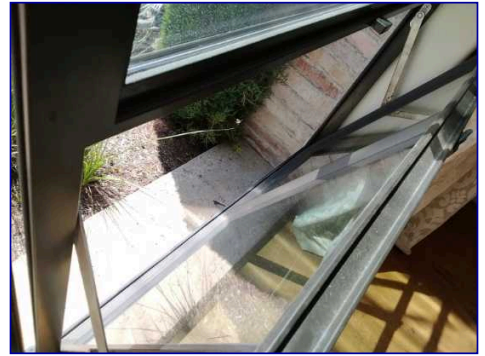
8.3. One or more exterior window frames and hardware have visible rusting, weathering. Recommend a professional contractor service to prevent additional damage.

Rusting

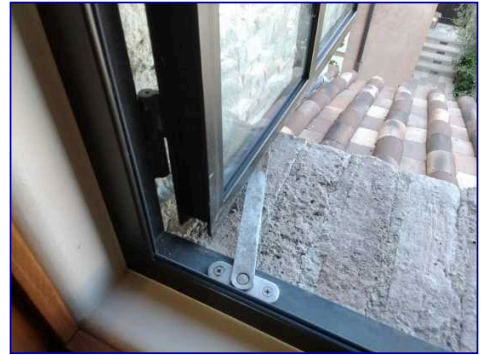
Rusting

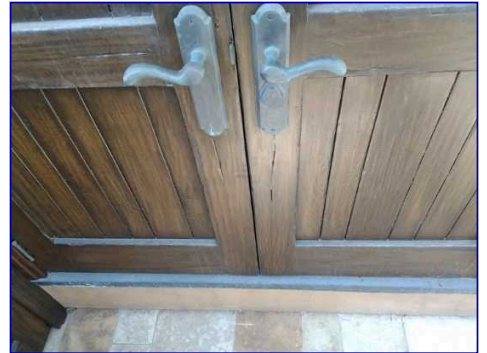
Right closet not latching

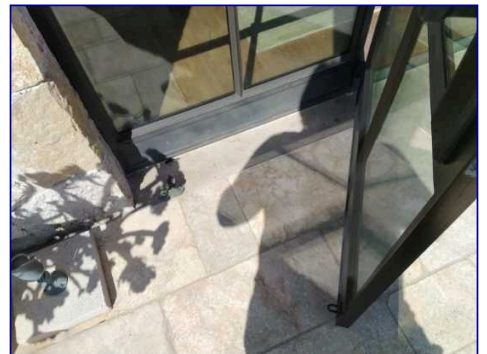
Kitchen hold down damage

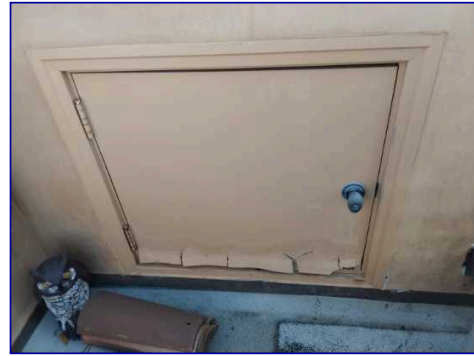
| Roof | | |
|---|---|---|
| Page 28 Item: 9 | Exterior Doors | <p>9.5. The rooftop attic door was damaged. Recommend a professional contractor repair or replace as needed.</p> |

Roof damage

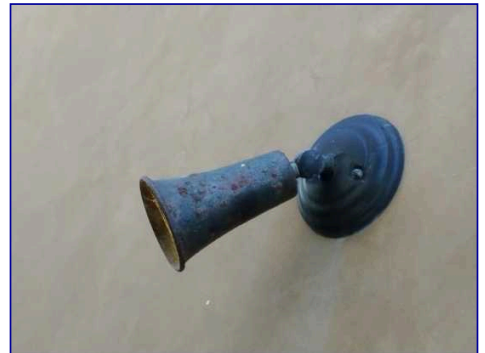
Rusting left

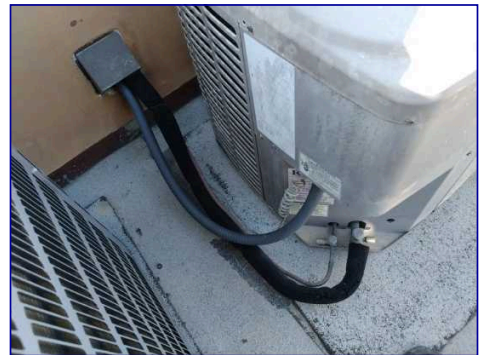
2.2. There is excessive rusting on the air conditioning compressor unit. Recommend evaluation from licensed HVAC technician.

Rusting

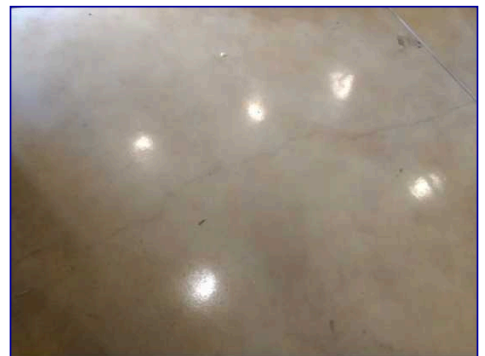
Cracks

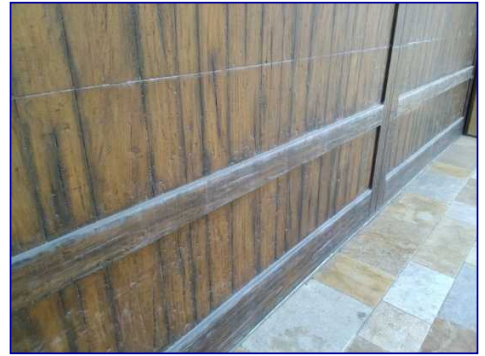
5.1. The garage doors were made of wood and/or Masonite. Doors/trim apparent discoloration. Recommend painting/staining the door to help prevent moisture damage.

Weathered

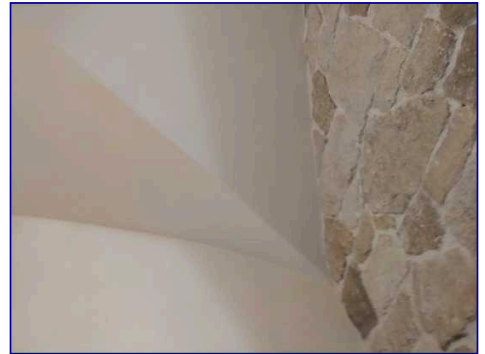
Cracks

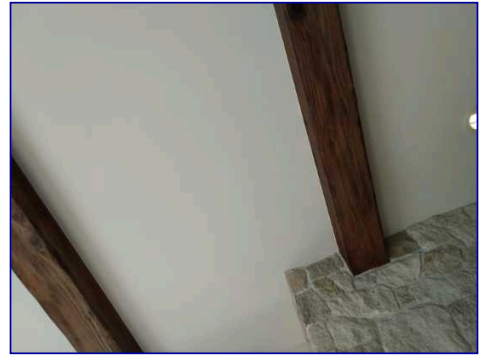
Cracks

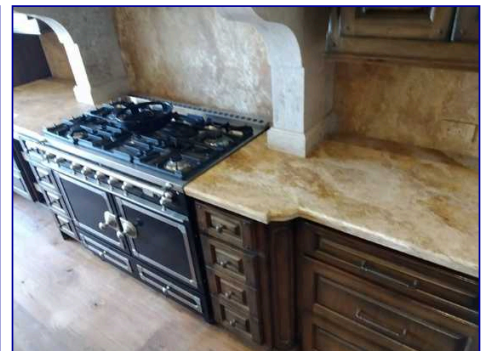
2.1. There are areas of missing or damaged grout/caulking near sink. Recommend re grouting, caulking to prevent condition from growing worse.

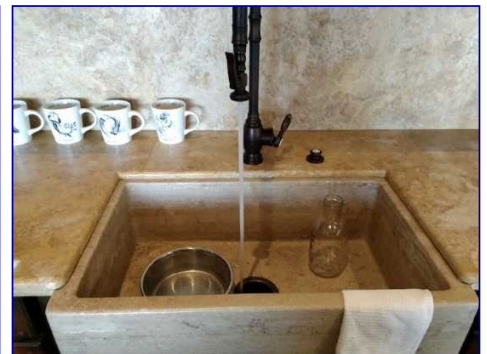
4.1. Sink faucet handles were not operating easily. Recommend evaluation from licensed plumber.

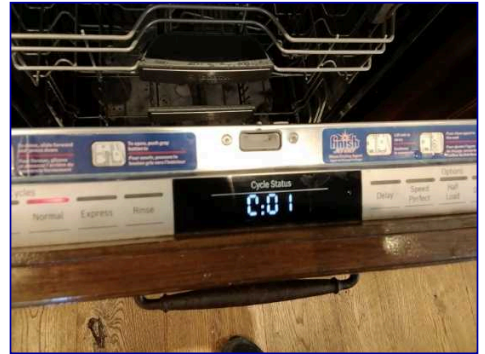
DW control worn

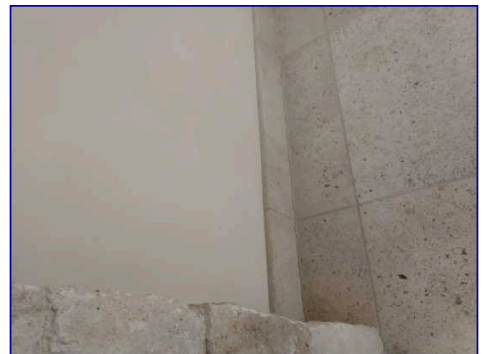
Floor grout cracks

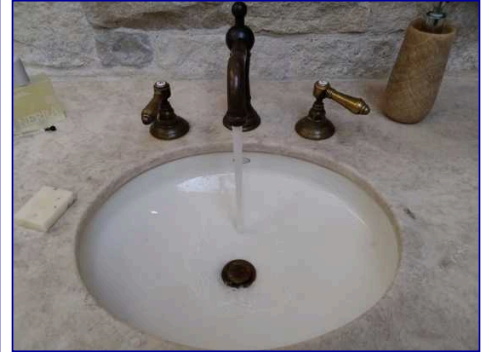
**Overall Condition:**  
4.1. Faucet handle(s) difficult to operate. Recommend further evaluation and repair from licensed plumber.

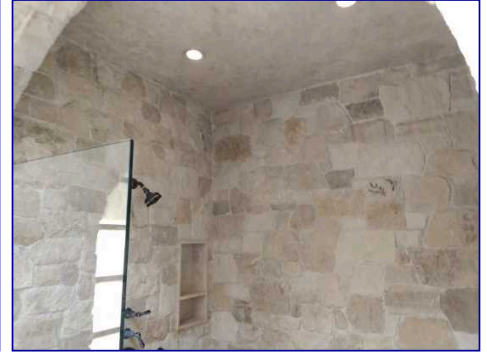
Corroded

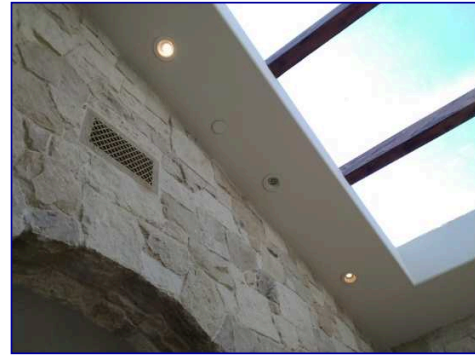
8.1. The bathroom light doesn't operate from the switch. Recommend changing the light bulb and retesting. Consult a licensed electrician as needed.

Light not operating

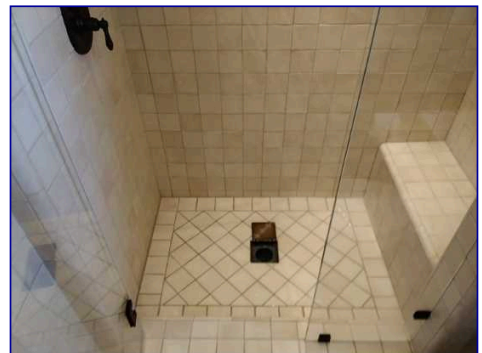
5.2. Damaged/cracking tiles observed within shower enclosure at seat. Recommend a full evaluation from licensed contractor and repair/replace as needed.

Cracks

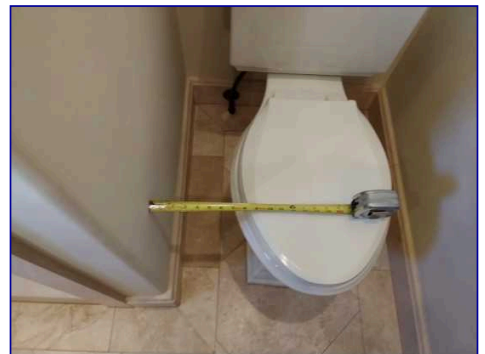
6.1. Toilet installed within 15" from center of bowl to adjacent obstruction. Recommend further evaluation from licensed plumber.

Less than 15"

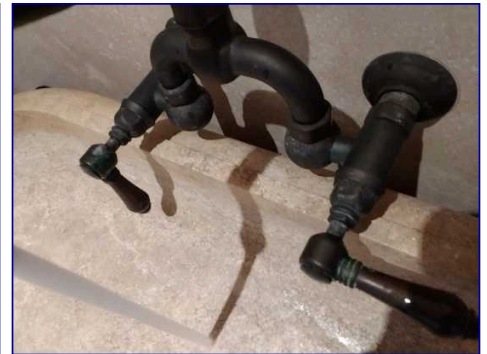
Corroded fixture

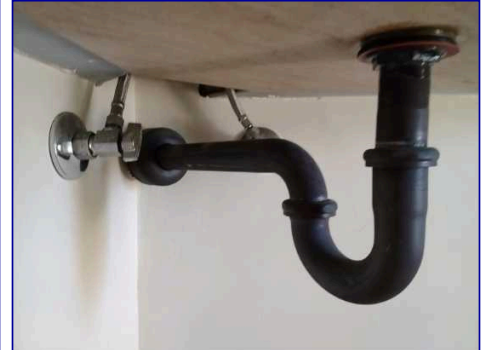
4.3. Apparent corrosion observed at sink faucet. Recommend a licensed plumber repair or replace as necessary.

Corroded fixture

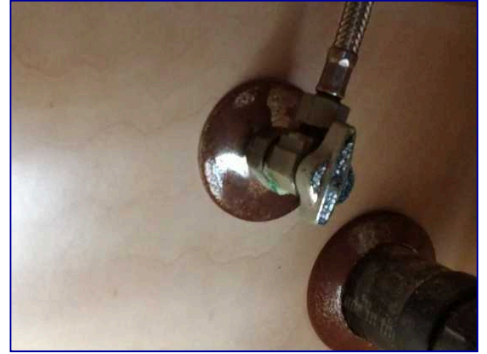
Corroded plumbing

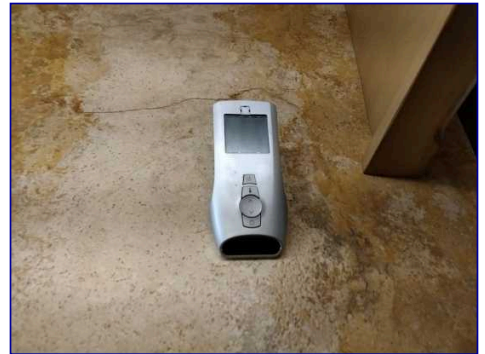
3.1. Remote control not operating. Recommend further inspection and repairs by a qualified professional.

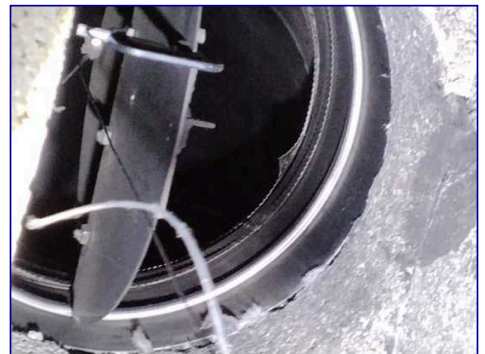
3.1. Open voids/bent edges at flue. Recommend further inspection and repairs by a qualified fireplace professional.

Flue bent, voids

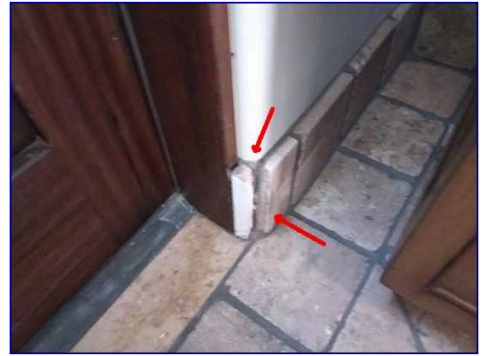
Damage by right entry

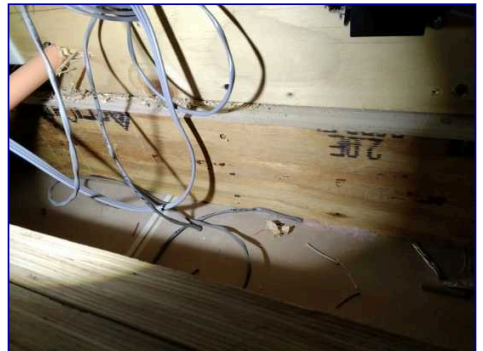
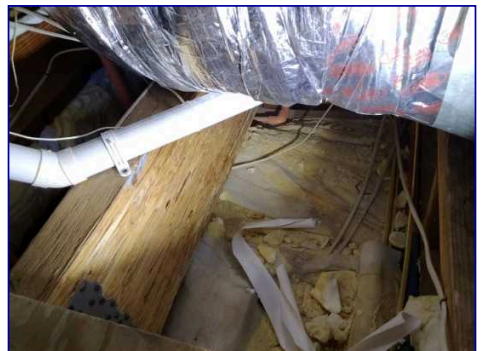
4.1. Insulation is displaced/compressed in the attic. Recommend a professional contractor add and or re-distribute the insulation around the attic.

4.2. Construction debris observed around attic. Recommend that all debris/trash be removed and attic cleaned. Work should be performed by qualified professional.

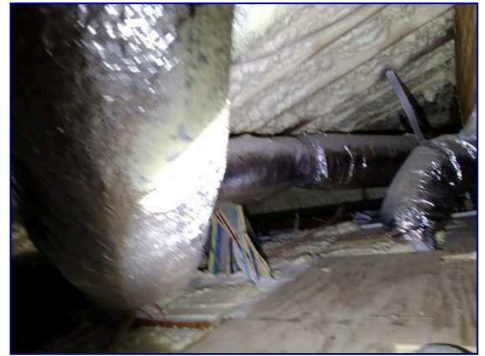
5.1. HVAC ducts within upper attic were torn/frayed, poorly supported. Register connections missing insulation. Duct was crushed, restricted near plenum. Recommend having duct work evaluated and repaired by licensed HVAC technician.

Damage,

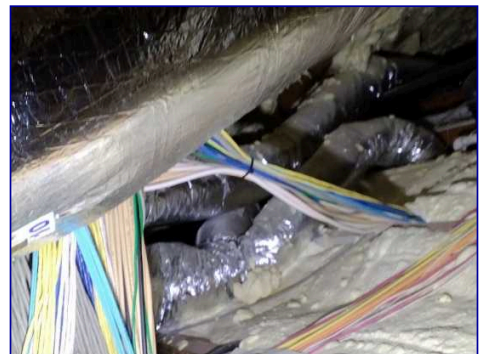
Missing insulation

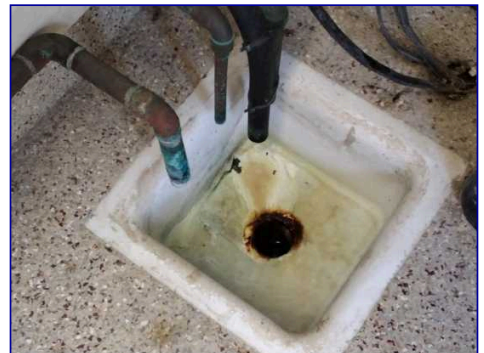
Corroded, rusting right closet

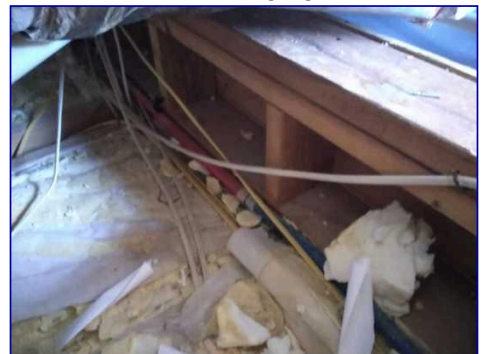
Non insulated

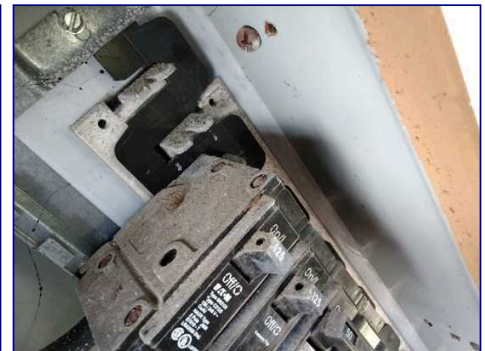
2.1. Bus bar heavy corrosion observed, which is a safety concern. Lower panel enclosure rusting.  
Recommend licensed electrician evaluate and make necessary repairs.

Bus corroded
