Ingraffia Home Inspections

PROFESSIONAL HOME INSPECTION

SUMMARY NOTES

11/13/2009

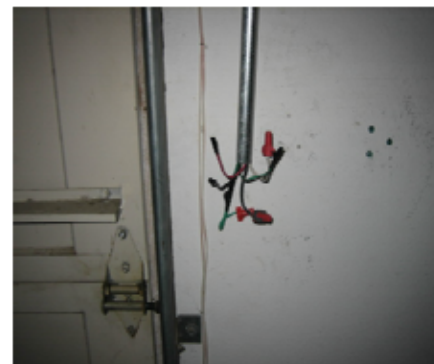
Note Number: F-01.11a

exposed wiring between the two garage doors was observed. The wiring hanging is live and should be mounted in a junction box. Recommend that a licensed electrician perform the work.

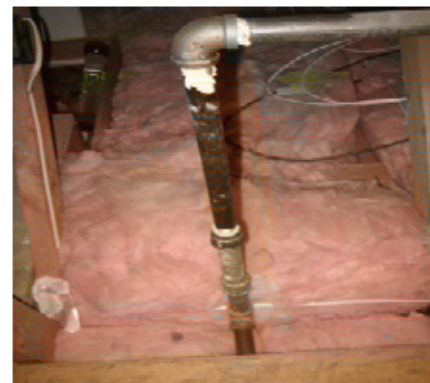
The gas line in the attic that supplies the heater is leaking at the elbow. Notice the white paste at the elbow in the picture.
