Home Inspection Report

Tuesday November 6, 2012

Ingraffia Home Inspections LLC www.Ingraffiahomeinspections.com 45 Blazewood, Foothill Ranch, CA 92610

Report Overview

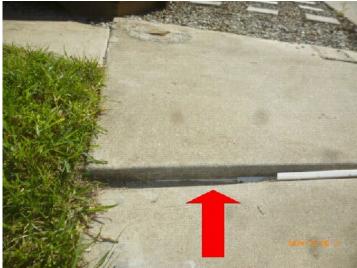
Trip hazard at front concrete walkway

Walkway had some cracking and settlement, should be repaired and/or replaced as needed.

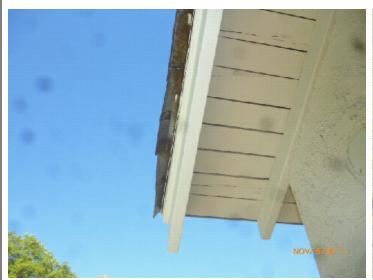
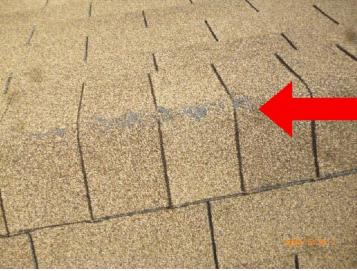
deterioration noted on roof

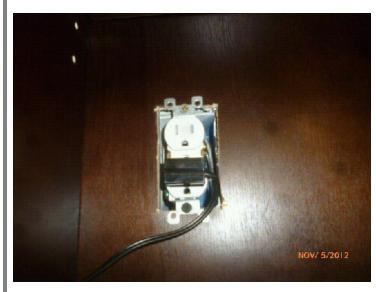
Front bedroom missing outlet cover

Missing outlet cover in front bedroom Main breaker is double-tapped - this is a safety concern. Recommend licensed electrician distribute the wires properly.
