Home Inspection Report

123 sample, sample, ca 92610

Inspection Date:

Tuesday November 6, 2012

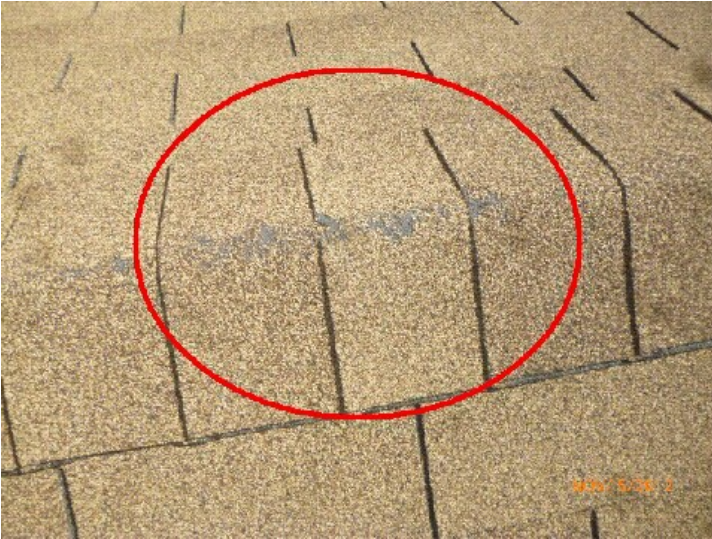
Monitor: Older roofs are, by their nature, a high maintenance roof. Annual inspection and repair should be anticipated. In addition, the older flashings should be monitored. In some cases, a deteriorated flashing can result in expensive repairs, because sections of the roofing have to be removed. As a rule of thumb, replacement of the entire roof covering may be logical if more than ten percent of the roof requires repair.

The roofing material employed on the majority of the roof is uncommon to this area. While it appears to be performing its intended function (keeping water out), we cannot estimate its future performance in this application. It is recommended that the roofer or manufacturer be contacted for more information and/or any warranties that may apply.

Roof surface deteriorating

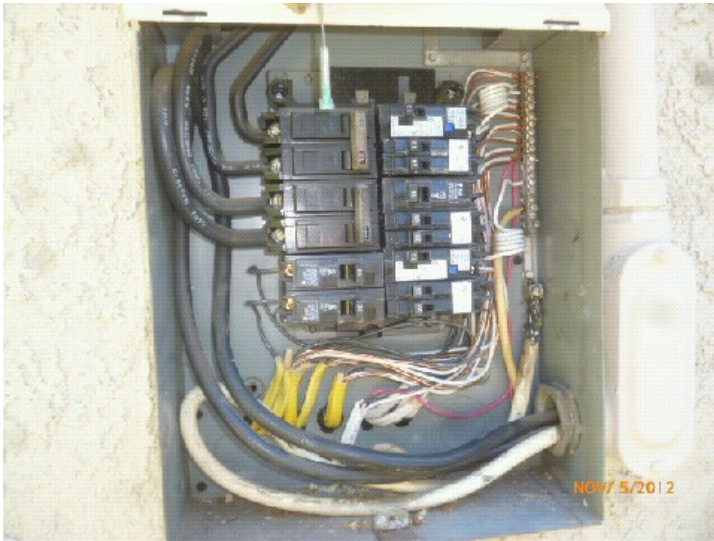
panel left side of house

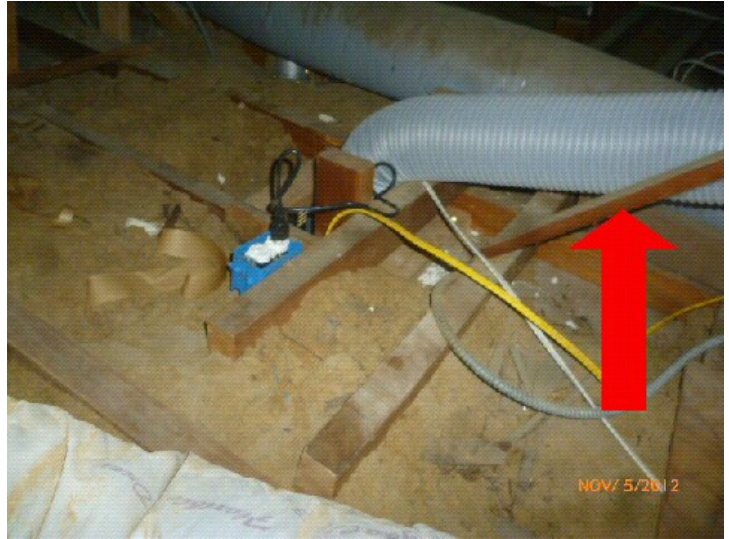
Damaged duct in attic

Improve: Duct cleaning is recommended.

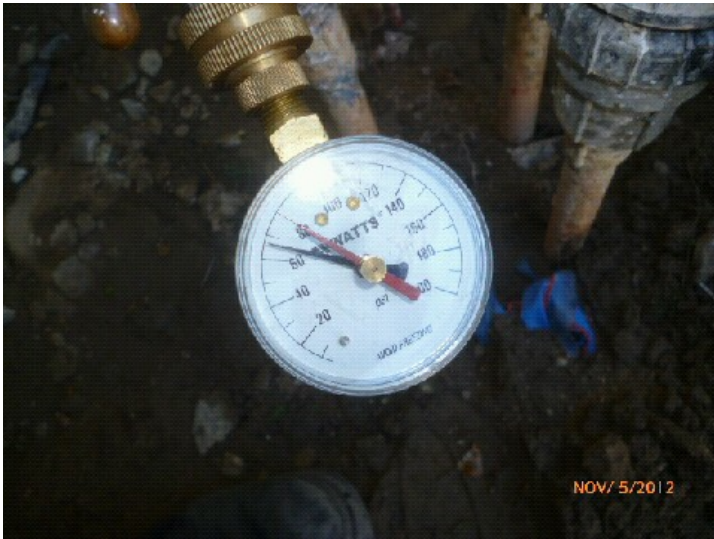
Water psi 75

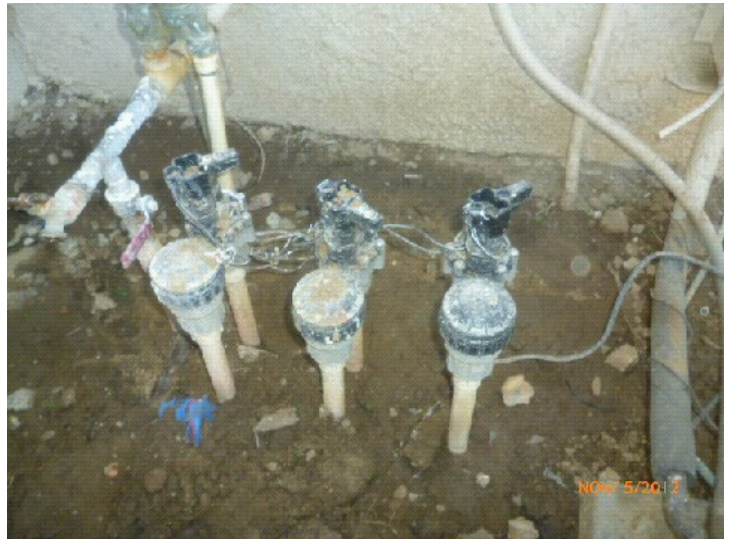
Water turn off front side of house

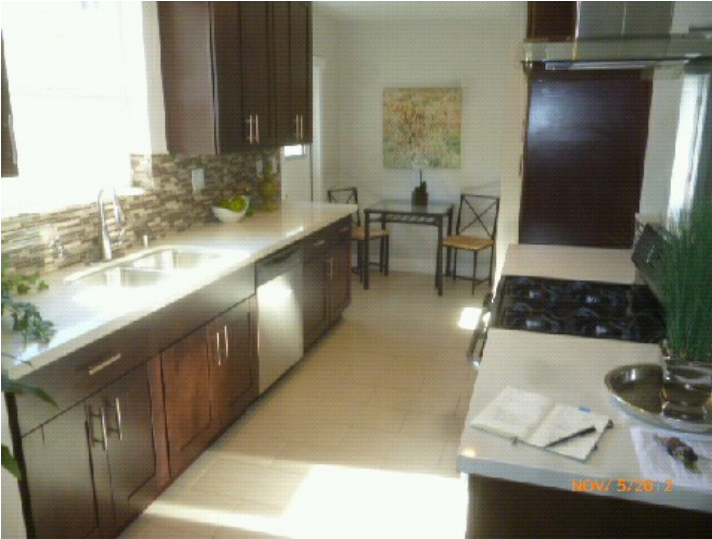
Kitchen

Monitor: The installation of the kitchen counters are relatively low quality.

Repair: Loose or damaged cabinet door hinges in the kitchen should be repaired.

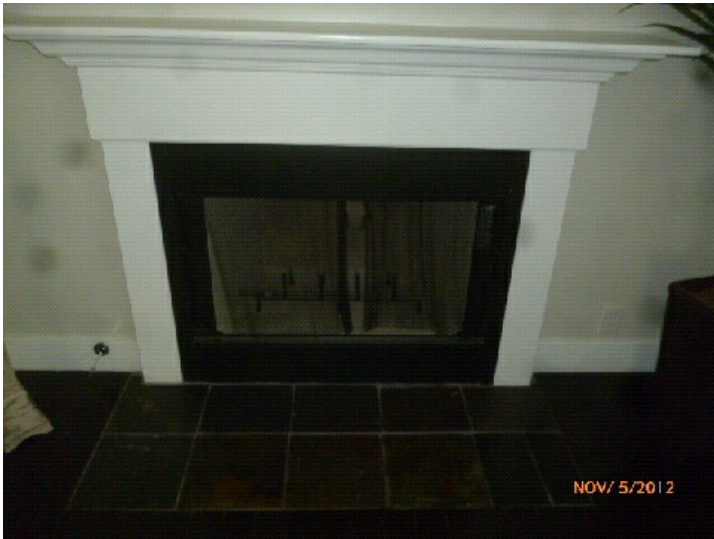
Living Room

On the whole, the fireplace and its components are in average condition. Typical minor flaws were observed in some areas.

Repair: The fireplace chimney should be inspected and cleaned prior to operation.
