INGRAFFIA  
HOME INSPECTIONS

PROPERTY INSPECTION

July 25, 2026

123 Sample Street  
Corona, 92879

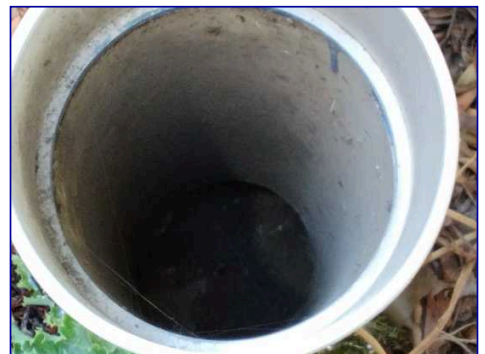
Debris, no cap

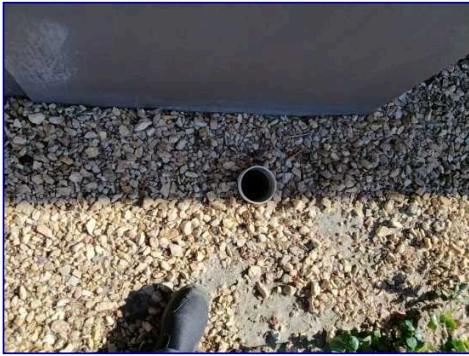
Front cap missing

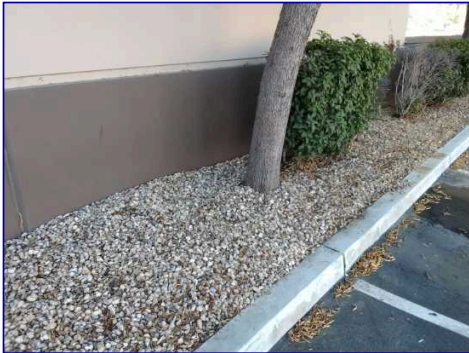
5.4. There is vegetation in contact with the rear building walls. Recommend trimming trees/vegetation at least 6-8", so it doesn't come into contact with the home.

Large tree at foundation

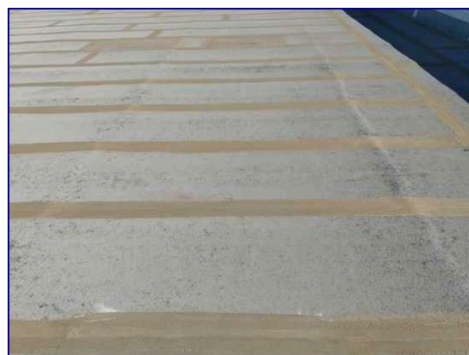
5.1. The roof was apparently in poor condition and will need repair or replacement by a professional roofer soon, but this cannot be warranted. Heavy deterioration of granules observed, joints were cracking/lifting. Recommend detailed evaluation from licensed roofing contractor.

Deterioration of granules

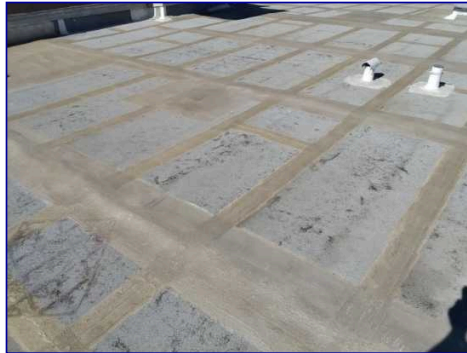
Deterioration of granules

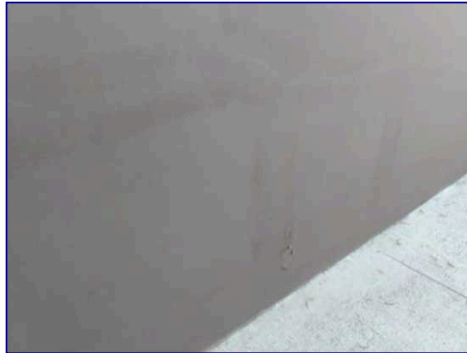
Discoloration, peeling left

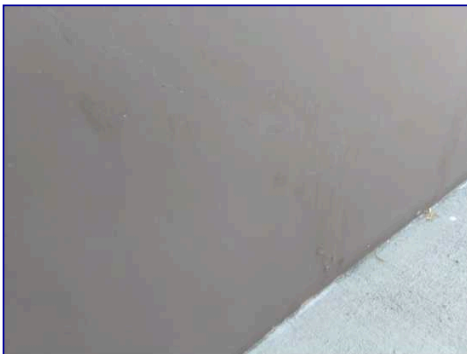
Cracks, peeling, discolored left

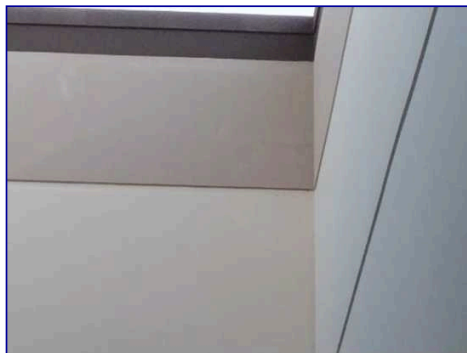
Cracks upper left

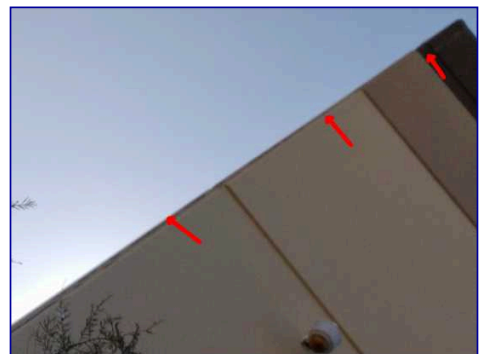
1.1. Upper left wall spalling, front left wall damage. Lower left walls were bubbling, deteriorated, efflorescence. Wall joints in need of service/repair, mastic cracking. Building walls were weathered, discolored. Recommend a licensed professional contractor evaluate and repair.

Rear left joint voids

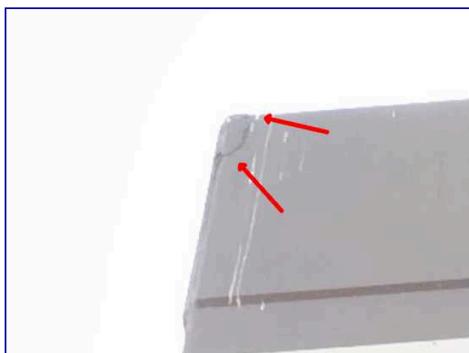
Ledt rear spalling

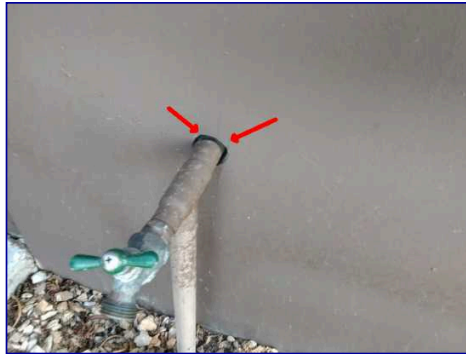
Poor caulking front pipe

2.1. Recommend caulking around plumbing, utility penetrations to prevent moisture and pest intrusion. Work should be done by qualified professional.

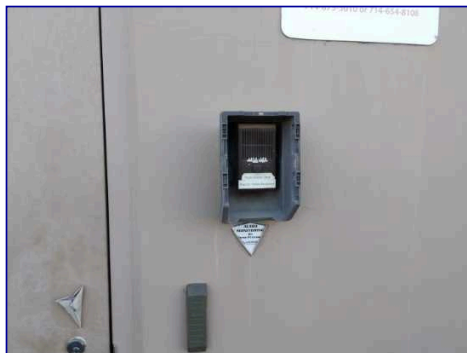
6.1. Left rear junction box cover was missing or damaged. Recommend a licensed electrician repair.

Left box cover missing

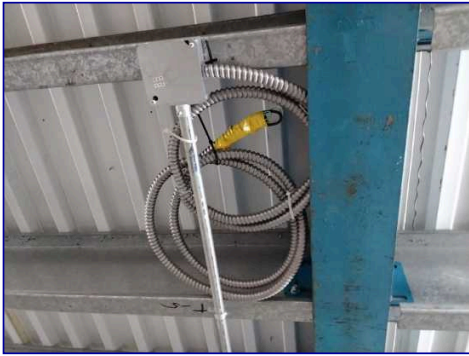
Open wire ends

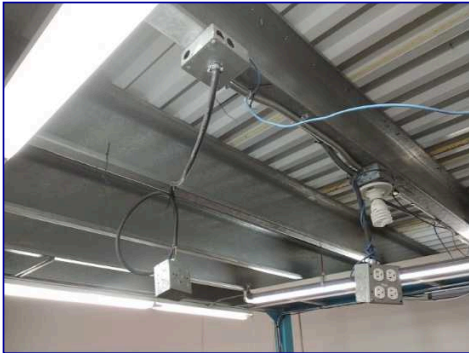
5.3. Several junction boxes were missing knock out plates around warehouse. This is a safety concern. Recommend a licensed electrician repair.

Open knock outs, damage wires

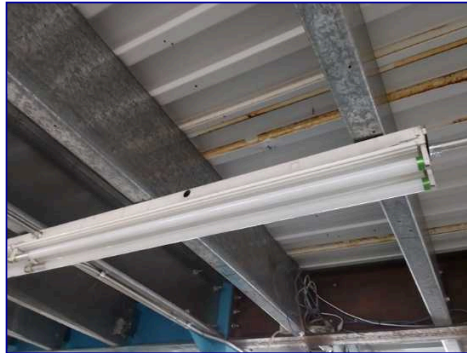
5.1. Several light don't operate when the light switch is engaged. Recommend changing the bulb and re-testing. Lower mezzanine light was damaged, bent. Consult a licensed electrician as needed.

Damage light under racks

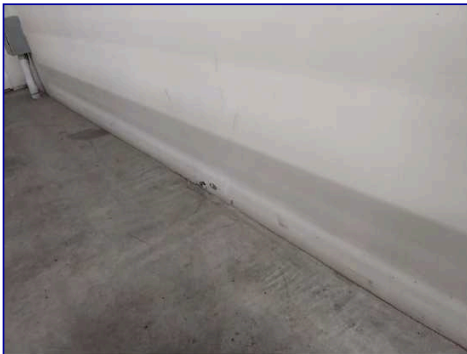
6.3. Lower walls off left side apparent deterioration, bubbling, efflorescence. Recommend monitoring and repair as needed by licensed contractor.

Discoloration, deterioration lower wall

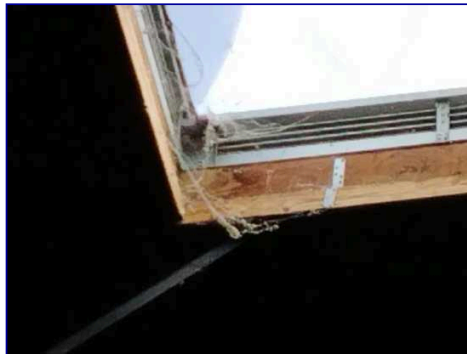
6.5. Apparent water stains/discoloration observed at roof trusses/plywood. Monitor and repair as needed by licensed contractor.

Stains near skylight

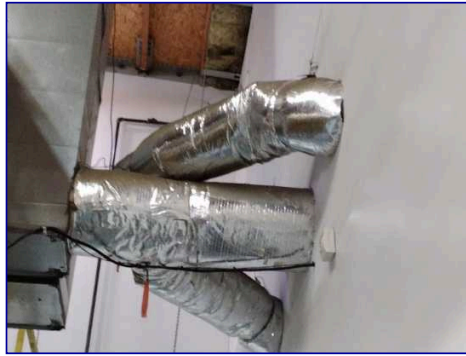
Flex ducts voids

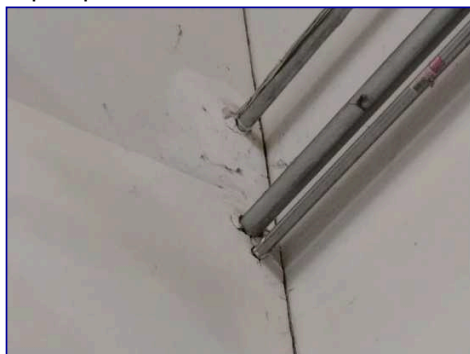
6.2. One or more holes and or penetrations were present at the firewall/ceiling adjacent to office spaces. Recommend installing fire caulk and repair all penetrations for added safety. Consult a professional contractor as needed.

Pipe voids firewall

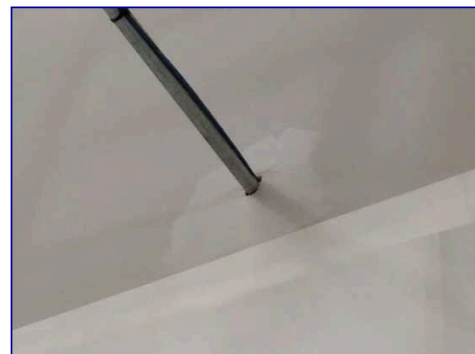
Pipe voids firewall

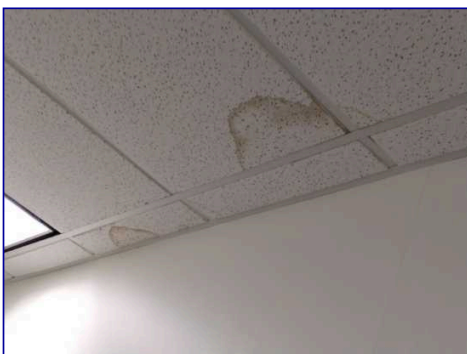
- 2.6. There is staining on the entry lobby right wall. There was no current moisture at the time of the inspection. Monitor and repair as needed.
- 2.7. There is water staining on the hallway ceiling tiles. There was no current moisture at the time of the inspection. Monitor and repair as needed.

Stains hall ceiling

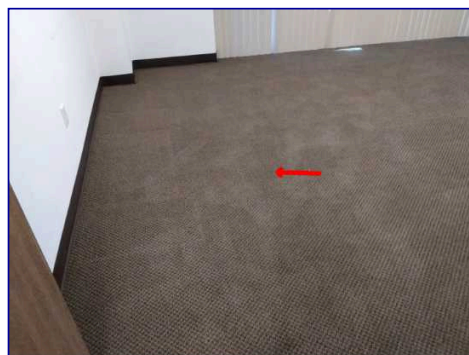
- 2.3. The flooring system was apparently sloping, uneven front left office, front center office. Recommend evaluation from qualified professional and or contractor.

Sloping front office

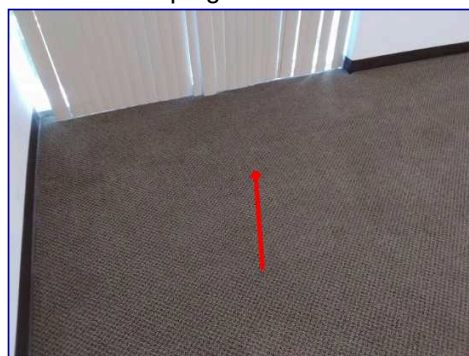
Floor uneven front office

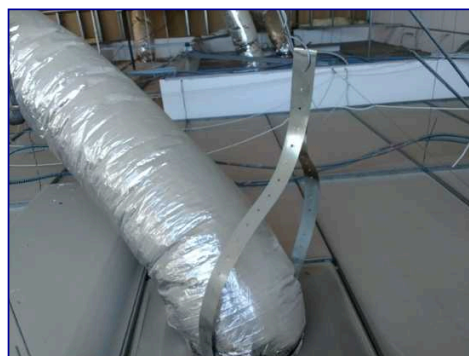
- 2.4. T bar cables loose above lobby. Recommend a professional contractor evaluate and repair.
- 2.5. Wall joints cracking, not properly sealed. Recommend monitoring and repair as needed by licensed contractor.

Lobby register ties loose

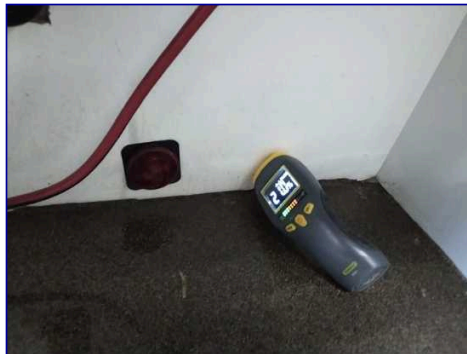
5.1. There are apparent moisture stains in the sink wall within cabinet. Moisture tested over 20%. Recommend further evaluation and repair by qualified professional.

Moisture under sink
