INGRAFFIA  
HOME INSPECTIONS

PROPERTY INSPECTION

# 123 Sample Street

## Santa Ana, 92701

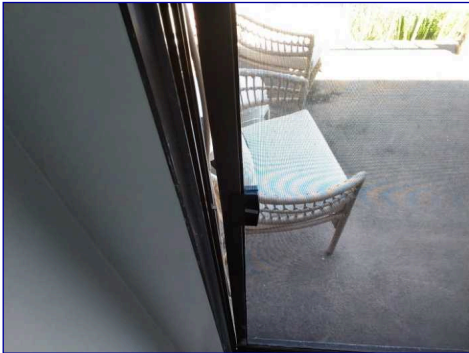
Balcony screen bent
