INGRAFFIA  
HOME INSPECTIONS

PROPERTY INSPECTION

July 25, 2026

123 Sample Street  
Corona Del Mar, 92625

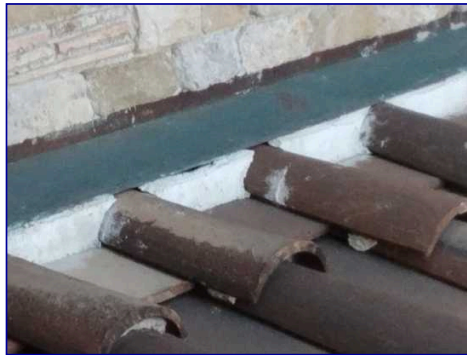
4.3. The roofing system was considered marginal and requires repair. Recommend a licensed contractor evaluate and repair all affected areas.

Right cement cracks

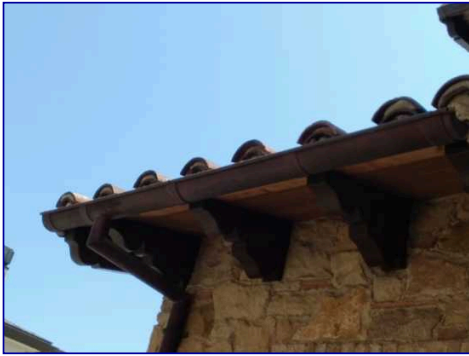
- 2.1. The gutters are dirty. Recommend cleaning the gutters to ensure proper water flow to the downspouts.
- 2.2. The gutters were incorrectly pitched at areas around building. Recommend a licensed professional repair.
- 2.3. There is evidence that the gutter is leaking at the seams. Recommend a professional contractor evaluate and repair as needed.
- 2.4. Gutters were rusting, weathered. Recommend a licensed professional repair or replace as needed.

Rusting, uneven right

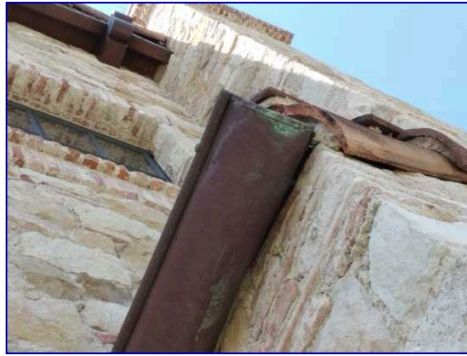
Leaking seam right

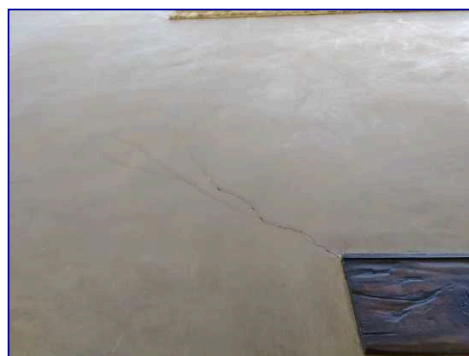
3.1. The stucco siding had typical cracking present in one or more areas. Monitor and repair as needed.

Cracks left rear

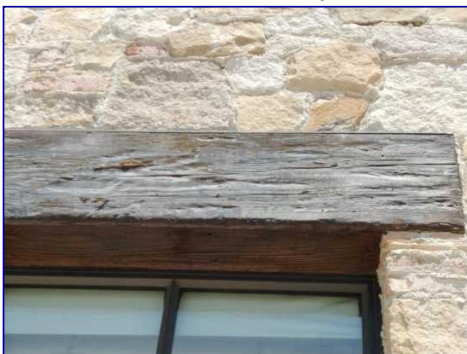
Weathered, peeling front

4.1. The exterior wood trim and shutters were in need of normal painting, service and maintenance. Recommend a professional painter repair/paint the exterior trim.

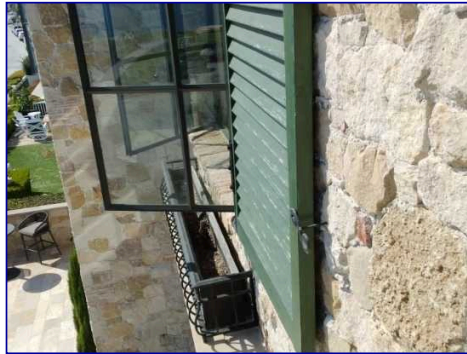
Shutters weathered, peeling

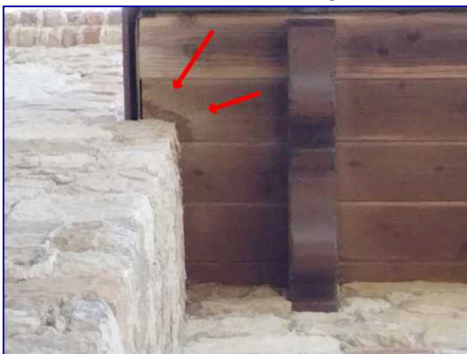
5.3. One or more areas have evidence of moisture stains. Recommend monitoring and repair as needed by qualified professional.

Water stains left

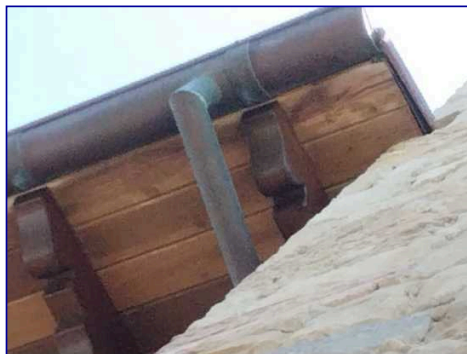
Water stains left

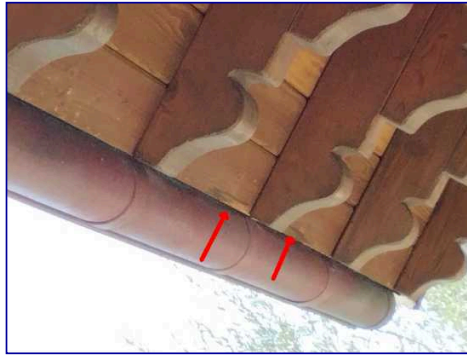
Water stains right rear

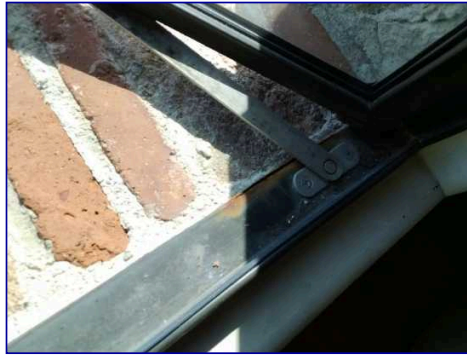
8.2. Second floor front center den lower frame was rusting, damaged. Repair as needed by qualified professional.

Front den rusting

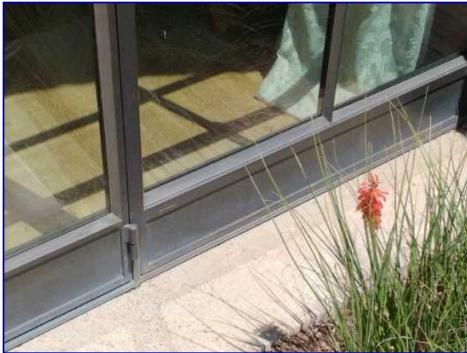
- 9.1. Rear balcony closet doors were weathered. Recommend a professional contractor paint or stain to protect from further damage.
- 9.2. Entry doors and hardware were weathered, rusting. Recommend a professional contractor service to prevent conditions from growing worse.
- 9.3. Exterior right water heater doors uneven, lower latch unable to close. Recommend a professional contractor repair.
- 9.4. Kitchen door floor hold down was damaged, loose. Recommend a professional contractor repair.
- 9.5. The rooftop attic door was damaged. Recommend a professional contractor repair or replace as needed.

Front right weathered

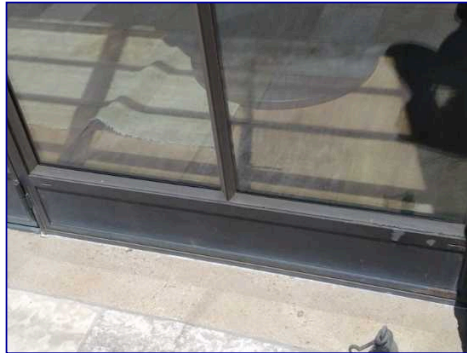
Front left rusting, weathering

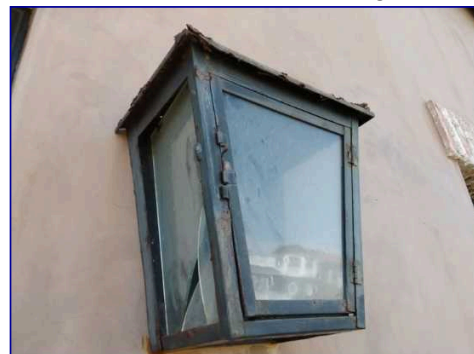
Deterioration upper right

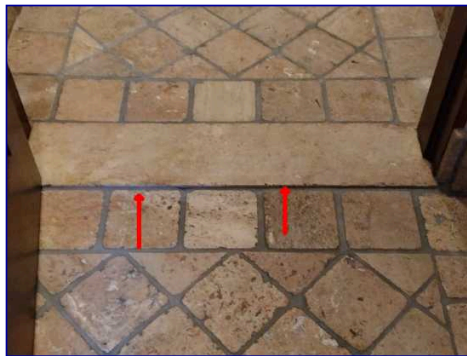
4.3. There was a trip hazard present on the garage floor at service entry. Potential safety concern. Consult a licensed contractor for repairs/replacement as needed.

Uneven entry floor

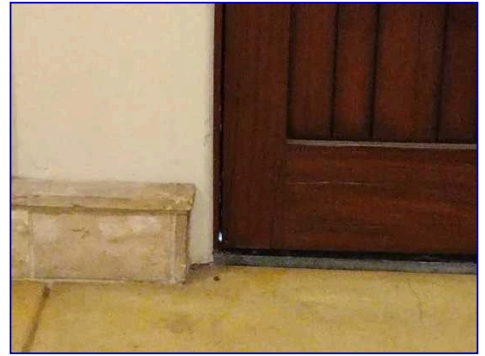
6.2. The garage rear service door weatherstripping is missing or damaged. Recommend replacing the insulation.

Rear poor weather stripping

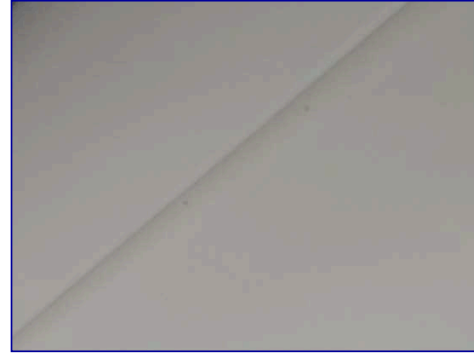
2.1. There is staining/spots on the right side room ceiling. There was no current moisture at the time of the inspection. Monitor and repair as needed by qualified professional.

Stains right ceiling

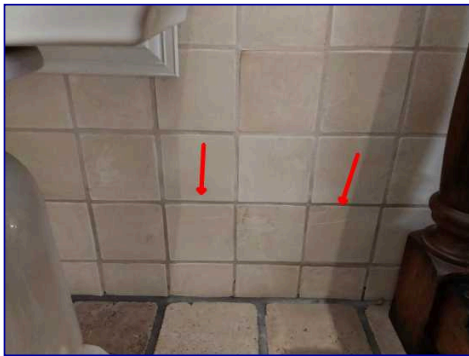
2.1. Right side walls cracking by sink and toilet. Recommend further evaluation from qualified professional.

Right wall cracks

Cracks

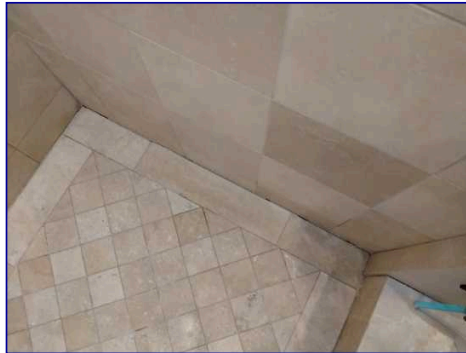
Poor grout

5.1. Recommend caulking/grouting in the shower area to help prevent damage from water penetration. Work should be performed by qualified professional.

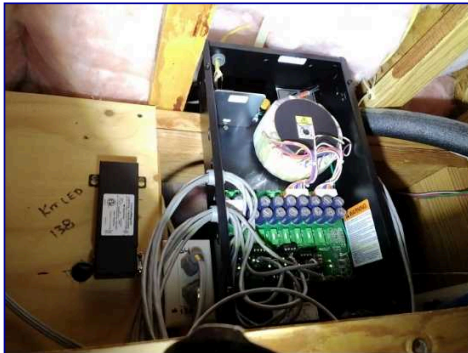
- 6.1. Lower attic junction box missing cover plate. Recommend a licensed electrician repair.
- 6.2. Light not operating within attic. Recommend bulb be replaced and checked for proper operation.

Box cover missing

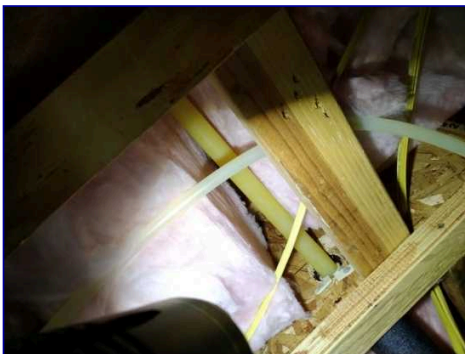
2.3. Water supply pipes hot side were not properly insulated in attics. Lower attic pex pipe missing sleeve at wall stud. Recommend a licensed plumber evaluate and repair as needed.

Missing insulation lower attic

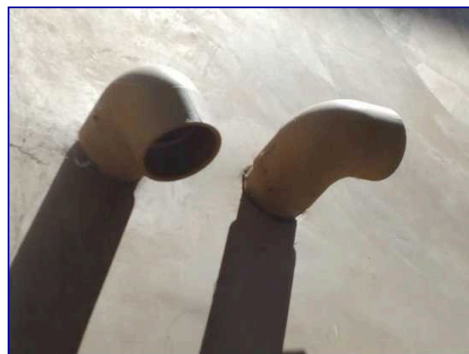
4.1. Vent pipes unsecured within closet, exterior pipes not sealed at house wall. Repair as needed by qualified professional.

Exterior pipe voids

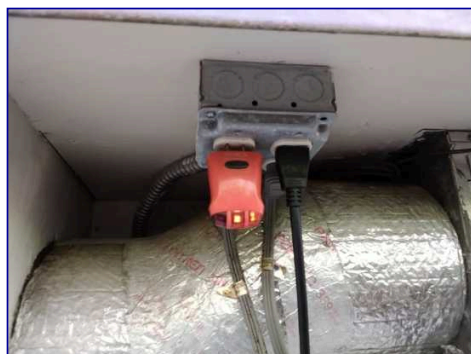
2.1. Exterior left side house cabinet systems showed signs of sweating, corroded cabinets. Housing enclosure stains, discoloration with rag wrapped around line set. Electrical outlet was non GFCI protected. Recommend evaluation from licensed HVAC technician.

Exterior no gfcf

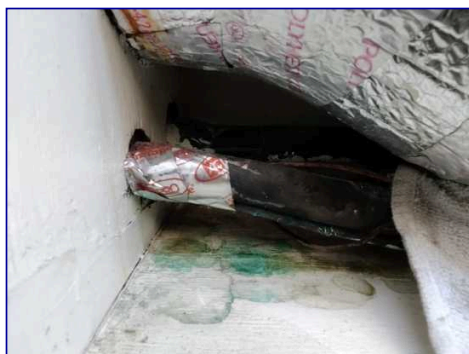
Exterior closet damage, stains
