INGRAFFIA  
HOME INSPECTIONS

PROPERTY INSPECTION

July 25, 2026

123 Sample Street  
Corona, 92879

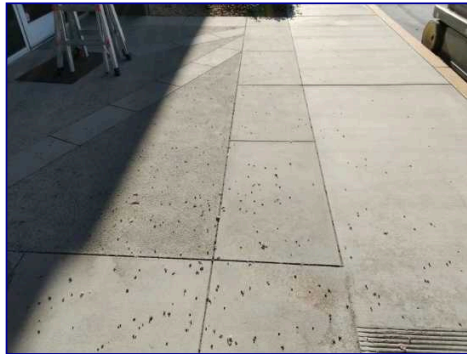
1.3. There are uneven slabs at the front walkway near warehouse entrance, which could be a tripping hazard. Recommend using additional caution in these areas. Repair or replace as needed by qualified professional.

The Service Walk View

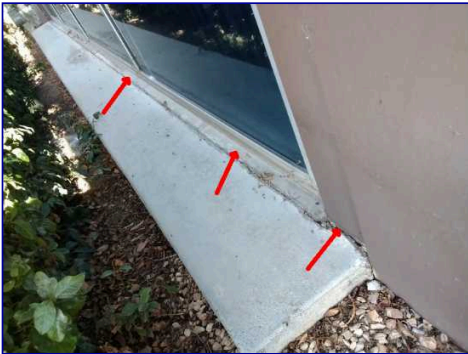
1.2. There is a gap between the walkways and the front building wall. Recommend sealing the gap between the walkways and home to prevent moisture intrusion.

Voids front

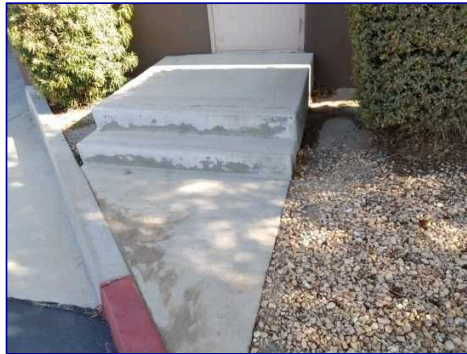
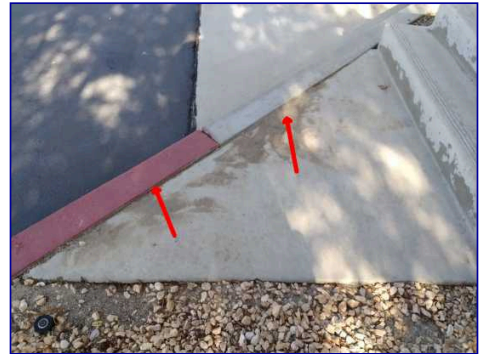
Trip front

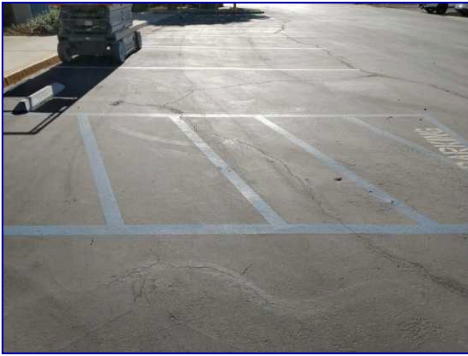
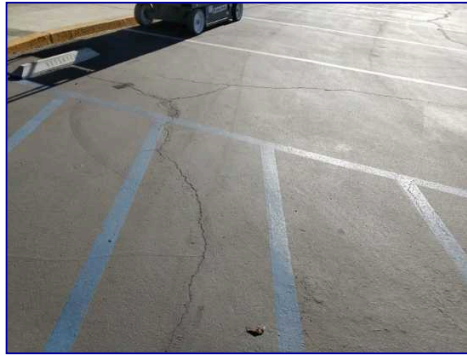
Cracks

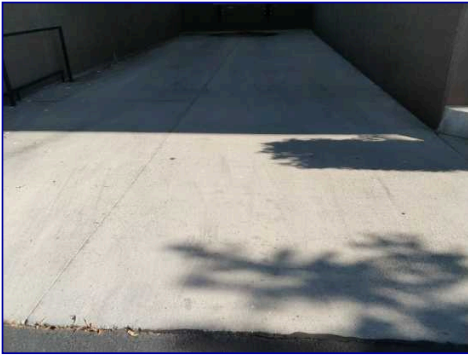
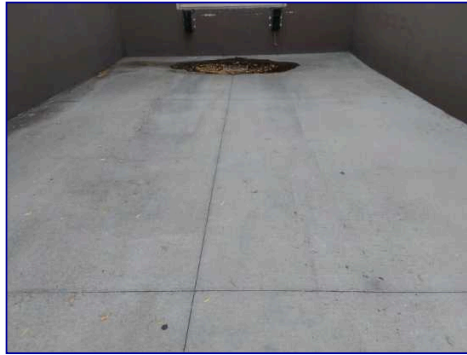
2.4. Standing water at loading dock, drain covered with debris. Recommend monitoring and consulting a professional contractor to repair as needed.

Standing water

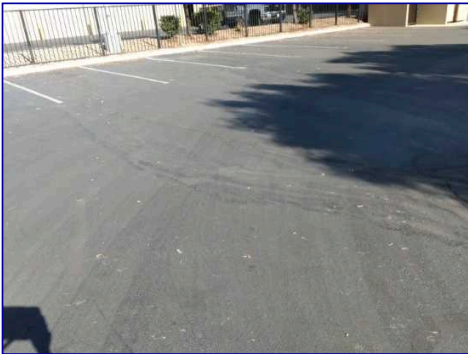
Cracks

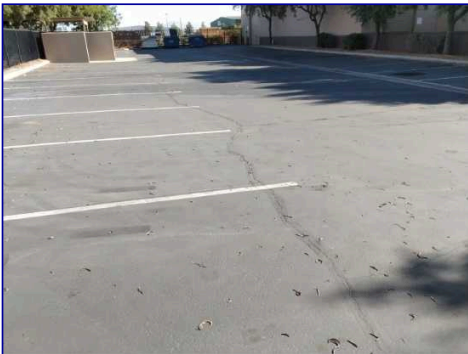
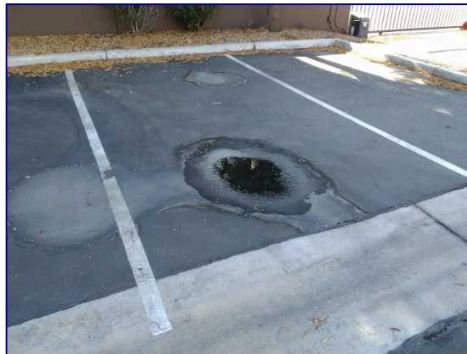
| Grounds | | |
|---|---|---|
| Page 11 Item: 2 | Driveway/Parking | 2.1. There are uneven, low spots in parking lot area near planter, which could be a tripping hazard and potential ponding water.. Recommend using additional caution in these areas. Repair or replace as needed.<br>2.2. The driveway has areas of low spots near roll up door left side building. Recommend a professional contractor repair to help prevent additional damage.<br>2.3. The driveway/parking material is asphalt. Asphalt should be kept sealed and larger cracks filled to prevent frost damage. Consult a professional contractor as needed.<br>2.4. Standing water at loading dock, drain covered with debris. Recommend monitoring and consulting a professional contractor to repair as needed. |

Uneven, ponding

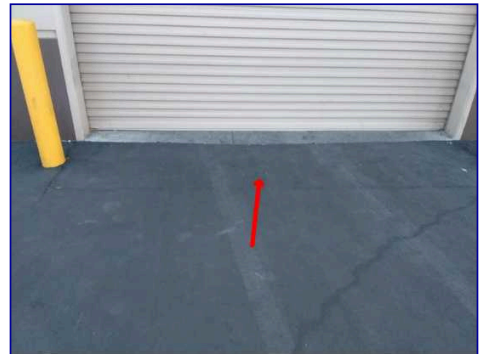
Low spots

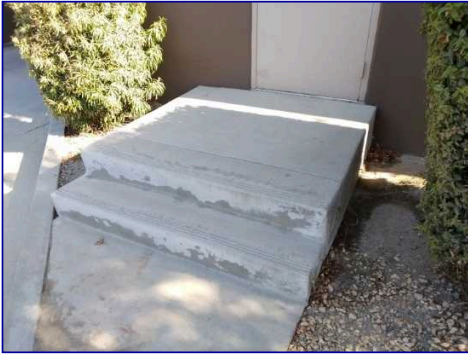
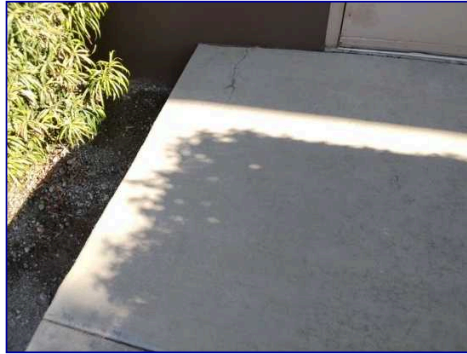
3.1. There are cracks on the landing. Recommend a professional contractor evaluate to help prevent additional damage.

Cracks

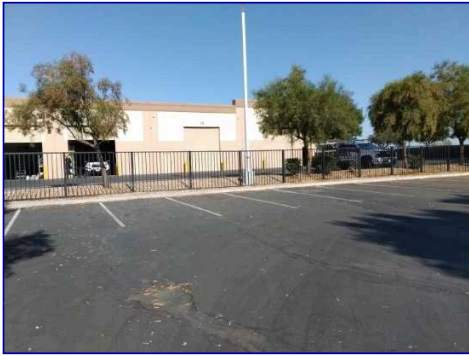
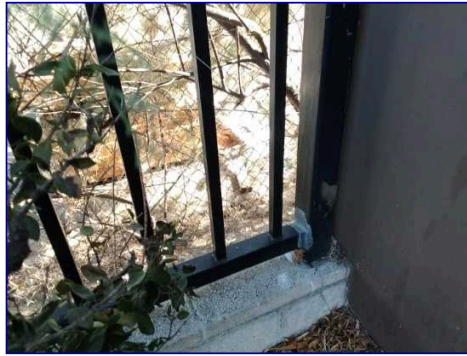
4.1. Recommend treating/painting on the metal fence to help prevent damage. Work should be performed by qualified professional.

Peeling, weathered

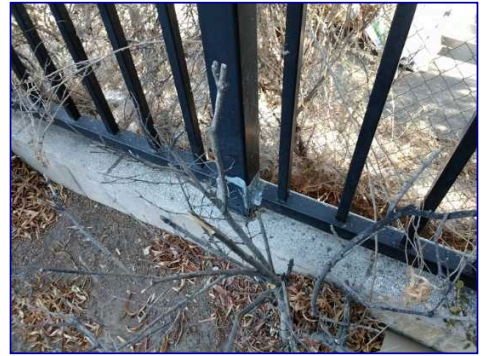
Peeling, weathered

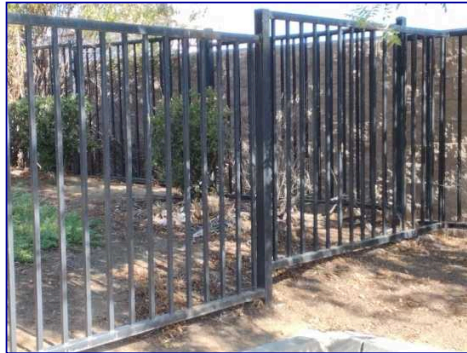
Rusting, weathered

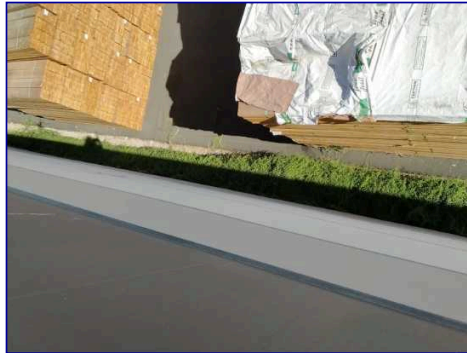
5.4. There is vegetation in contact with the rear building walls. Recommend trimming trees/vegetation at least 6-8", so it doesn't come into contact with the home.

Bushes near rear wall

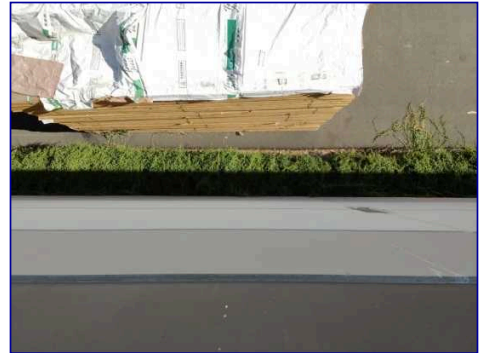
Bushes near rear wall

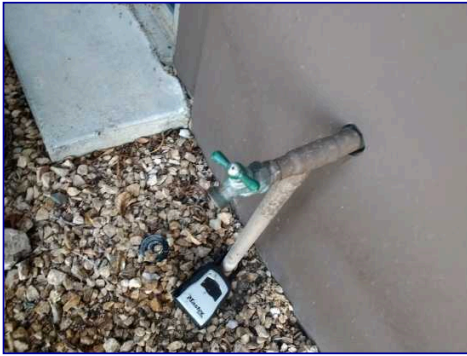
No anti-siphon

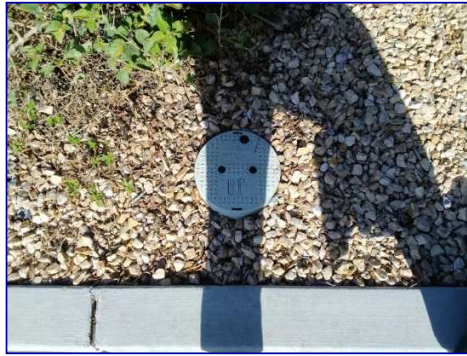
6.1. General Note: The lawn irrigation/sprinkler system was not within the scope of the home inspection and not tested. Recommend an irrigation/landscape company to evaluate before use.

Irrigation not evaluated

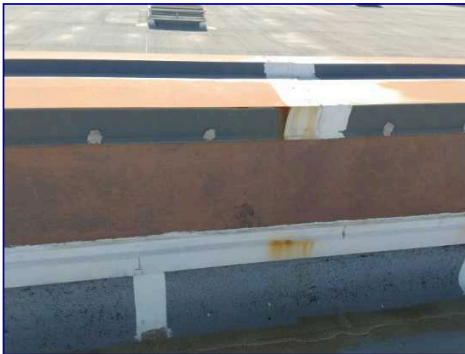
4.1. Cap flashings show signs of rusting. Front flashing apparently bent. Recommend a licensed roofer repair or replace as needed.

Rusting

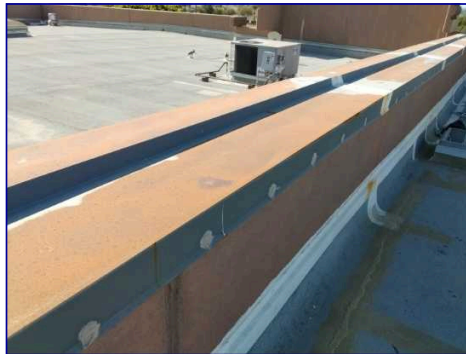
Rusting

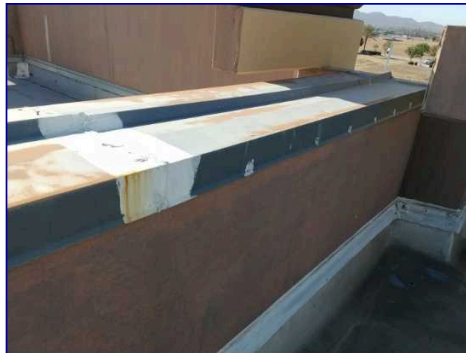
Rusting

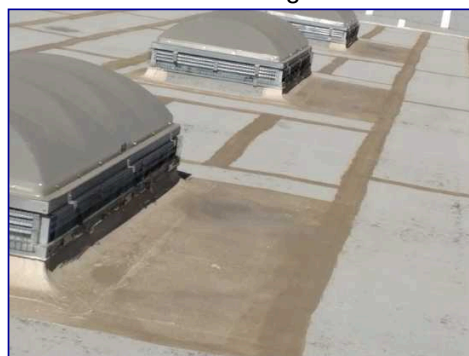
5.2. Water ponding visible on the flat roof surface. Ponding can cause premature failure of the roofing material. Recommend a qualified roofing contractor evaluate and repair as needed.

Ponding

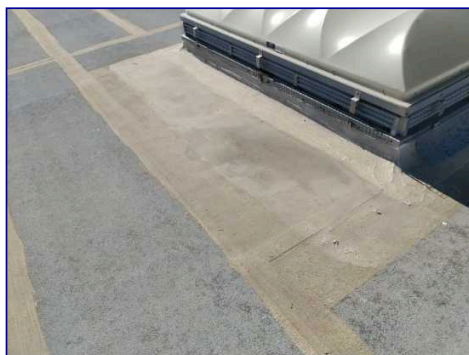
Ponding

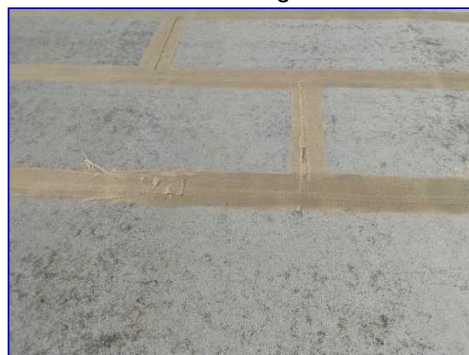
5.1. The roof was apparently in poor condition and will need repair or replacement by a professional roofer soon, but this cannot be warranted. Heavy deterioration of granules observed, joints were cracking/lifting. Recommend detailed evaluation from licensed roofing contractor.

Joints cracks

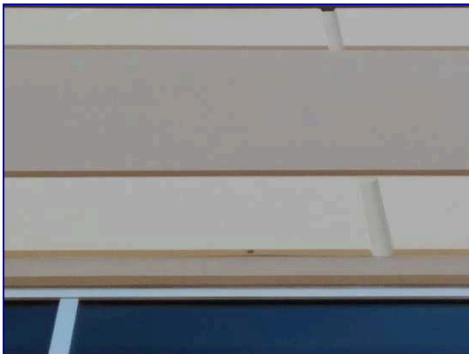
1.2. Siding had typical cracking present in one or more areas around building. Monitor and repair as needed.

Cracks front

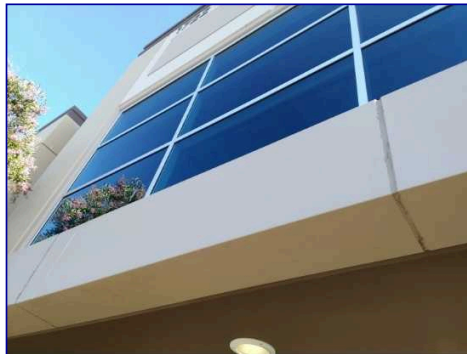
Peeling front

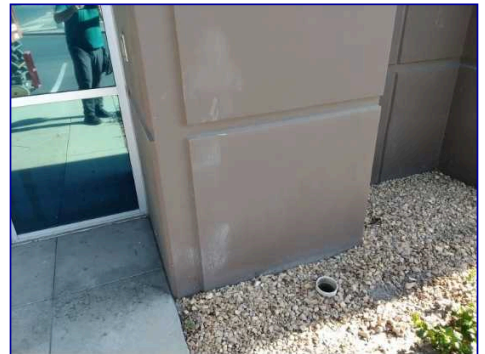
Discoloration

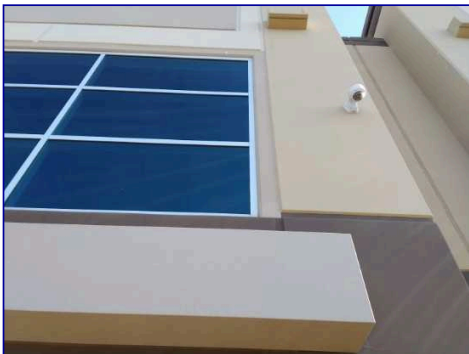
Cracks front

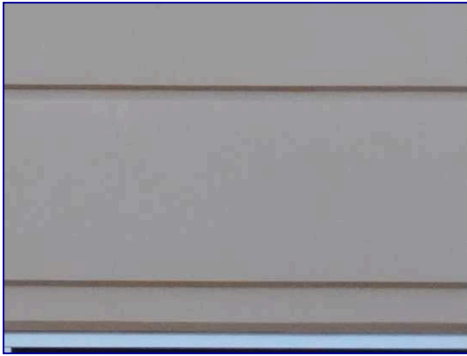
Cracks front

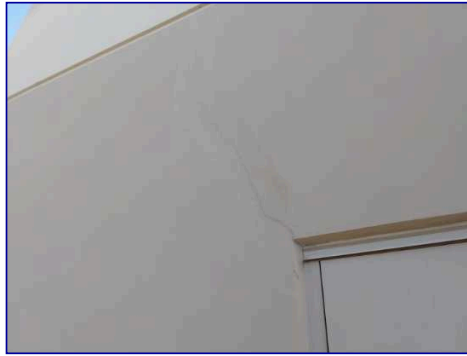
Cracks front

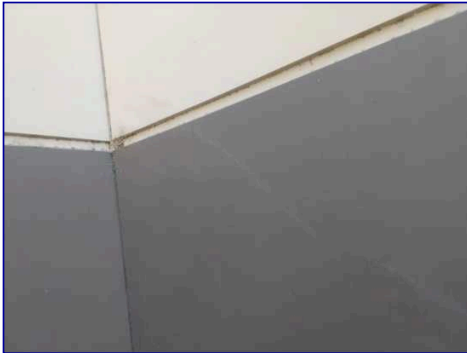
Cracks left

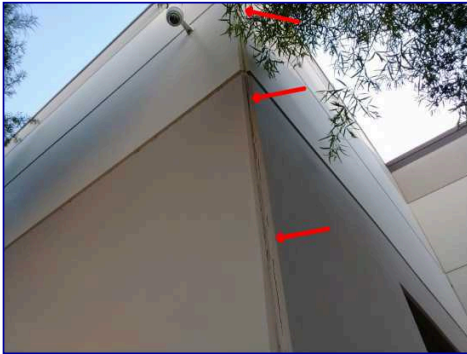
Voids left

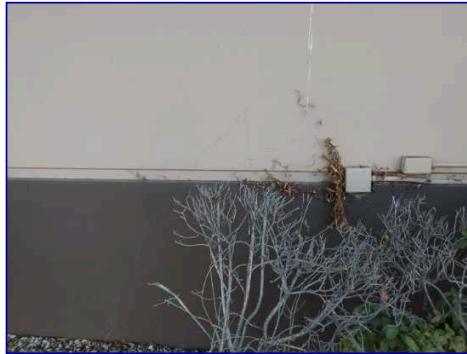
Cracks left

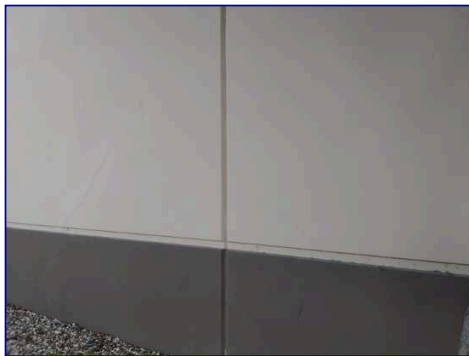
Cracks left

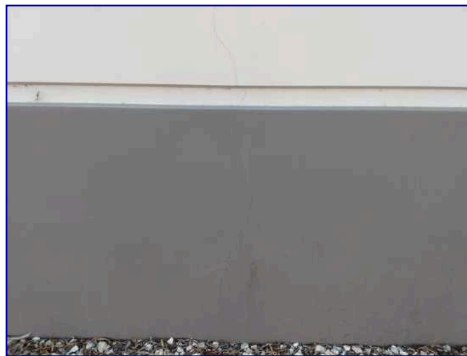
Cracks left

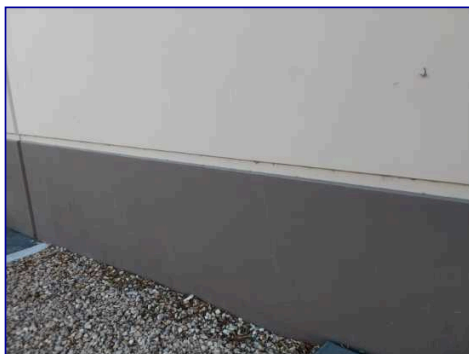
Cracks left

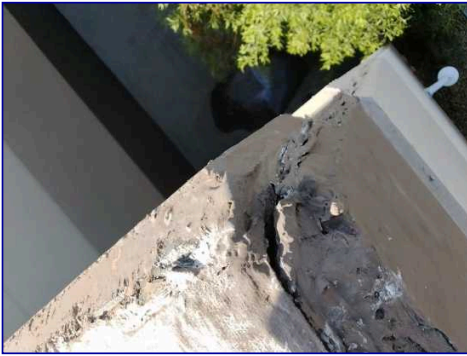
Joints cracks

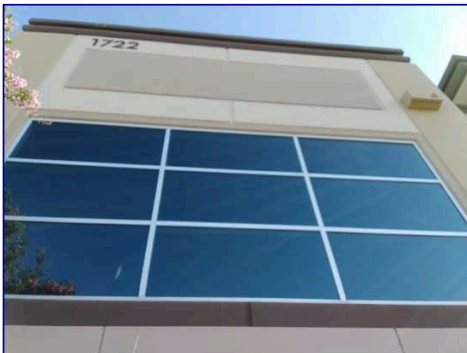
3.1. Lower front window frames were deteriorating, weathered against floor. Recommend repair to help prevent additional damage.

Front rusting

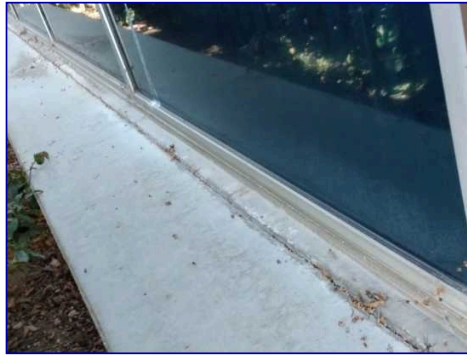
Front rusting

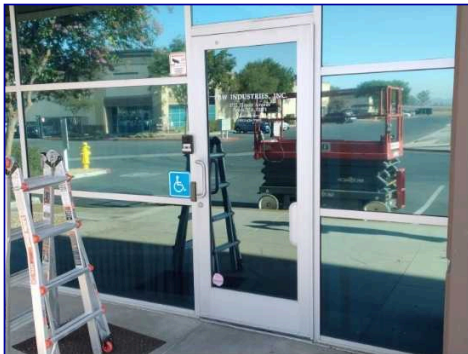
Main entry

4.1. The front entry door was uneven, poor weather stripping. Lock/latch was damaged. Recommend a professional contractor repair or replace.

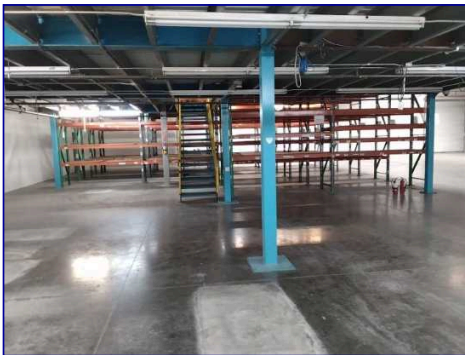
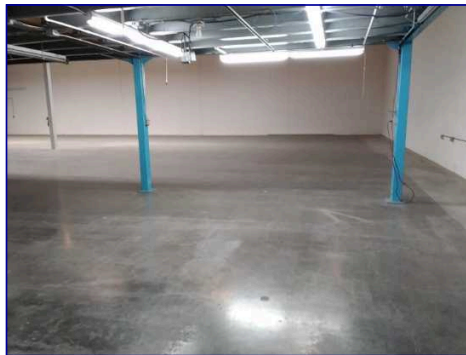
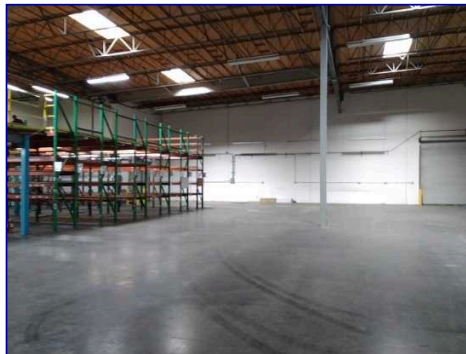
1.1. Mezzanines are not part of the inspection, but items noted should be further evaluated. Missing washers at joist bolts. Staircase stinger bolts not used, lower end welded. Staircase upper riser heights uneven near landing. Recommend evaluation and repair by qualified professional.

Missing washers mezzanine

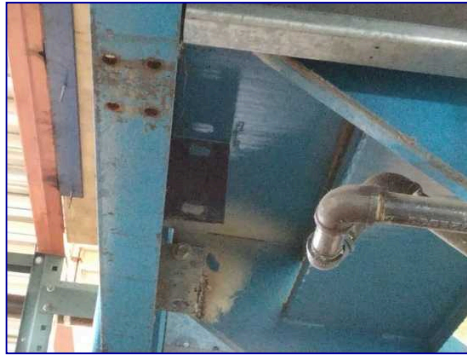
Welded stringer

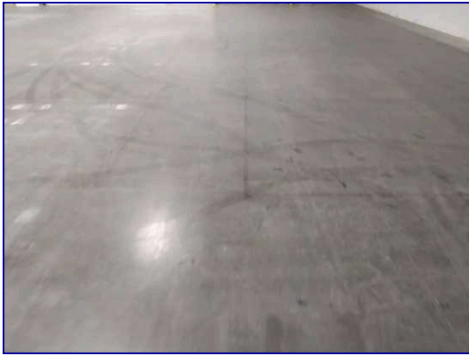
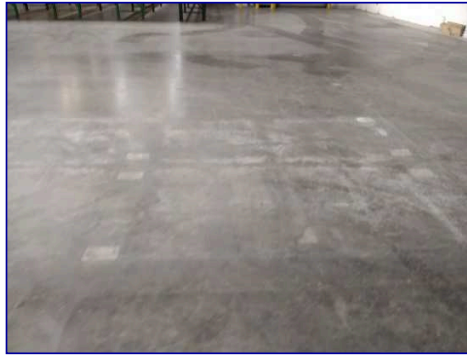
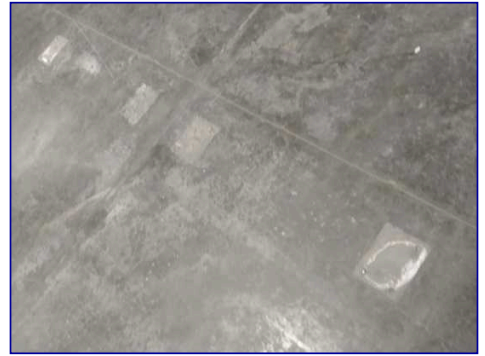
2.2. The garage floor has areas of efflorescence at cut off bolt areas. Monitor and repair or replace as needed by qualified professional.

Efflorescence

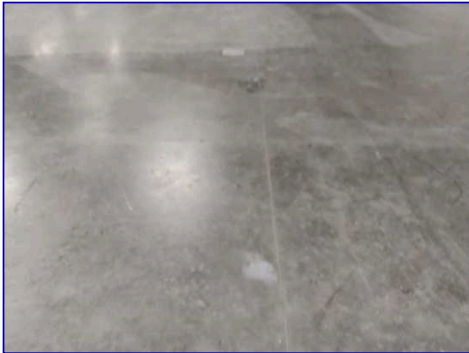
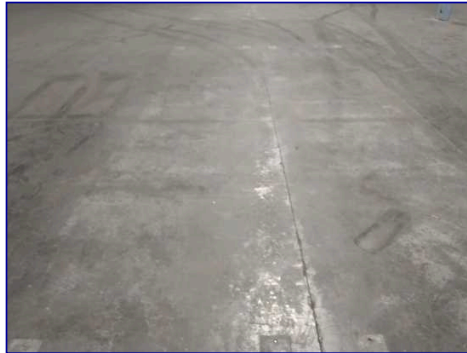
2.1. Floor apparent spalling near racks. Recommend further evaluation by a qualified contractor.

Spalling

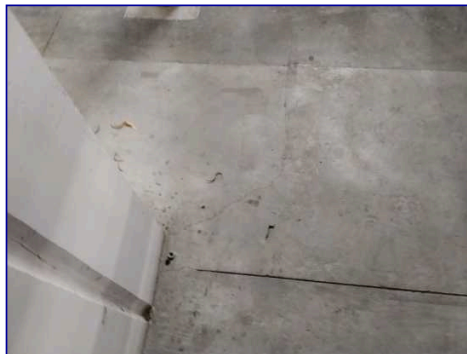
2.3. The garage floor has expected cracks. Recommend a professional contractor to seal the cracks to help prevent additional damage.

Cracks

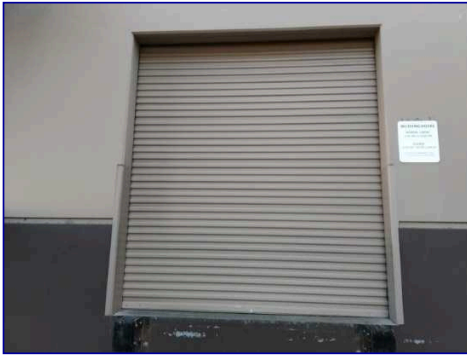
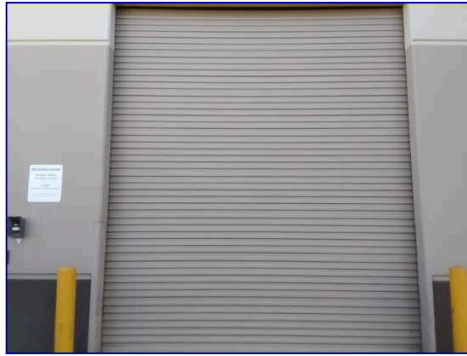
3.2. The rear left door panel(s) bowed at upper wall. Recommend further evaluation and repair by door specialist.

Left bowed

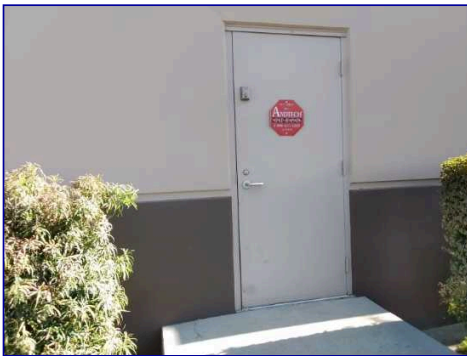
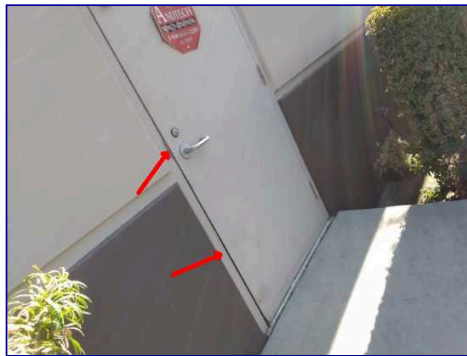
4.2. Exterior service door was uneven to frame when closed. Recommend repair or replacement by qualified professional.

Uneven

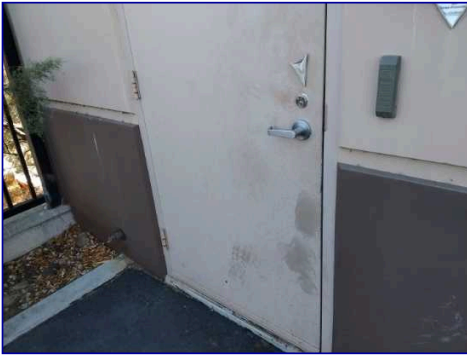
4.1. The exterior service doors were weathered. Recommend paint to protect from further damage. Repair as needed.

Rusting, weathered

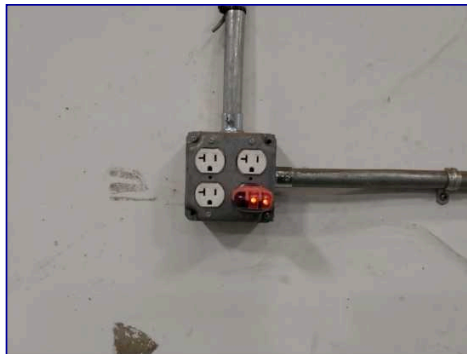
5.3. Several junction boxes were missing knock out plates around warehouse. This is a safety concern. Recommend a licensed electrician repair.

Open knock outs

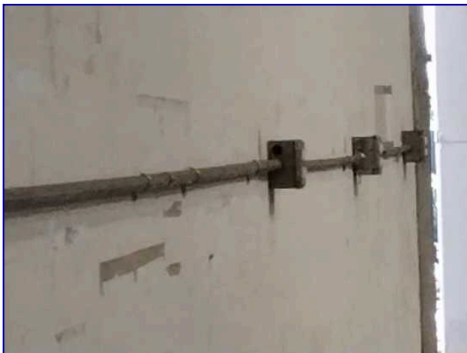
Open knock outs

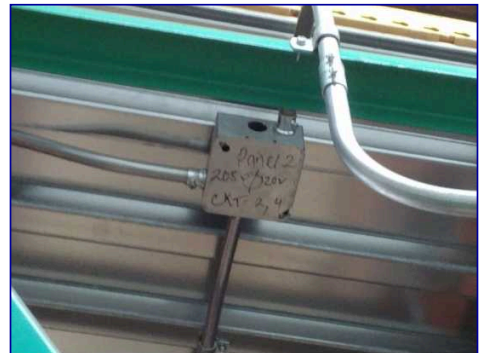
Open knock outs

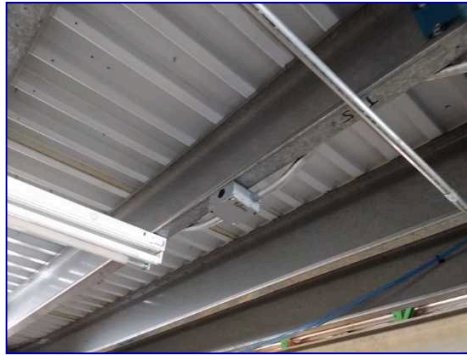
Open knock outs

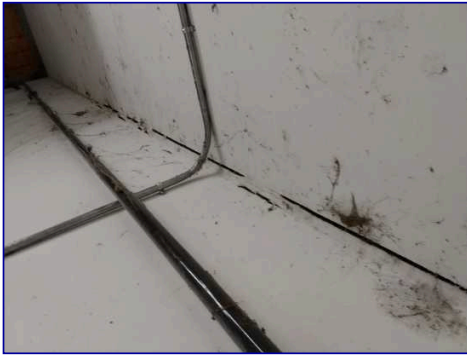
6.4. Wall joints cracking, not properly sealed. Recommend monitoring and repair as needed by licensed contractor.

Joints cracks

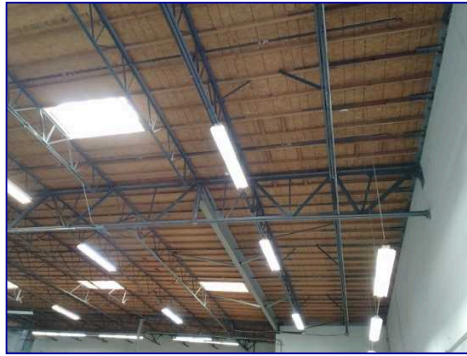
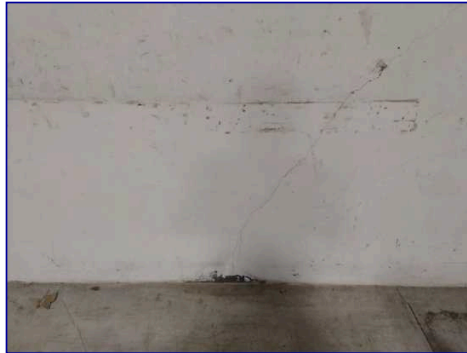
6.3. Lower walls off left side apparent deterioration, bubbling, efflorescence. Recommend monitoring and repair as needed by licensed contractor.

Left cracks,efflorescence

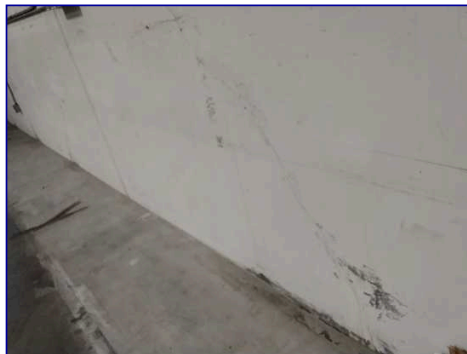
Cracks, efflorescence

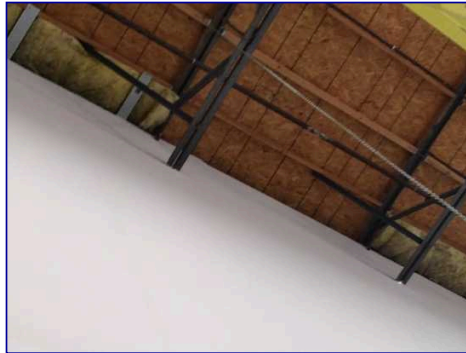
6.2. One or more holes and or penetrations were present at the firewall/ceiling adjacent to office spaces. Recommend installing fire caulk and repair all penetrations for added safety. Consult a professional contractor as needed.

Voids firewall

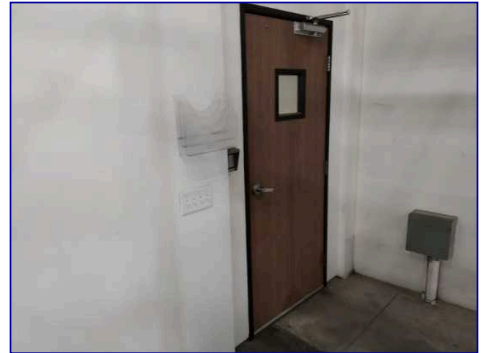
Pipe voids firewall

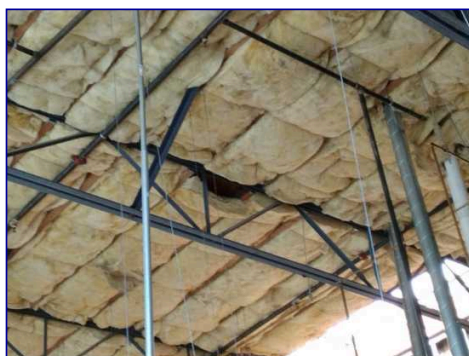
- 2.11. Fiberglass insulation was loose, damaged inside above ceiling panels. Recommend further evaluation from qualified professional and repair/replace as needed.

Insulation falls

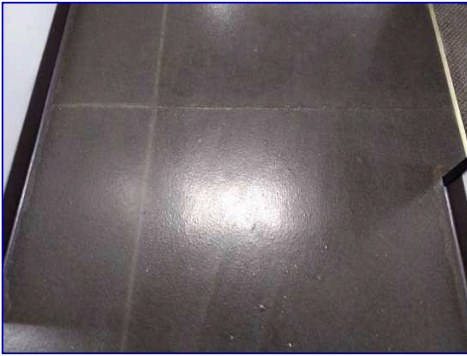
- 2.1. Entry lobby walls patched. Monitor and repair as needed.
- 2.2. The floor covering has some peeling, bubbling, discoloration around rooms, hallway. Recommend further evaluation from qualified professional and repair/replace as needed.

Hall bubbling

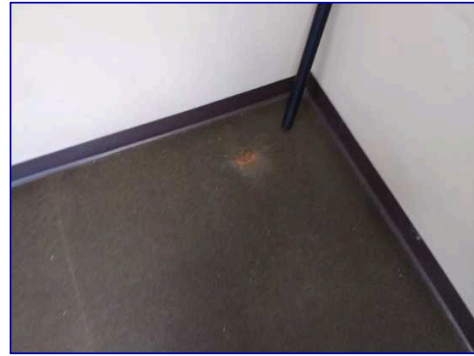
Lobby discoloration

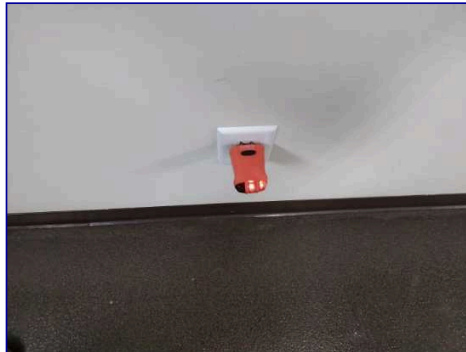
3.1. At least one electrical cover plate is missing, several plates cracking. Recommend installing cover plate(s) by qualified professional.

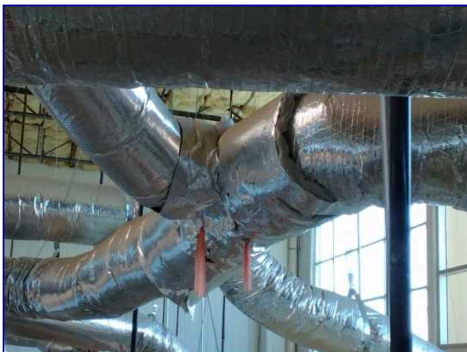
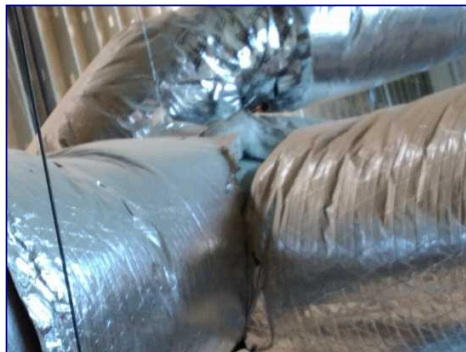
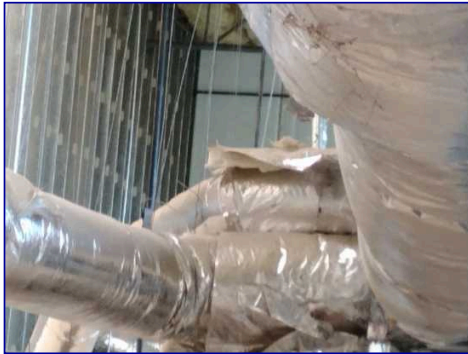
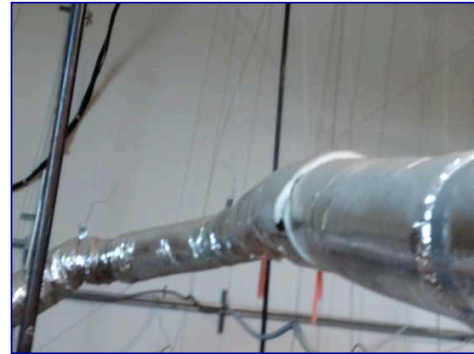
4.1. The HVAC ducts were poorly insulated at joints/connections. Peeling, damage at plenum. Taping around joints poor, peeling. Recommend a qualified professional to repair as needed.

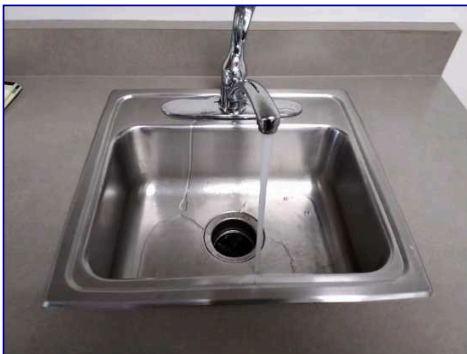
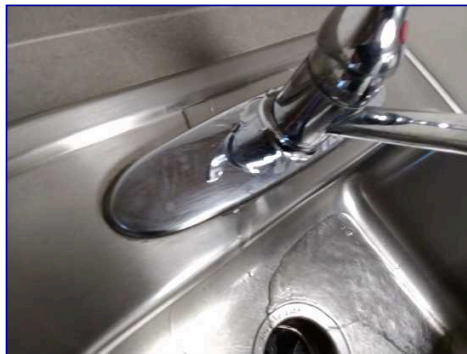
4.2. The kitchen faucet is leaking. Recommend a licensed plumber to evaluate and repair.

Faucet leaks

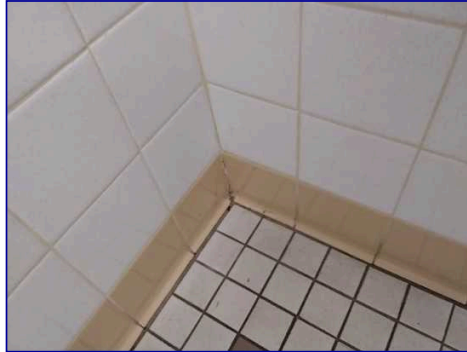
2.1. Grout cracks corner wall. Recommend further evaluation from qualified professional.

Grout cracks

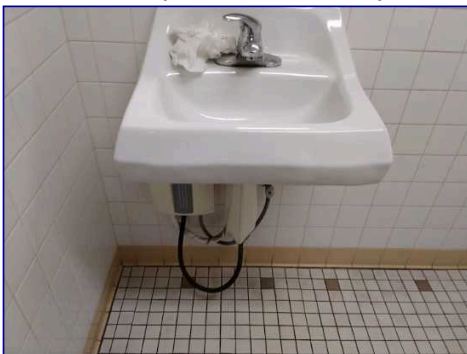
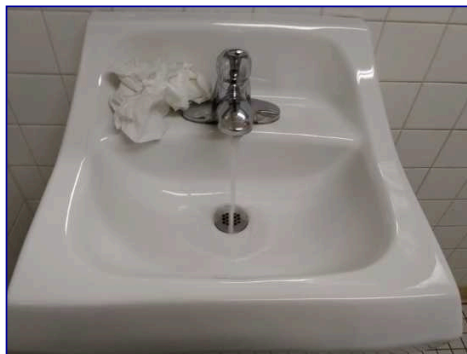
4.1. Apparent corrosion observed at plumbing within vanity. Recommend a licensed plumber repair or replace as necessary.

Corroded plumbing

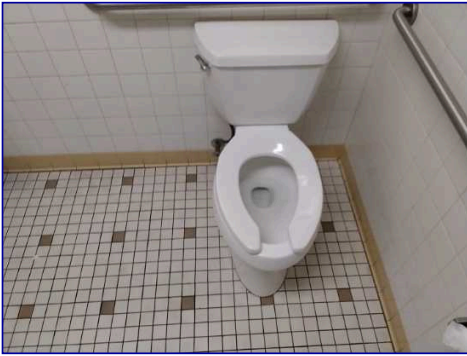
5.1. Toilet plumbing/valve was corroded. Recommend further evaluation from licensed plumber.

Corroded plumbing

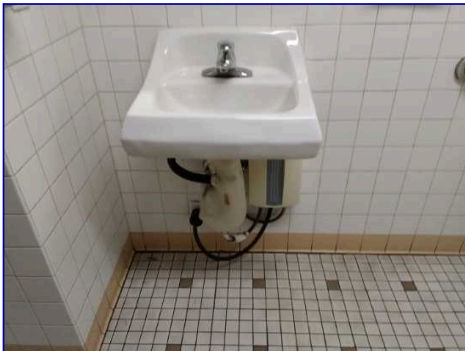
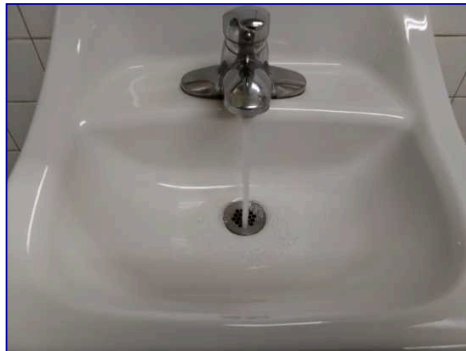
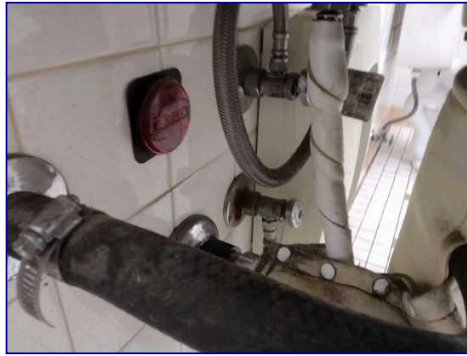
4.1. Apparent corrosion observed at plumbing within vanity. Recommend a licensed plumber repair or replace as necessary.

Corroded plumbing

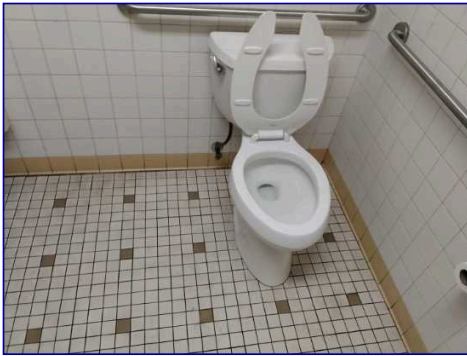
5.2. Toilet plumbing/valve was corroded. Recommend further evaluation from licensed plumber.

Corroded plumbing

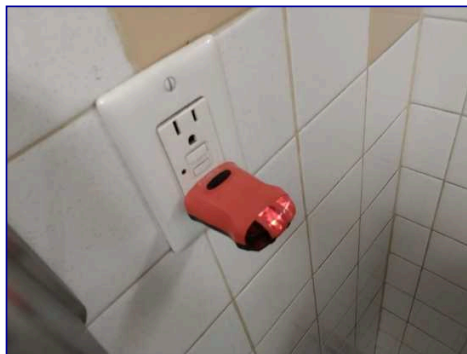
6.1. Ground-fault outlet was not operating properly in bathroom. Recommend a licensed electrician to repair or replace.

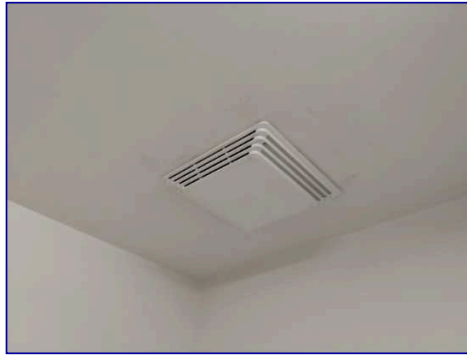
7.1. The exhaust fan was not operating in bathroom. Recommend repair/replacement by qualified professional.

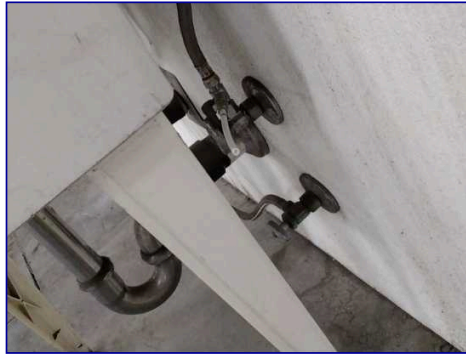
2.1. Water supply pipes are corroded at warehouse sink. Recommend a licensed plumber repair and/or replace as necessary.

Warehouse sink plumbing corroded

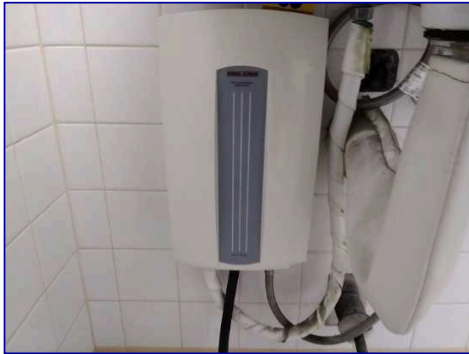
2.2. The water temperature is greater than 120 degrees, which is a scalding concern and safety concern. Recommend reducing the temperature. Consult a professional contractor as needed.

Temp over 120 womens

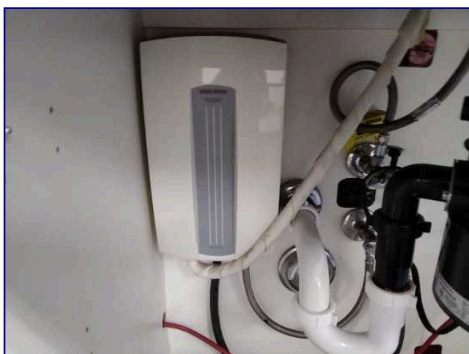
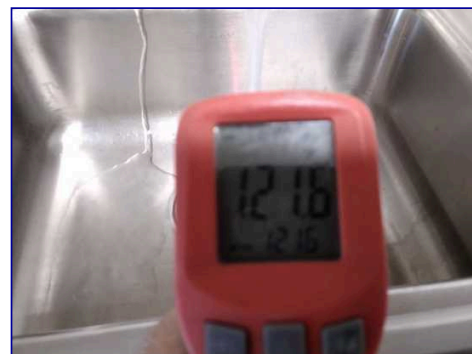
2.2. The water temperature is greater than 120 degrees, which is a scalding concern and safety concern. Recommend reducing the temperature. Consult a professional contractor as needed.

Temp over 120

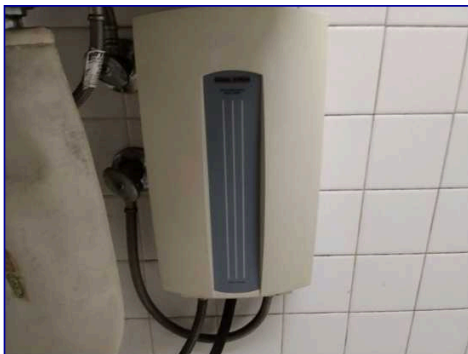
2.1. The water heater was coming into/passing the average theoretical life expectancy of 8-12 years. Recommend budgeting for replacement and having a detailed evaluation from licensed HVAC technician.

2.2. The water heater was not operating. Recommend further evaluation from qualified professional.

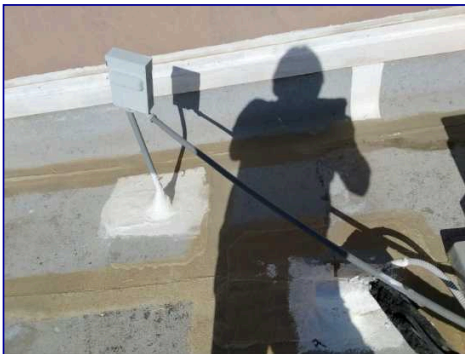
2.2. Rooftop line set deterioration, electrical conduit damaged. Cabinet enclosure in room was sagging. Recommend evaluation from licensed HVAC technician.

Electrical damage

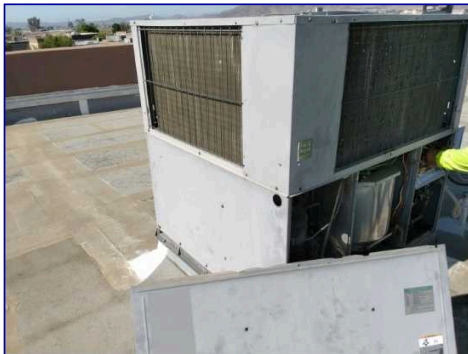
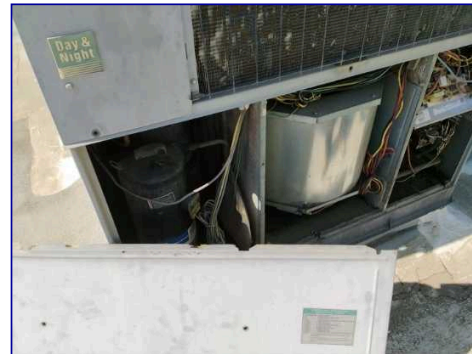
2.1. The average life expectancy of systems is 20 years. Recommend budgeting for repairs or replacement.

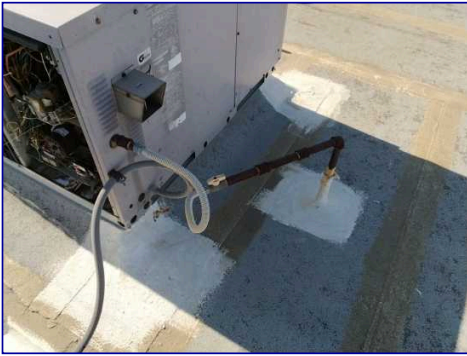
2.1. The average life expectancy of systems is 20 years. Recommend budgeting for repairs or replacement.  
 2.2. Gas line heavy rusting. Recommend evaluation from licensed HVAC technician.

Rusting

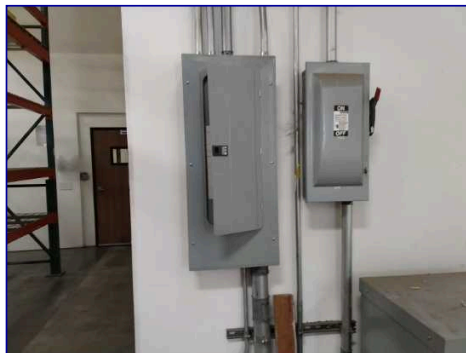
2.1. No bushing sleeves at conduit entrance pipes, which is a safety concern. Recommend licensed electrician evaluate and make necessary repairs.

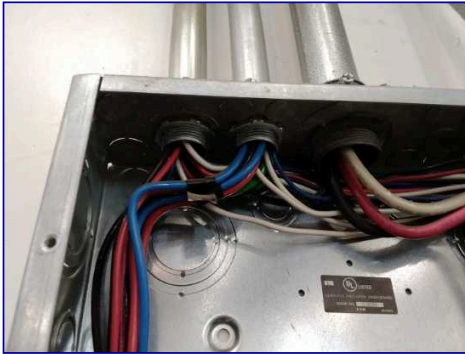
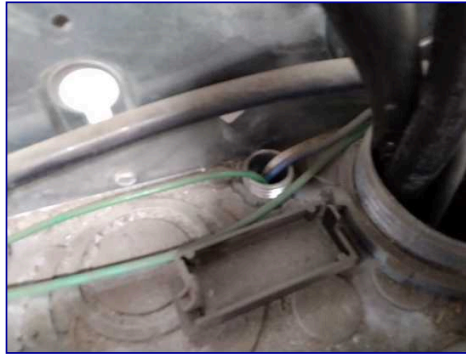
2.2. Upper bus apparent overheating, corrosion, which is a safety concern. Recommend licensed electrician evaluate and make necessary repairs.

Arching

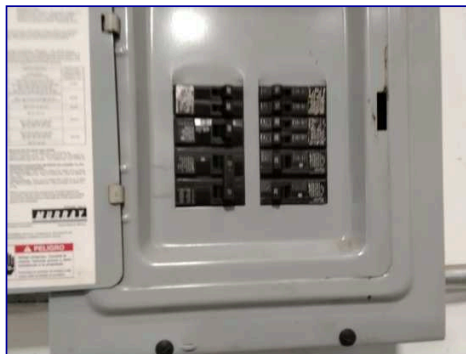
3.1. Main panel breakers not properly labeled, which is a safety concern. Recommend licensed electrician evaluate and make necessary repairs.

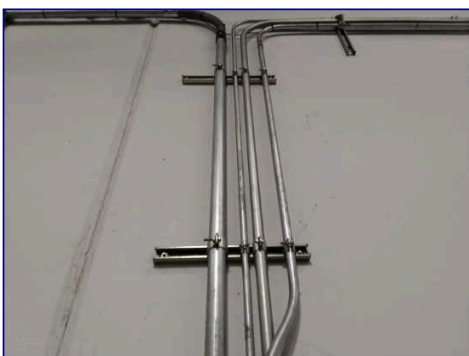
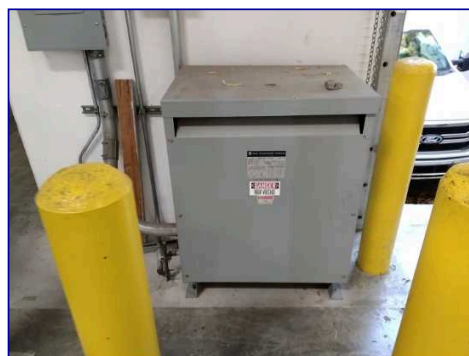
Transformer

1.1. Recommend service, evaluation of warehouse transformer. Recommend further evaluation from licensed electrician.
