INGRAFFIA  
HOME INSPECTIONS

PROPERTY INSPECTION

# 123 Sample Street

## Santa Ana, 92701

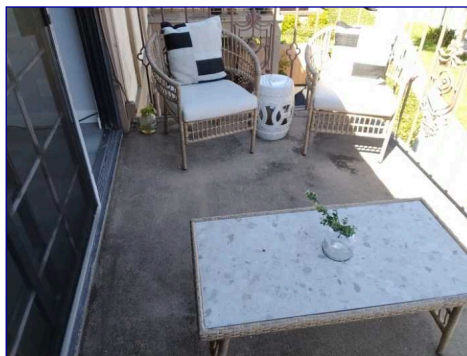
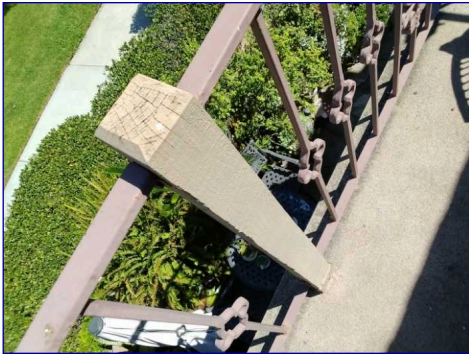
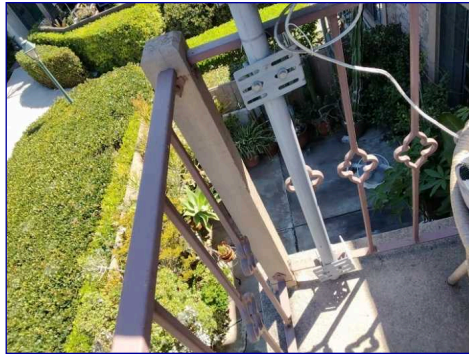
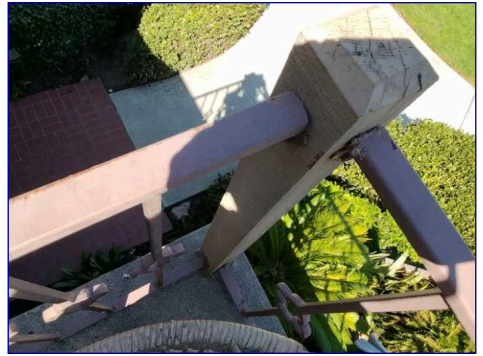
1.3. There is damaged wood observed at railing posts. Post joints at floor open voids. Recommend repair or replacement by a professional contractor.

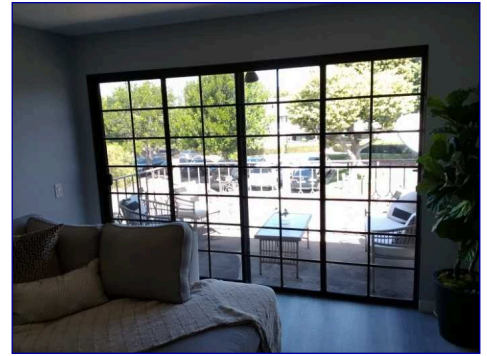
Balcony

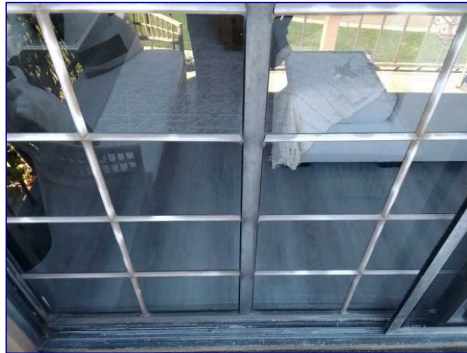
Balcony weathered

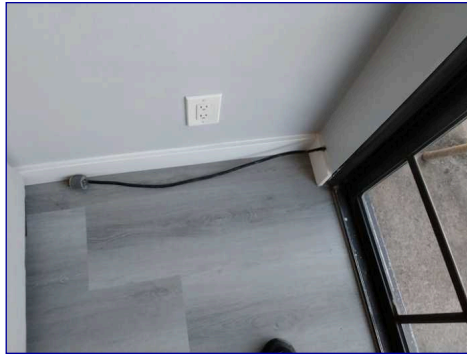
| Grounds | | |
|---|---|---|
| Page 11 Item: 5 | General Electrical | 5.1. Extension cord wiring exists off balcony, installed into house which should never be used as permanent wiring, which is a safety concern. Recommend a licensed electrician repair. |

Extension

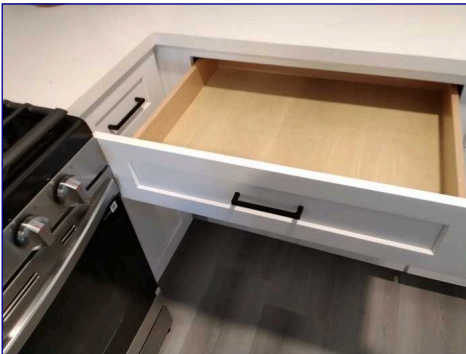
3.1. The kitchen cabinet drawers hit near stove and were in need of repair. Recommend repairing or replacing as needed.

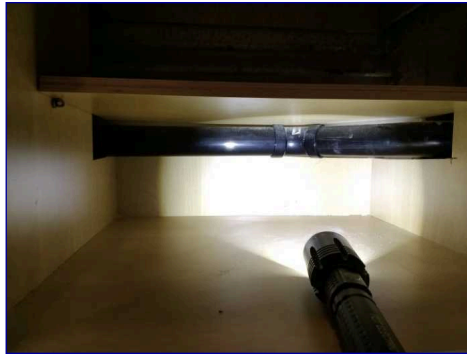
Negative Grade

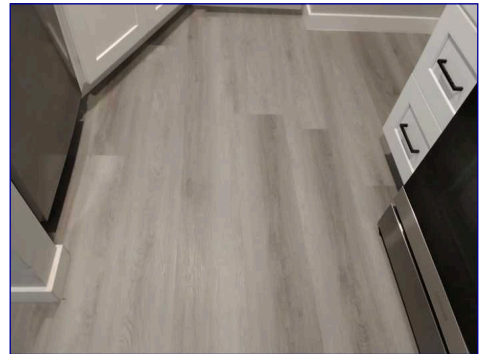
Sloping

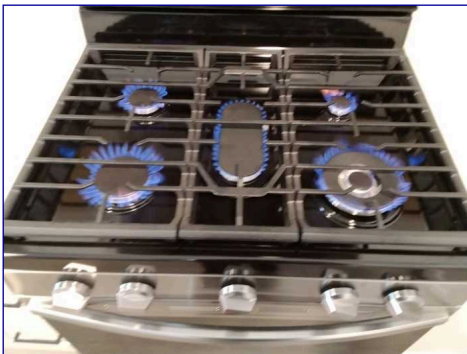
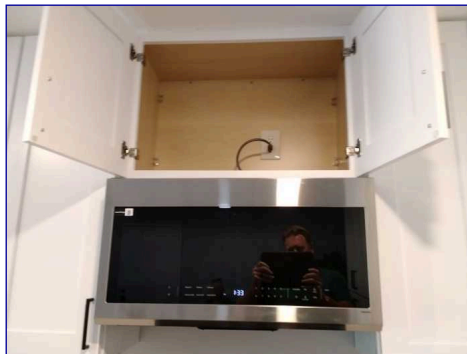
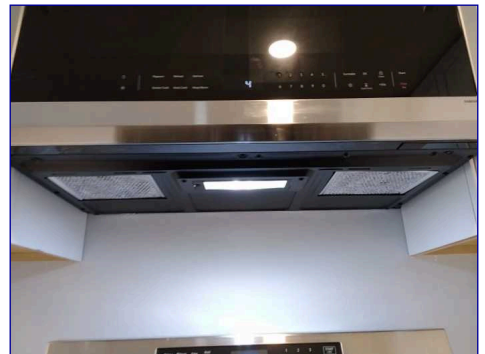
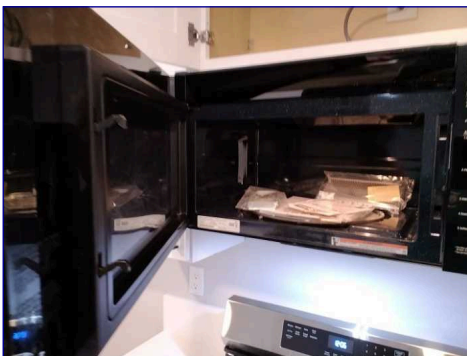
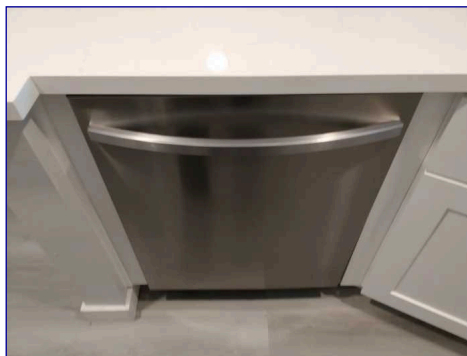
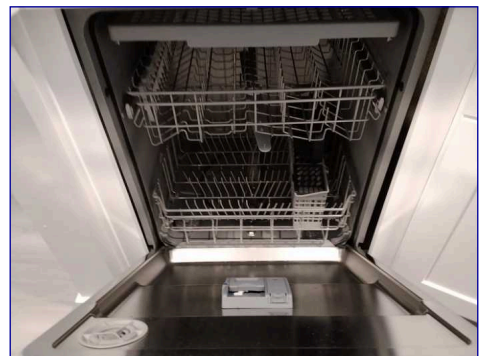
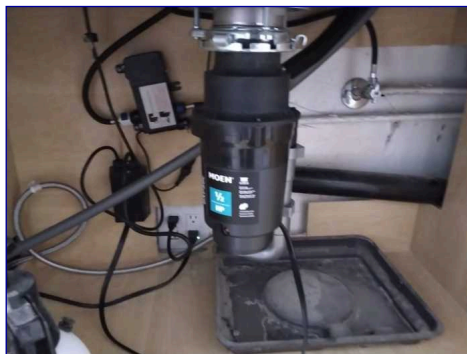
7.1. Unable to push oven back to wall, gas valve restricted clearance. Recommend further evaluation and repair by qualified professional.

Gas restricted

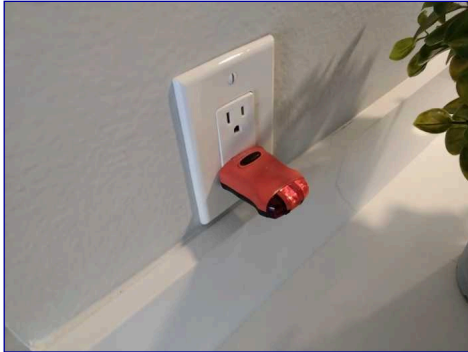
8.1. Missing **GFCI** receptacles observed in the kitchen at required locations, which is a safety concern. Recommend a licensed electrician install GFCI receptacles as required.

No gfci

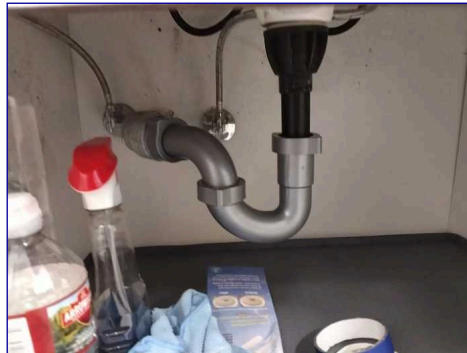
4.1. Sink was draining slowly during operation. Recommend a licensed plumber repair or replace as necessary.

Slow

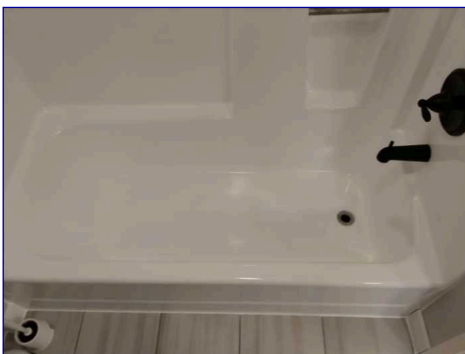
5.4. Faucet handle was difficult to operate. Recommend further evaluation and repair from licensed plumber.

Difficult

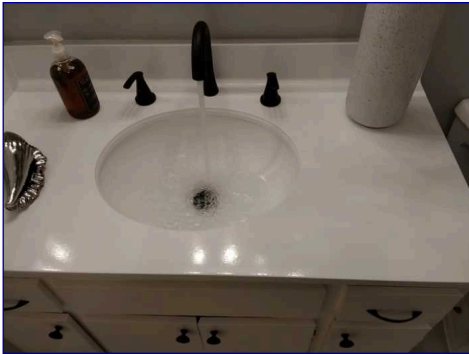
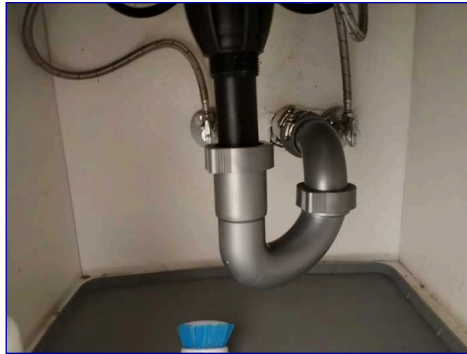
4.1. Sink was draining slowly during operation. Recommend a licensed plumber repair or replace as necessary.

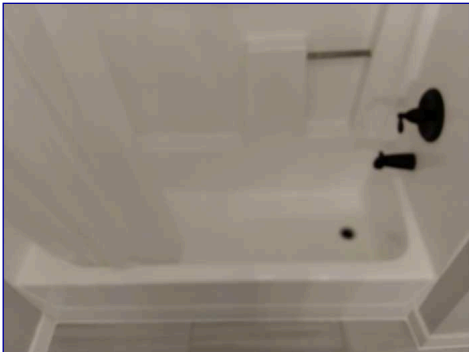
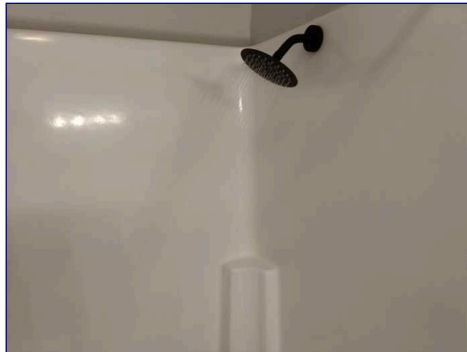
**5.4.** Faucet handle was difficult to operate. Recommend further evaluation and repair from licensed plumber.

Difficult

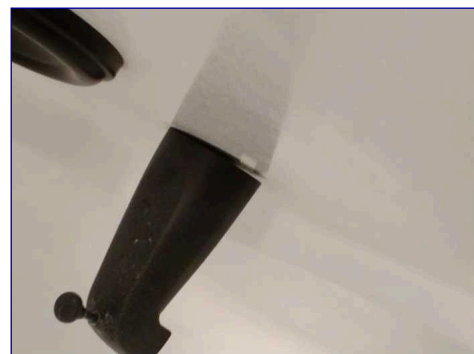
**5.3.** Recommend caulking/grouting in the tub area to help prevent damage from water penetration. Work should be performed by qualified professional.

Poor caulking

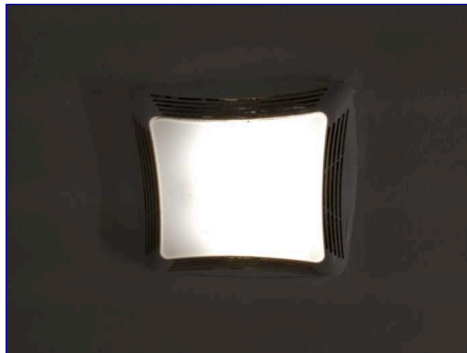
8.1. The exhaust fan was dirty and in need of cleaning, service. Recommend further evaluation by qualified professional.

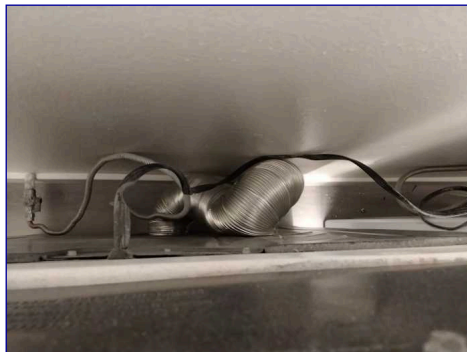
6.1. General Note: Recommend that the dryer vent/duct be inspected and cleaned prior to initial use of appliance.

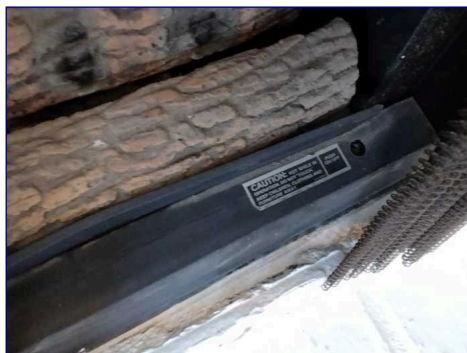
**3.1. Fireplace not operating at time of inspection. Recommend further inspection and repairs by a qualified professional or have seller show operation.**

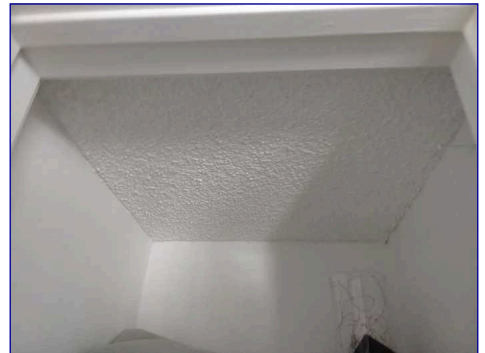
1.1. There are popcorn ceilings installed in one or more rooms of the home. If the ceilings were installed prior to 1978, they might contain a higher level of asbestos-type material. Recommend testing be performed by a professional contractor prior to repairs or remodeling. Concealing, removal and replacement options are available. Consult a licensed contractor as needed.

Popcorn

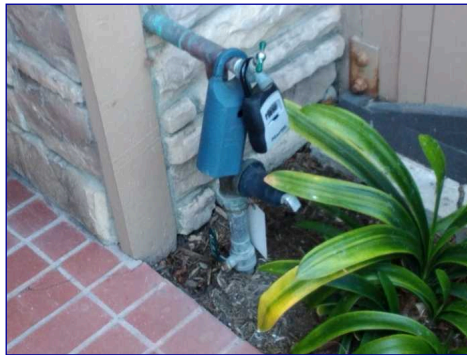
Shut off

**Water Shut-off Location:** Exterior front house wall

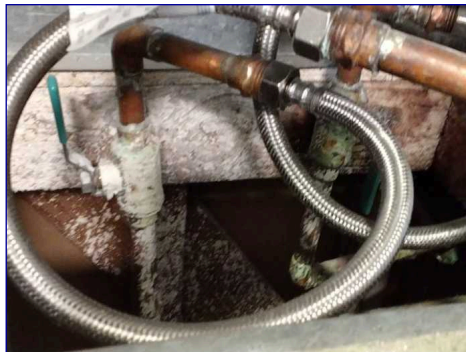
Corroded

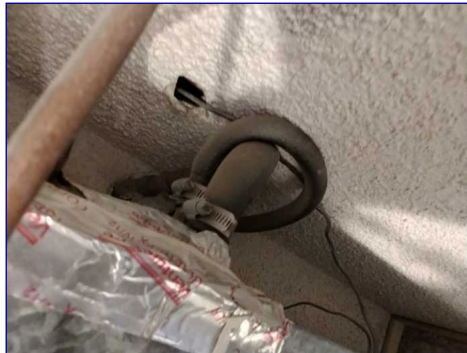
3.1. The condensate drain line was not installed with proper vent trap. Drain crushed, restricted. Recommend a licensed HVAC contractor to evaluate and repair.

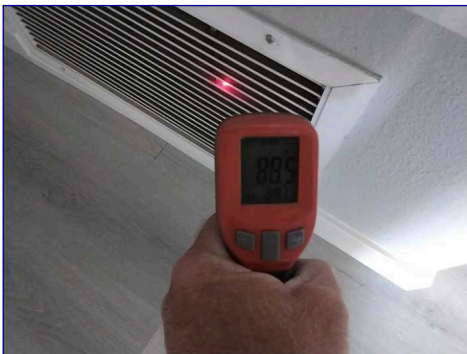
4.2. The air conditioner temperature differential was lower than normal operating standards. The system was not operating as designed. Recommend a licensed HVAC contractor evaluate and to make recommendations for repair.

Return 88

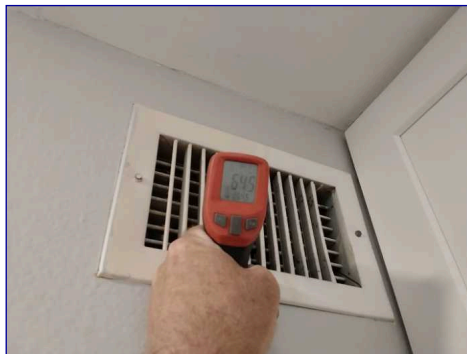
Registered 64

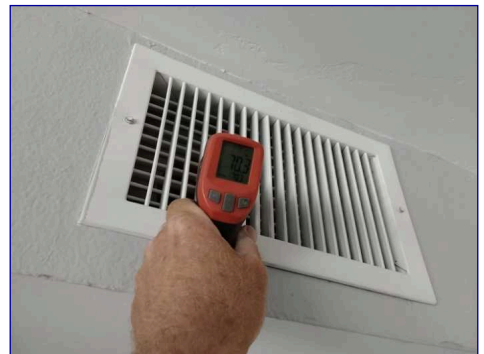
Register 70
