INGRAFFIA  
HOME INSPECTIONS

PROPERTY INSPECTION

July 25, 2026

123 Sample Street  
Corona Del Mar, 92625

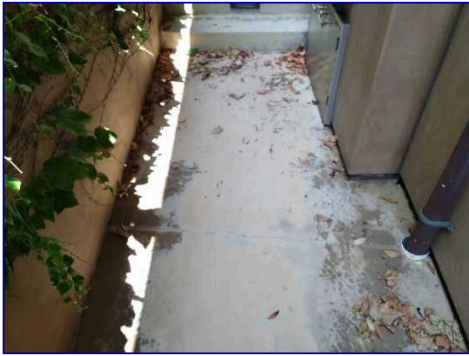
Cracks left

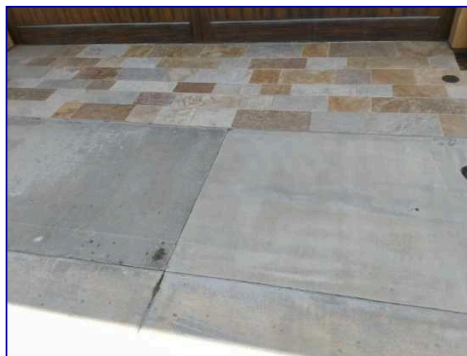
2.1. The driveway is cracked. Recommend sealing the cracks to help prevent additional damage. Consult a professional contractor as needed.

Cracks

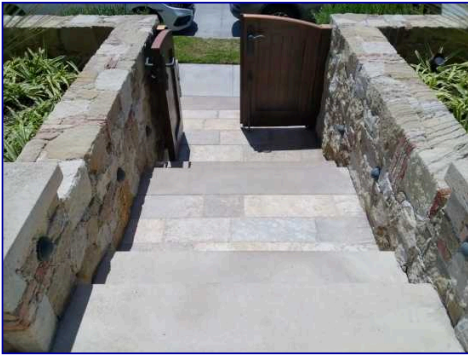
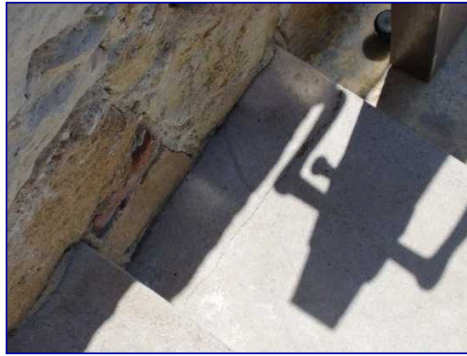
3.1. There are cracks on the front steps. Recommend a professional contractor evaluate to help prevent additional damage.

Cracks front

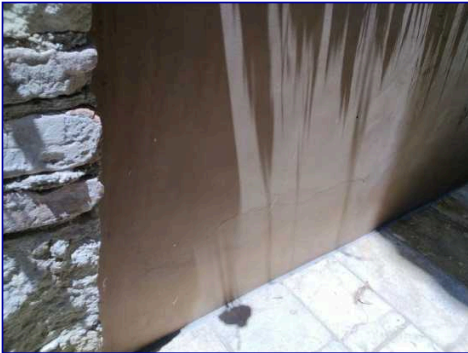
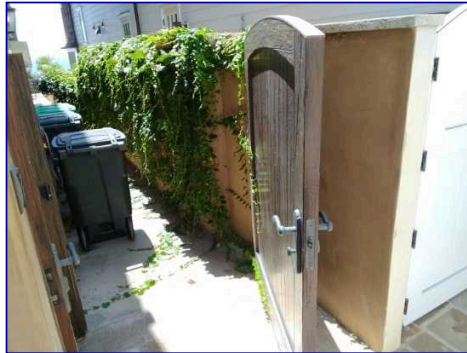
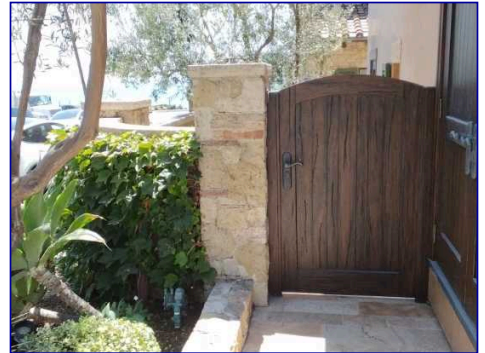
6.2. Block/stucco walls cracking off left and right sides of house. Recommend consulting with a professional contractor for maintenance and or repairs.

Cracks left

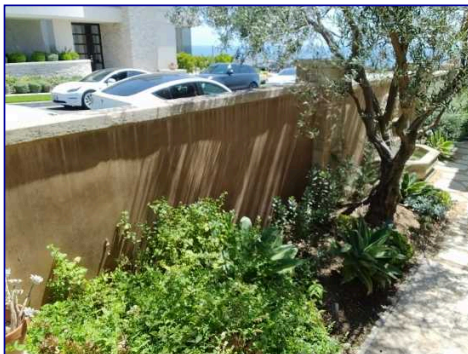
Cracks right

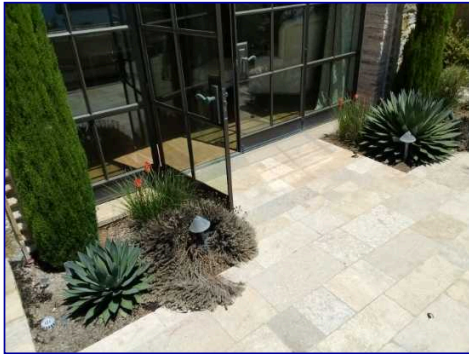
7.2. High grade against house walls (refer to pictures). Recommend removal of at least 3" below finished siding to prevent damage. Replace any damaged areas as needed.

High grade right

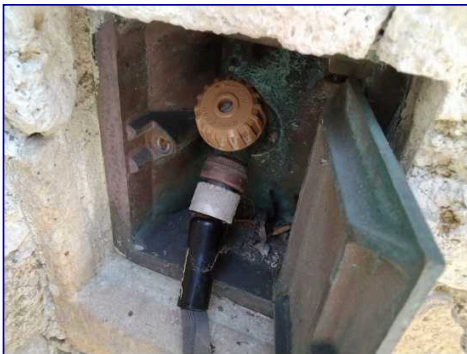
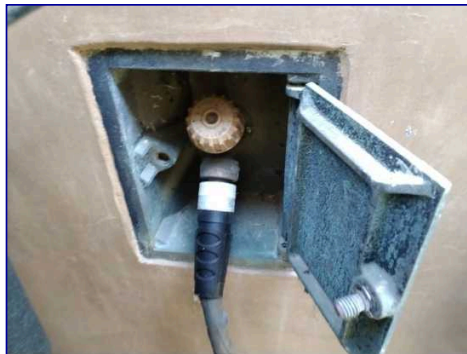
8.2. At least one hose bib is not equipped with an anti-siphon device. A possible cross-contamination can occur, which is a potential safety concern. A licensed plumber should install an anti-siphon/vacuum breaker.

No anti-siphon exterior right

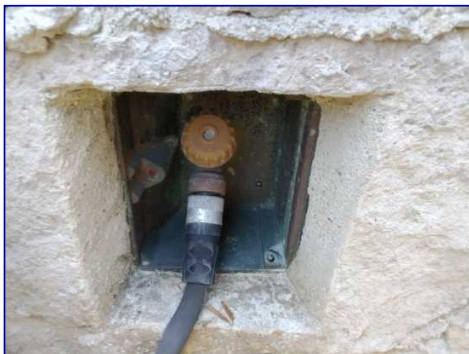
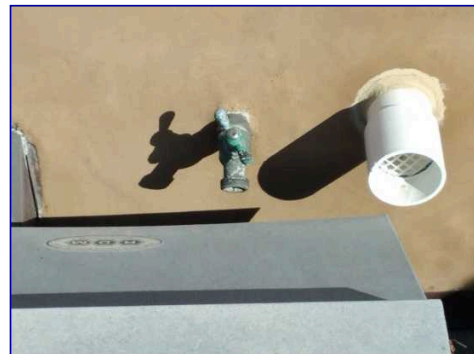
No anti-siphon

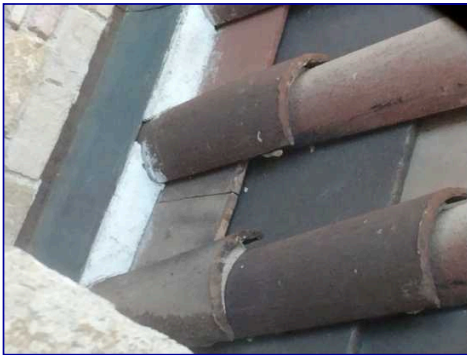
4.1. One or more broken/loose tiles exist on the roof. Recommend a licensed roofer to replace the damaged tiles.

4.3. The roofing system was considered marginal and requires repair. Recommend a licensed contractor evaluate and repair all affected areas.

Cracking right

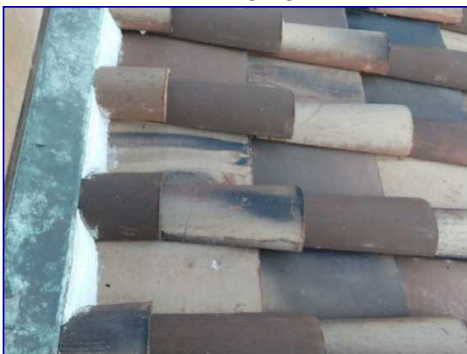
Cracking rear

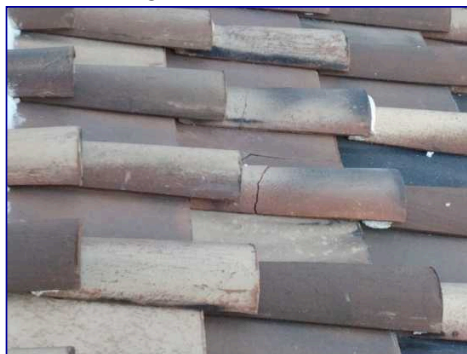
Cracking rear

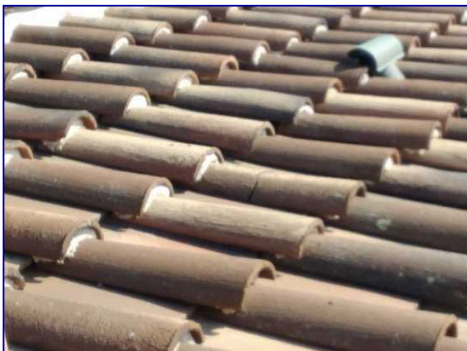
Cracking

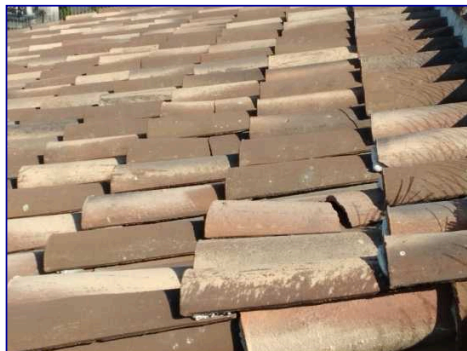
Damage

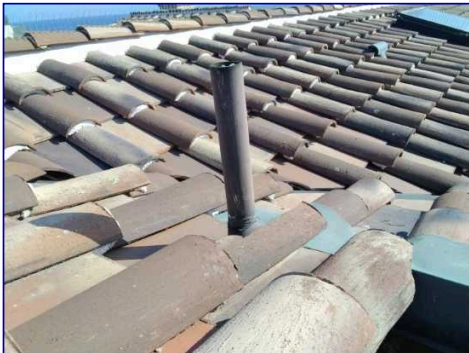
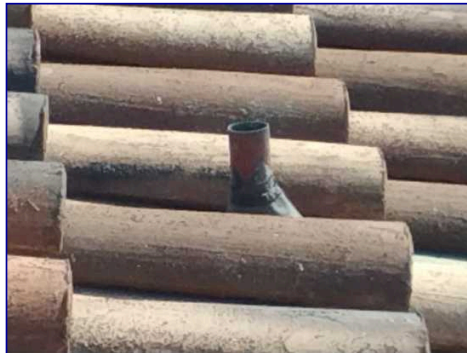
5.1. The mastic joint sealer were old and cracked, which can allow water to penetrate and cause damage to the roof coverings. Recommend a licensed roofer evaluate and repair, seal.

Mastic cracking

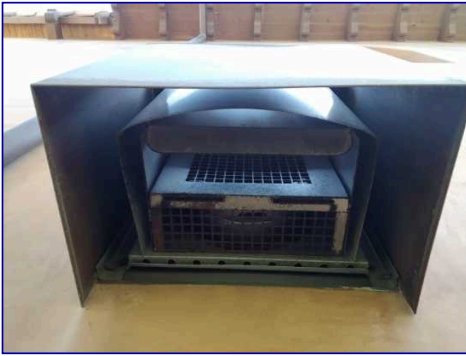
1.1. Left side wall vent apparent rusting. Recommend further evaluation and repair by qualified professional.

Rusting left

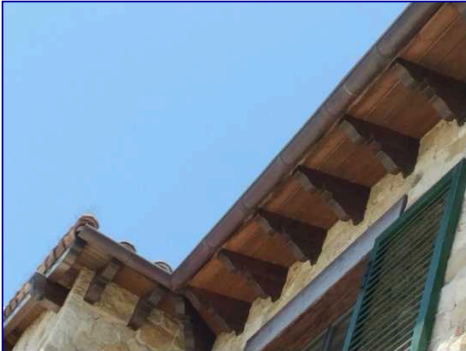
- 2.1. The gutters are dirty. Recommend cleaning the gutters to ensure proper water flow to the downspouts.
- 2.2. The gutters were incorrectly pitched at areas around building. Recommend a licensed professional repair.
- 2.3. There is evidence that the gutter is leaking at the seams. Recommend a professional contractor evaluate and repair as needed.
- 2.4. Gutters were rusting, weathered. Recommend a licensed professional repair or replace as needed.

Unevenly sloped left

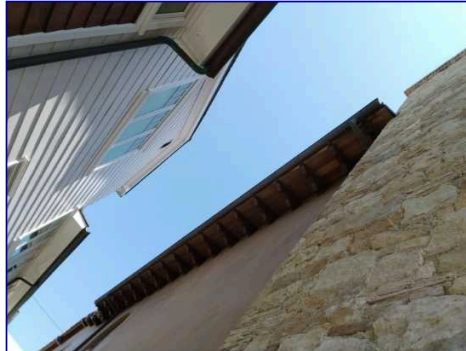
Seams leak left

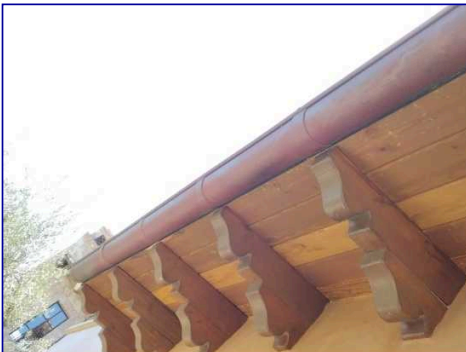
Rusting right

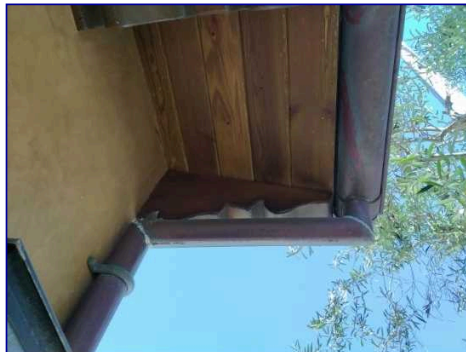
Corroded right

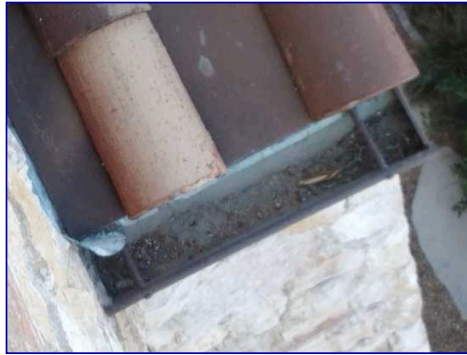
Debris

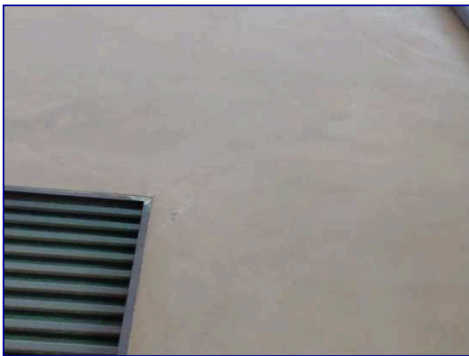
3.1. The stucco siding had typical cracking present in one or more areas. Monitor and repair as needed.

Cracks left

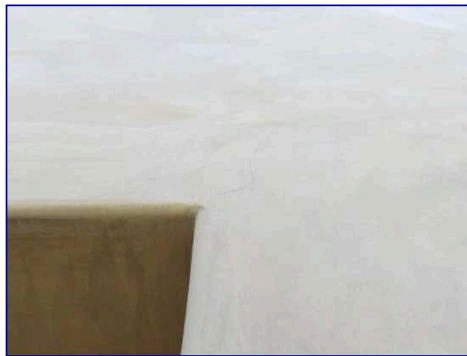
Cracks left

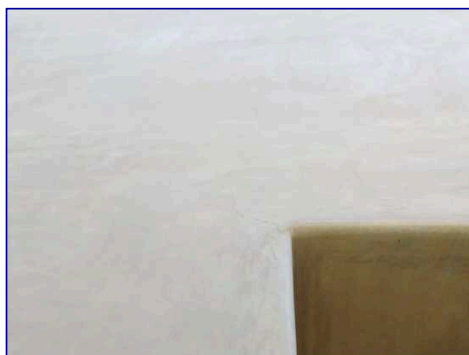
Cracks left

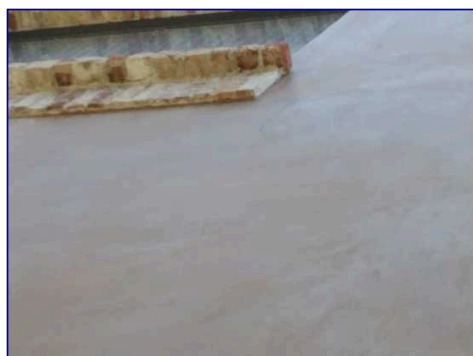
Cracks left

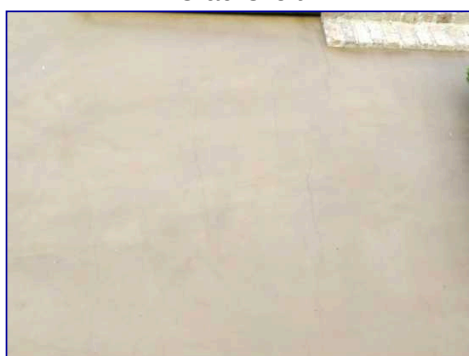
3.2. The stucco walls were in need of repairs, patching and crack sealing to help prevent moisture from penetrating and causing damage to the stucco. Walls weathered, discolored off rear and right house. Recommend a licensed professional contractor evaluate and repair.

Cracks rear

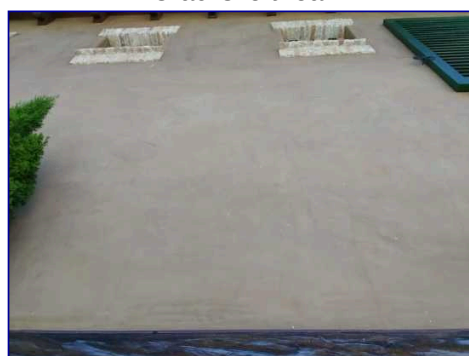
Cracks rear

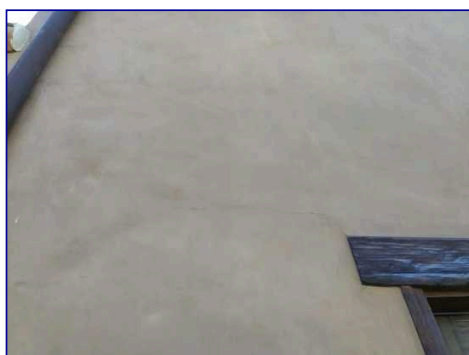
Cracks rear

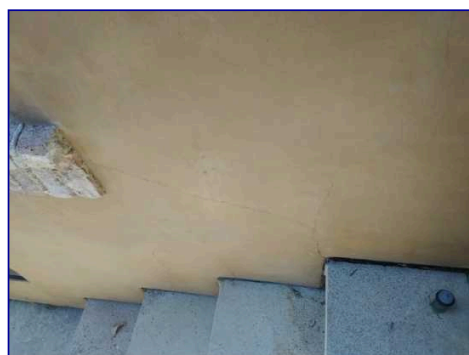
Cracks right

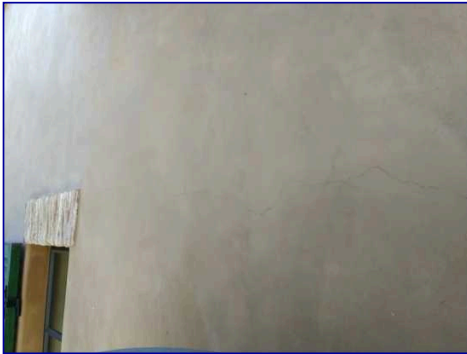
Cracks right

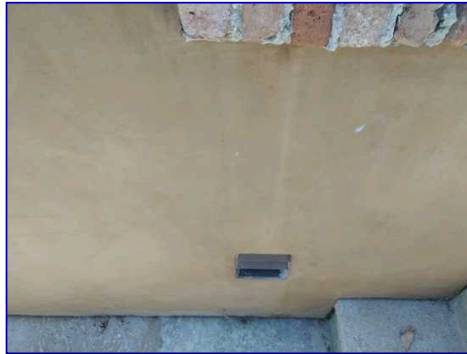
Cracks right

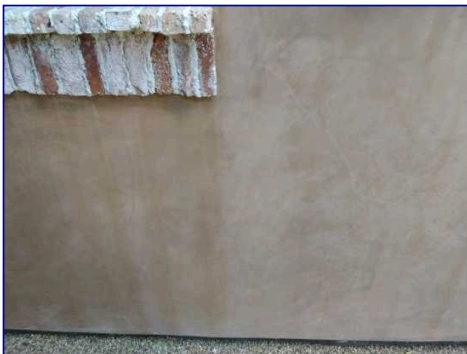
Cracks right

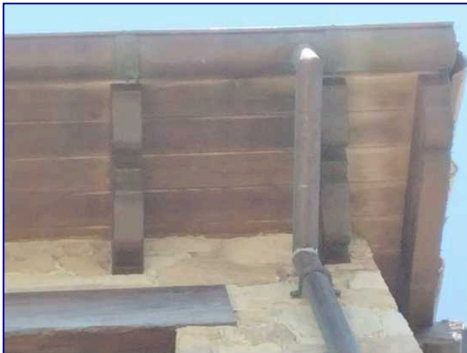
5.2. Wood eaves needed routine painting, caulking maintenance. Recommend a professional painter repair/paint as needed.

Weathered front right

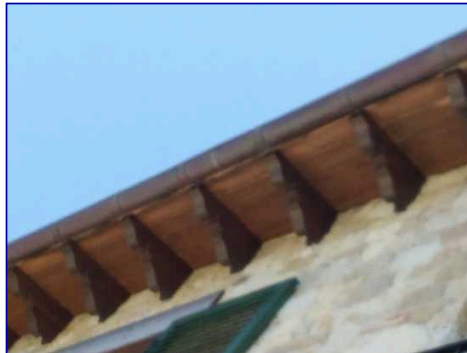
Weathered front

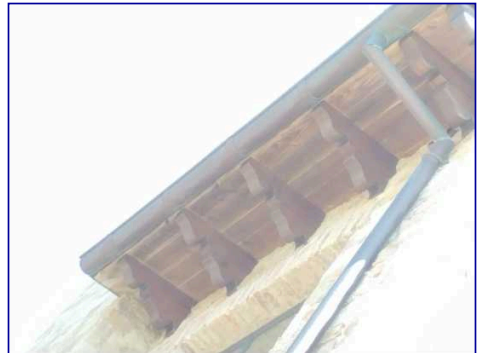
Weathered left

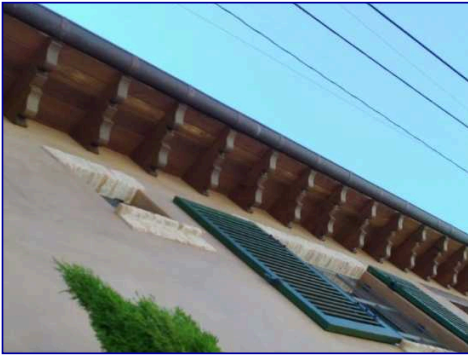
Weathered

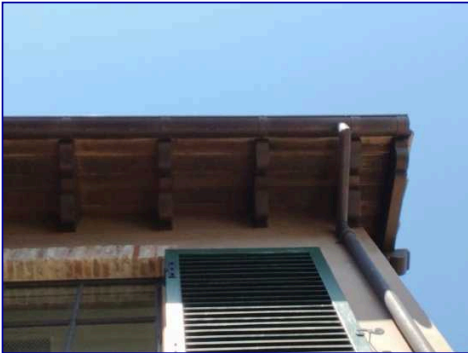
Weathered right

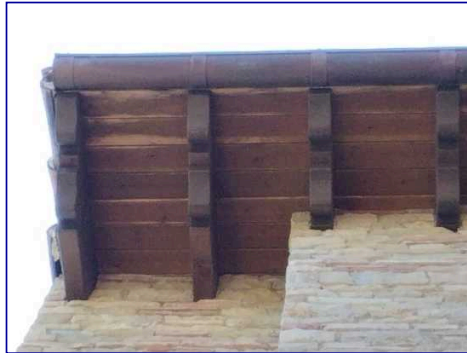
Weathered right

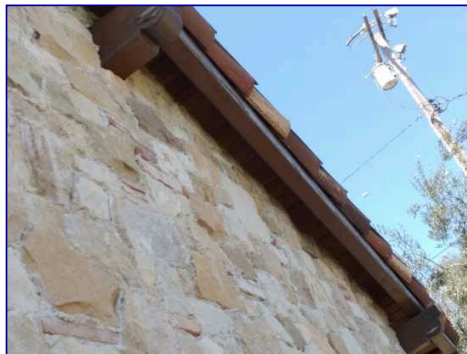
Peeling paint

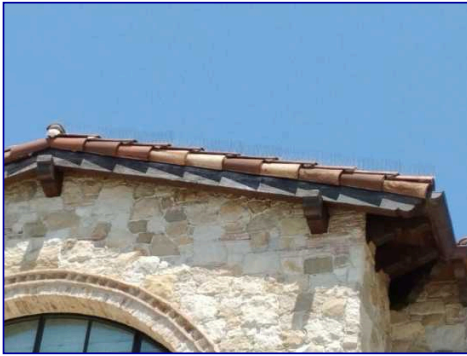
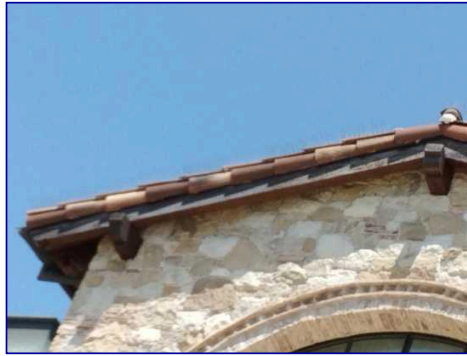
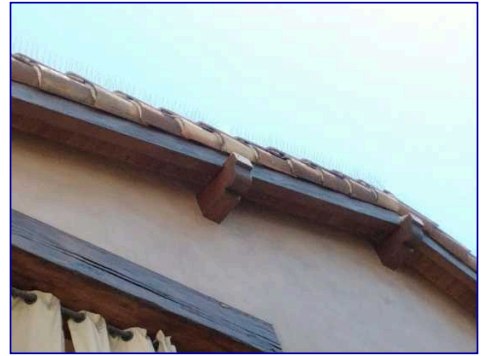
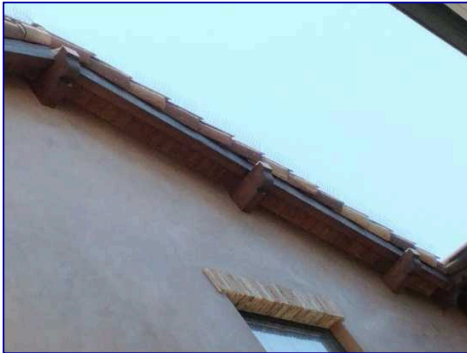
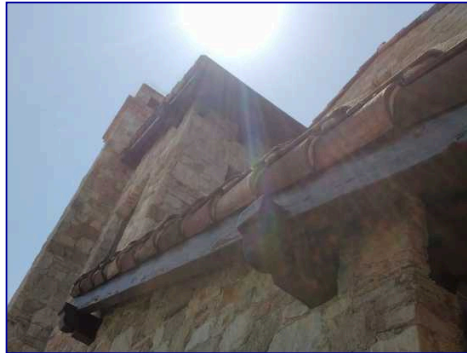
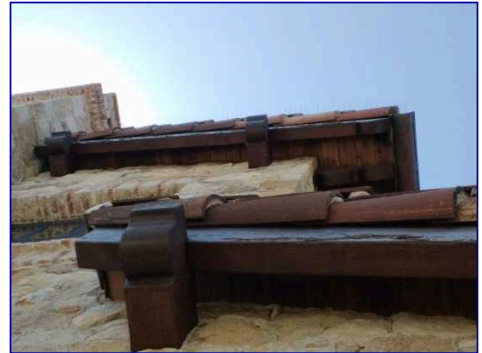
6.2. The fascia needs routine painting maintenance. Recommend a professional painter repair/paint the fascia around house.

Peeling, weathered

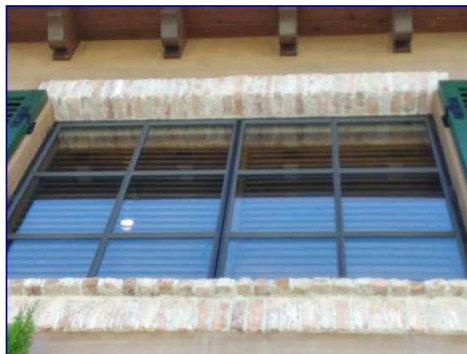
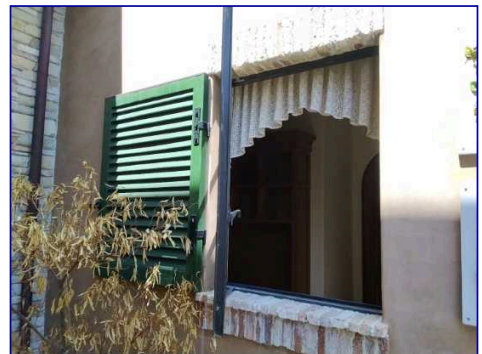
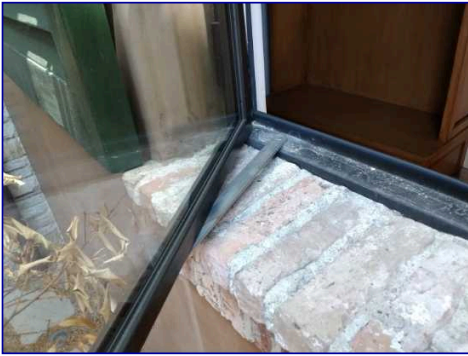
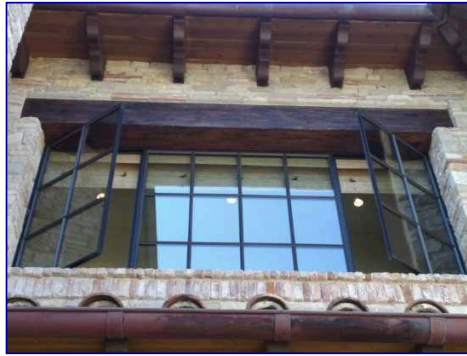
8.3. One or more exterior window frames and hardware have visible rusting, weathering. Recommend a professional contractor service to prevent additional damage.

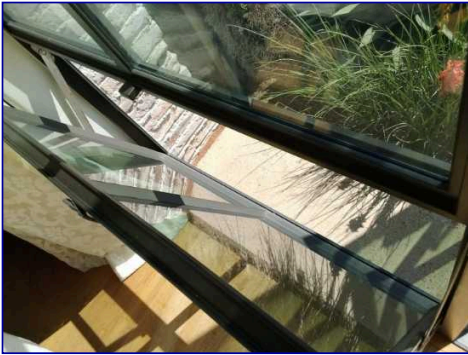
Rusting

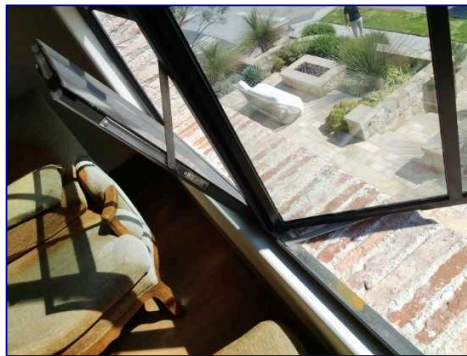
Rusting

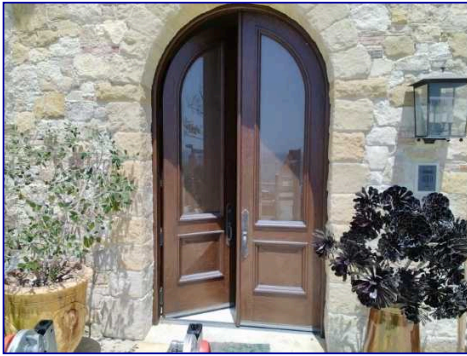
Main entry

- 9.1. Rear balcony closet doors were weathered. Recommend a professional contractor paint or stain to protect from further damage.
- 9.2. Entry doors and hardware were weathered, rusting. Recommend a professional contractor service to prevent conditions from growing worse.
- 9.3. Exterior right water heater doors uneven, lower latch unable to close. Recommend a professional contractor repair.
- 9.4. Kitchen door floor hold down was damaged, loose. Recommend a professional contractor repair.
- 9.5. The rooftop attic door was damaged. Recommend a professional contractor repair or replace as needed.

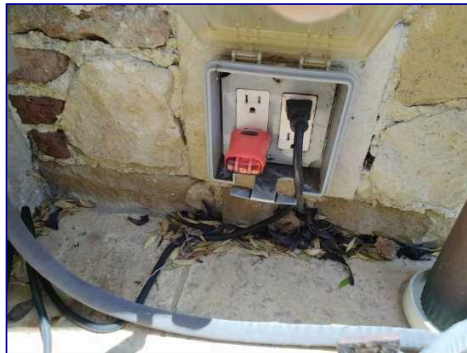
11.3. **GFCI** receptacles are not installed at left side outdoor locations, which is a safety concern. Recommend a licensed electrician install GFCI receptacles.

No gfc front left

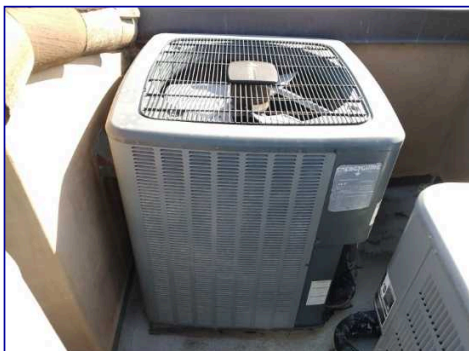
2.1. The air conditioner was not elevated off finished floor at least 3". Unit installed against wall, restricting air flow. Recommend evaluation and repair by licensed HVAC technician.

near wall

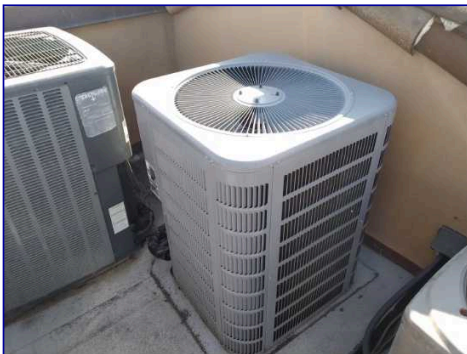
2.1. The air conditioner was not elevated off finished floor at least 3". Recommend evaluation and repair by licensed HVAC technician.

not elevated

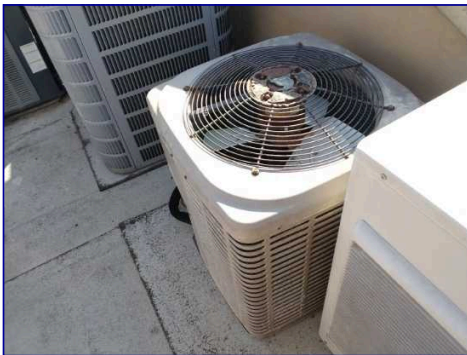
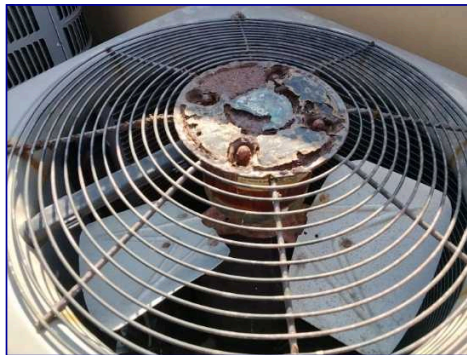
2.2. There is excessive rusting on the air conditioning compressor unit. Recommend evaluation from licensed HVAC technician.

Rusting

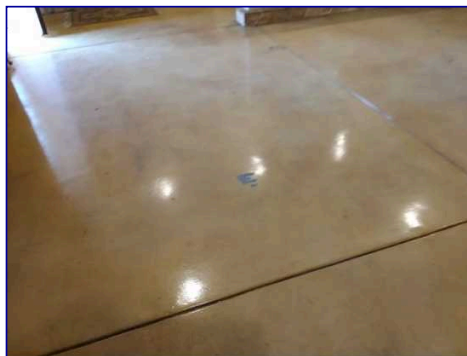
4.1. Epoxy floors installed which are NOT evaluated with inspection. Peeling paint observed. Unknown if floors were tested for moisture prior to epoxy coating. Recommend consulting seller regarding documentation.

Peeling

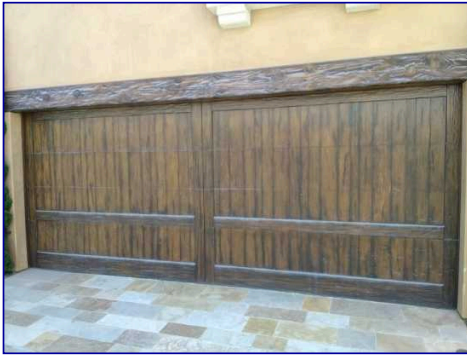
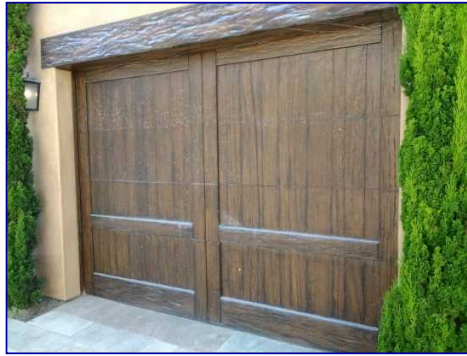
5.1. The garage doors were made of wood and/or Masonite. Doors/trim apparent discoloration. Recommend painting/staining the door to help prevent moisture damage.

Weathered

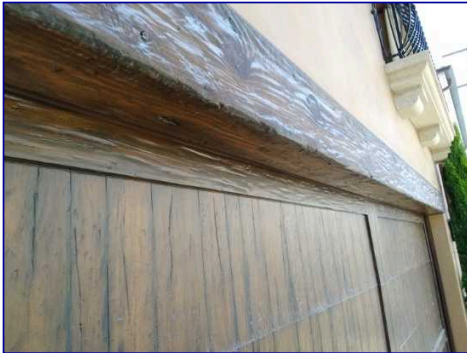
Weathered

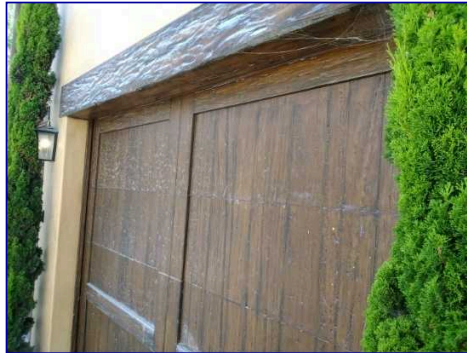
Weathered

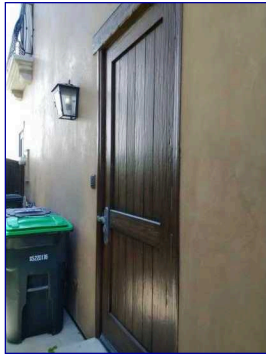
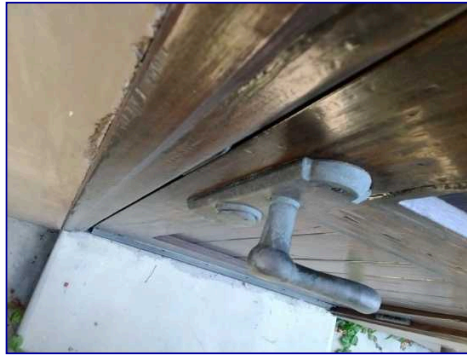
6.1. Wood door not even with casing. Recommend a qualified professional to evaluate.

Door uneven

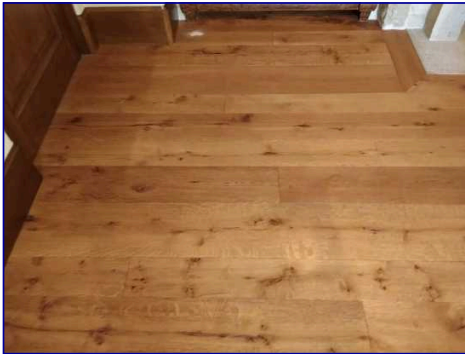
2.2. The floor covering was hollow to sound at various locations. Recommend further evaluation from qualified professional and repair/replace as needed.

Hollow

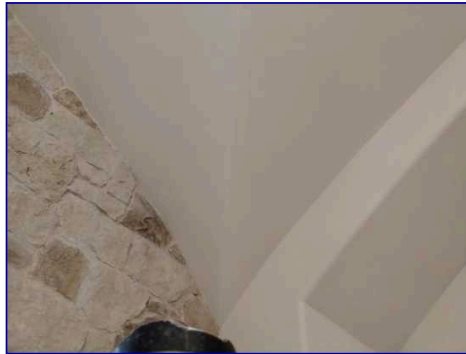
2.1. There are typical cracks on the walls/ceilings. Monitor and repair as needed.

Cracks

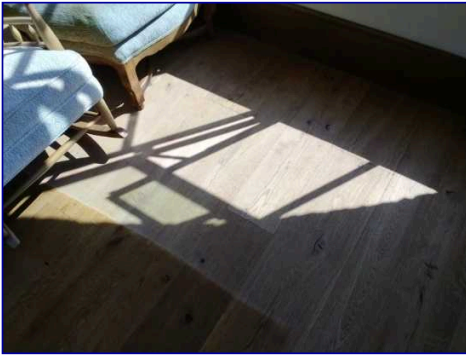
2.2. Finished floor covering was weathered, discolored. Recommend further evaluation from qualified professional and repair/replace as needed.

Weathered

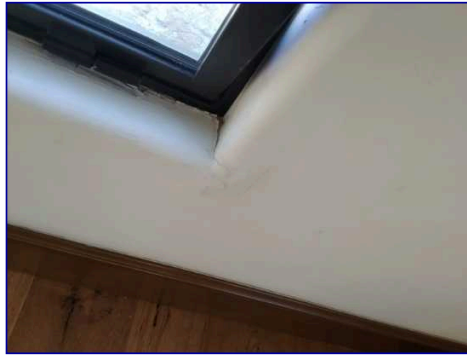
2.1. There are typical cracks on the walls/ceilings. Monitor and repair as needed.

Cracks

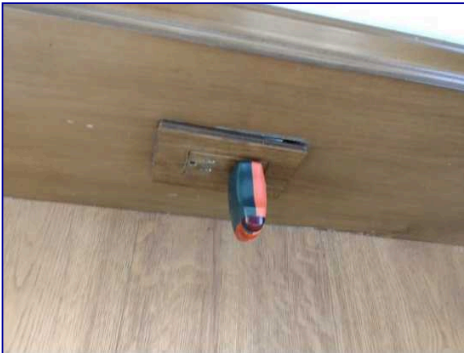
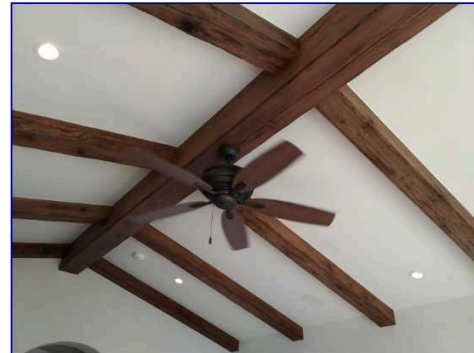
3.2. The ceiling fan is out of balance and wobbles. Repair or replace as needed by qualified professional.

Wobble

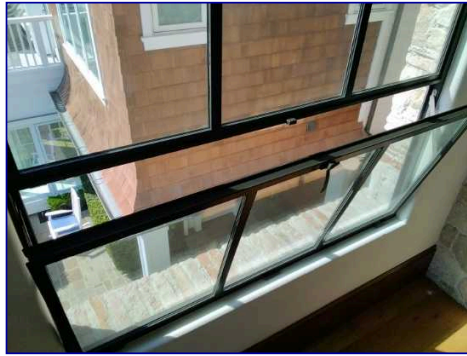
6.1. One or more window(s) difficult to operate, in need of service/repair. Recommend a qualified professional to evaluate and repair.

Difficult

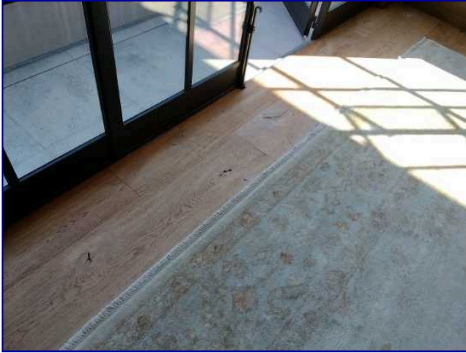
2.2. Finished floor covering was weathered, discolored. Recommend further evaluation from qualified professional and repair/replace as needed.

Weathered

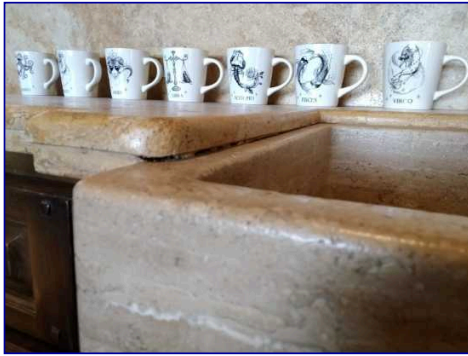
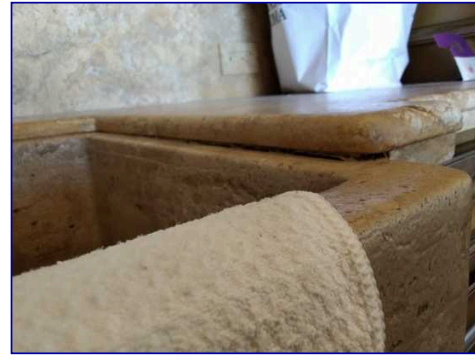
2.1. There are areas of missing or damaged grout/caulking near sink. Recommend re grouting, caulking to prevent condition from growing worse.

Voids

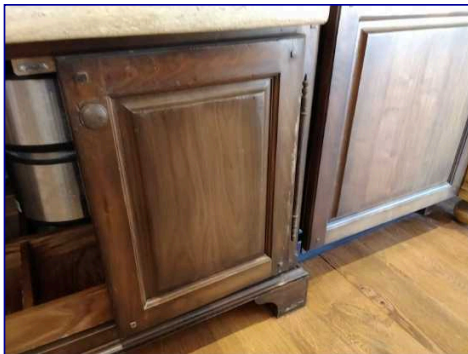
3.1. Lower sink cabinet weathered, peeling. Recommend further evaluation and repair by qualified professional.

Peeling

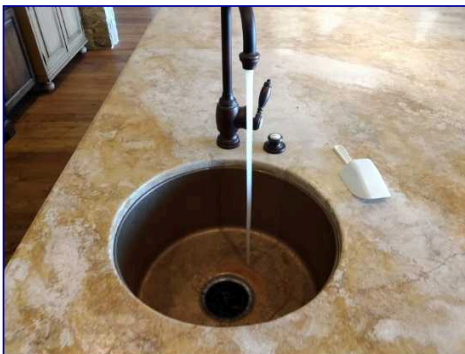
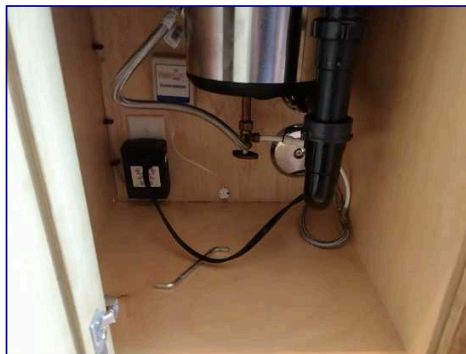
4.1. Sink faucet handles were not operating easily. Recommend evaluation from licensed plumber.

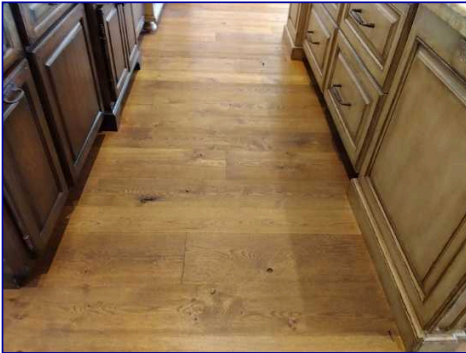
5.2. Finished floor was hollow to sound around room. Recommend repairing as needed by qualified professional.

Hollow

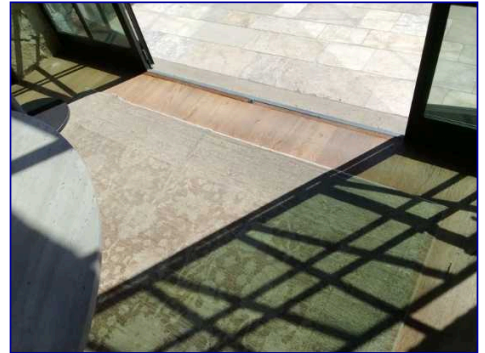
5.1. Finished floor covering observed to be discolored, weathered near patio entry doors. Recommend further evaluation from qualified professional.

Weathered floors

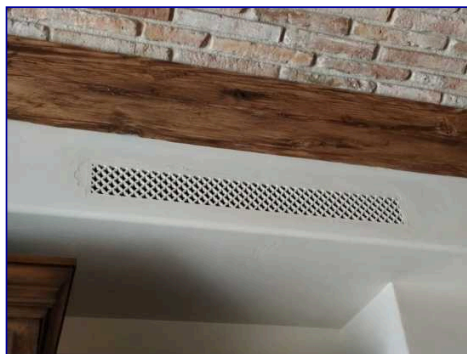
5.3. Cracking/peeling present in the kitchen walls around registers. Recommend monitoring and repair as needed by qualified professional.

Cracks

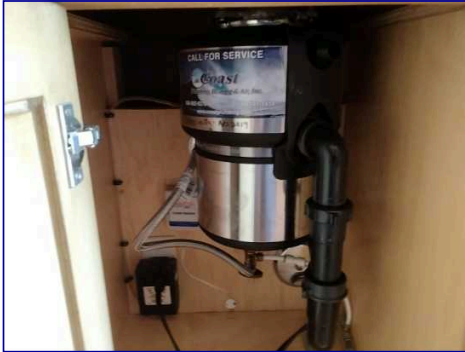
Island

8.2. Garbage disposal not operating at island. Recommend repair or replacement by qualified professional.

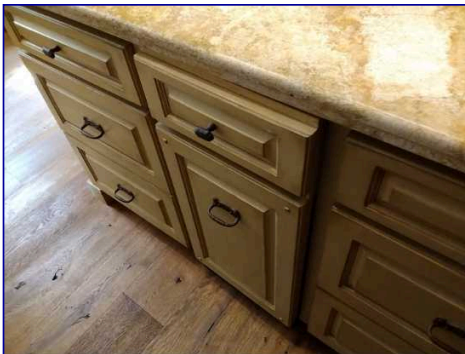
8.3. Trash compactor door uneven, not closing properly. Recommend repair or replacement by qualified professional.

Uneven

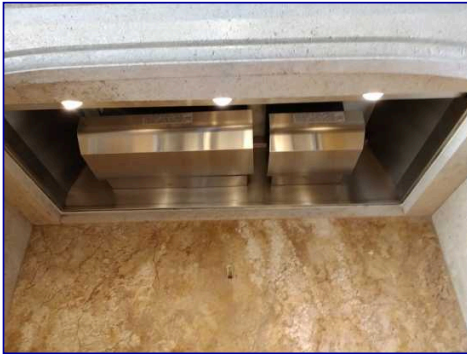
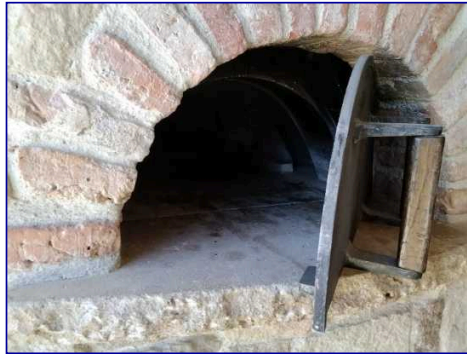
Pizza

8.4. Oven lights not operating. Recommend repair or replacement by qualified professional.

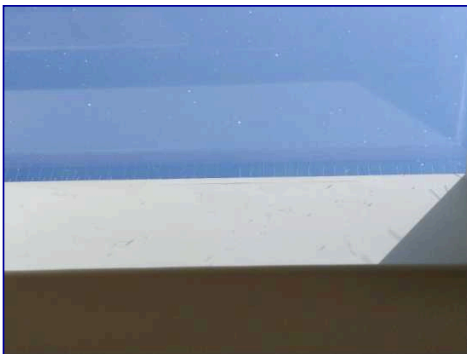
Cracking

**Overall Condition:**  
3.1. Typical cracks observed at wall/ceilings. Floor grout cracks near walls. Recommend evaluation and repair by qualified professional.

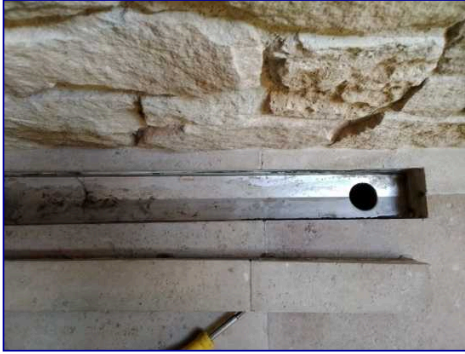
6.1. The shower drain strainer was missing. Recommend further evaluation and repair by a licensed plumber.

No strainer

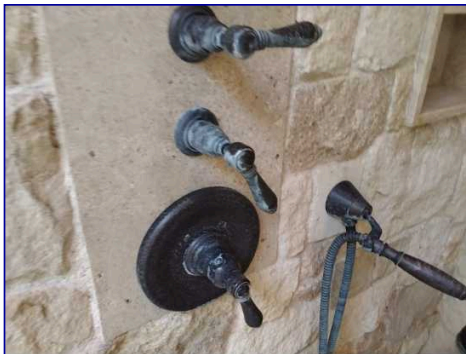
6.2. Fixtures were corroded, trim plates loose at wall. Recommend further evaluation and repair from licensed plumber.

Corroded

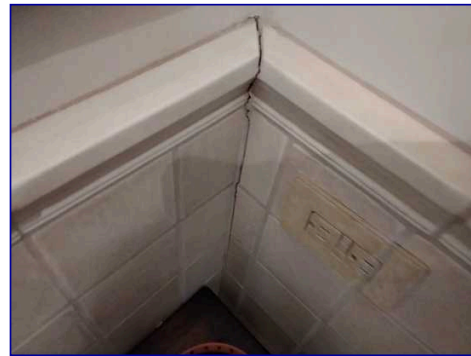
2.1. Right side walls cracking by sink and toilet. Recommend further evaluation from qualified professional.

Right wall cracks

Cracks

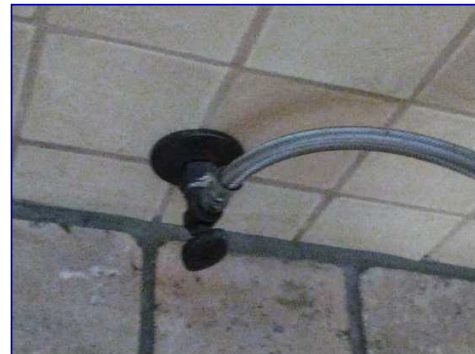
6.1. Toilet plumbing/valve was corroded. Recommend further evaluation from licensed plumber.

Corroded plumbing

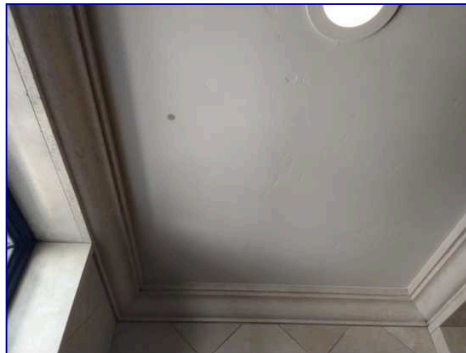
2.1. Apparent stains, discoloration observed at ceiling textures above shower. Recommend repair by qualified professional to prevent condition from growing worse.

Shower ceiling spotting

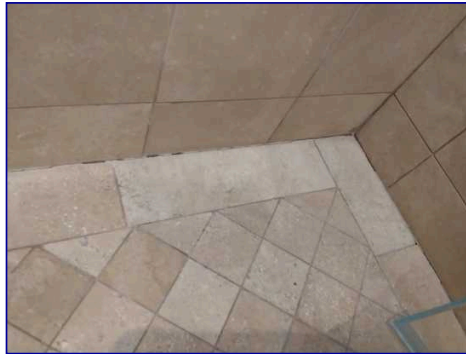
5.1. Recommend caulking/grouting in the shower area to help prevent damage from water penetration. Work should be performed by qualified professional.

Poor grout

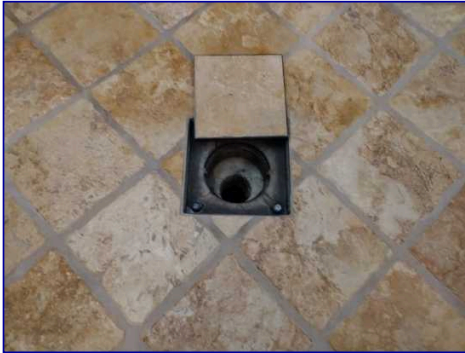
5.1. The shower drain strainer missing. Recommend further evaluation and repair by a licensed plumber.

No strainer

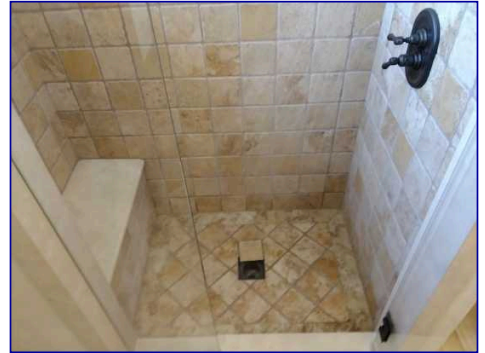
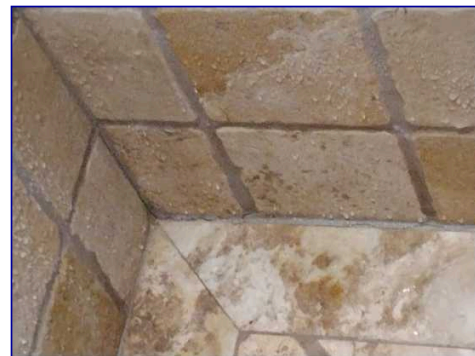
Poor grout

5.2. Recommend caulking/grouting in the shower area to help prevent damage from water penetration. Work should be performed by qualified professional.

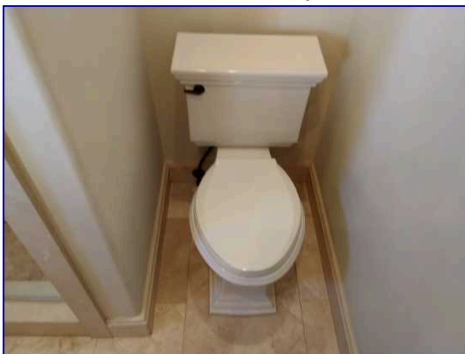
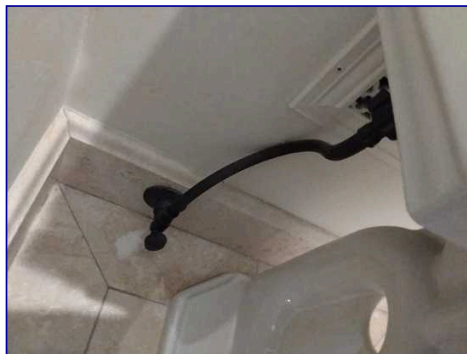
6.1. Toilet installed within 15" from center of bowl to adjacent obstruction. Recommend further evaluation from licensed plumber.

Less than 15"

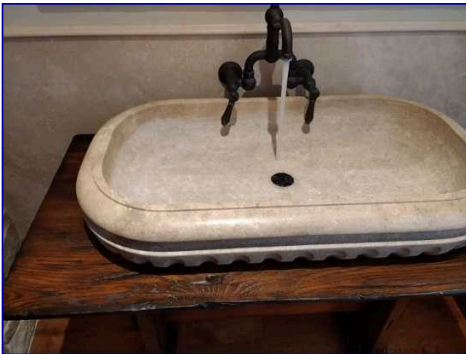
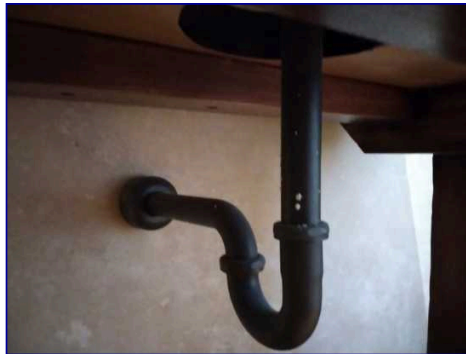
4.1. Apparent corrosion observed at plumbing under vanity. Recommend a licensed plumber repair or replace as necessary.

Corroded plumbing

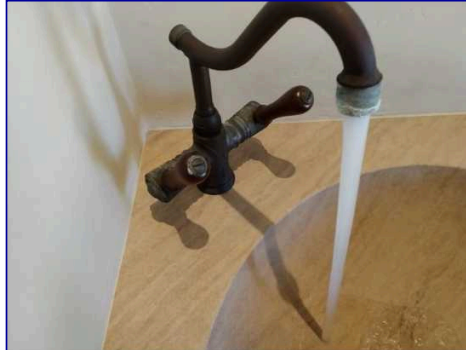
4.3. Apparent corrosion observed at sink faucet. Recommend a licensed plumber repair or replace as necessary.

Corroded fixture

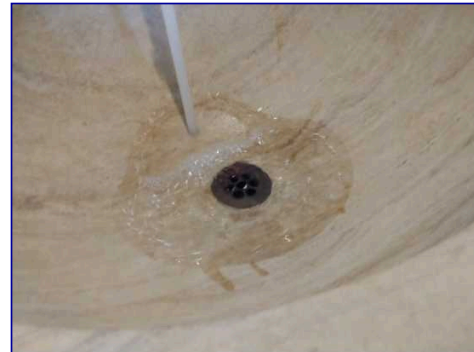
4.1. Sink was draining slowly during operation. Recommend a licensed plumber repair or replace as necessary.

Slow

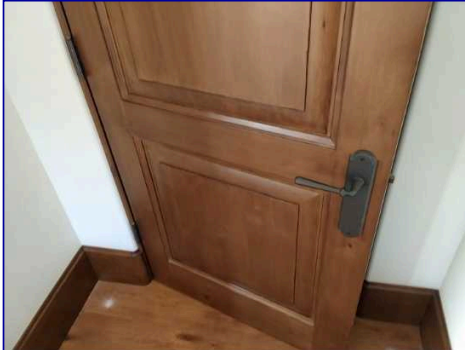
3.1. The entry door was uneven, not latching strike plate. Recommend a professional contractor repair or replace for proper operation.

Door uneven

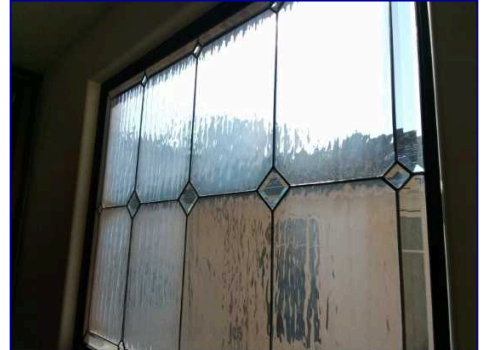
3.3. Window apparent fogging/hazy panes of glass. Recommend evaluation and repair by qualified professional.

Fogging

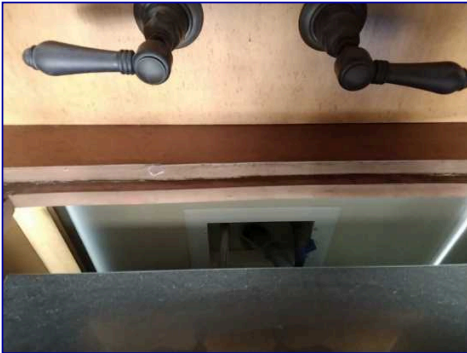
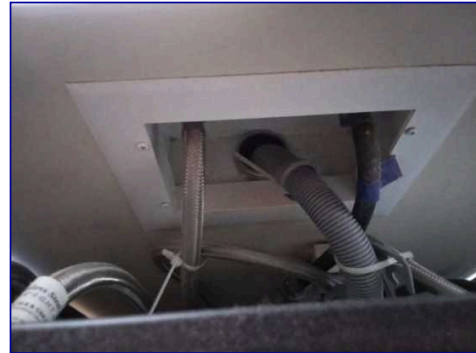
5.3. Washer plumbing valves were not installed with water hammer arresters. Recommend a licensed plumber repair or replace as necessary.

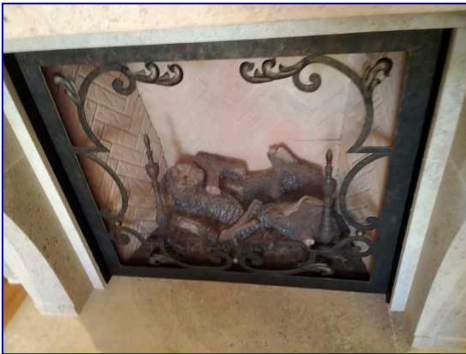
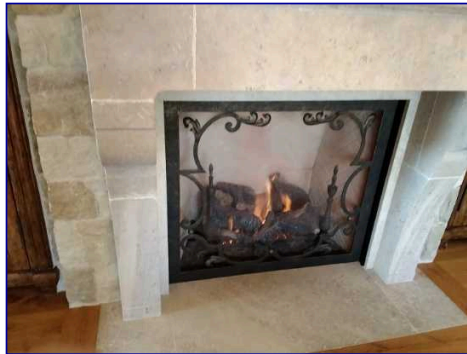
3.1. Remote control not operating. Recommend further inspection and repairs by a qualified professional.

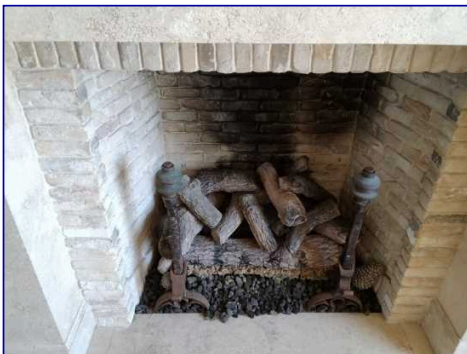
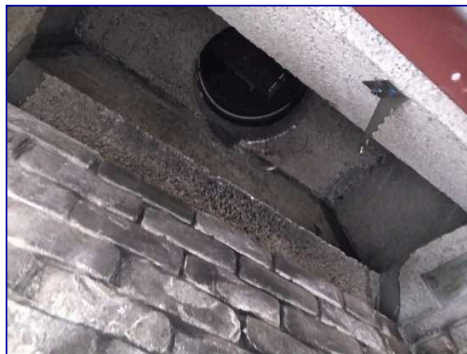
3.1. Open voids/bent edges at flue. Recommend further inspection and repairs by a qualified fireplace professional.

Flue bent, voids

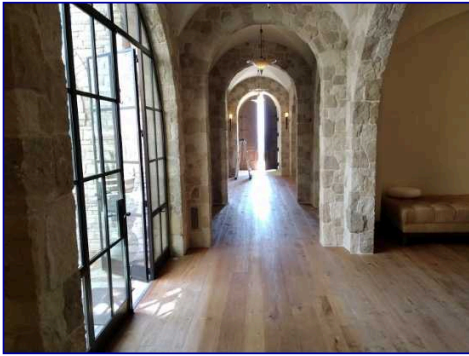
1.2. The hallway lights don't operate when the light switches are engaged off rear right hall and upstairs hallway. Recommend changing the bulb and re-testing. Consult a licensed electrician as needed.

Lower rear light not operating

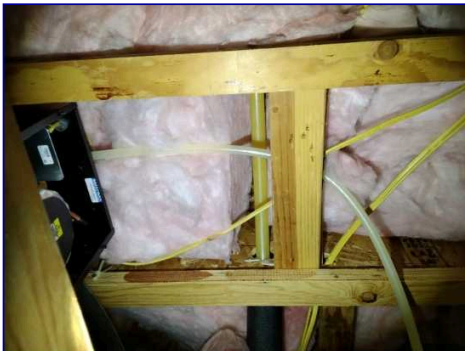
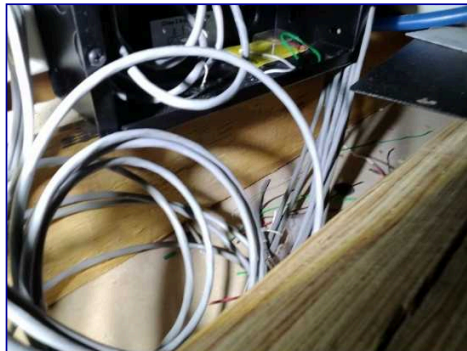
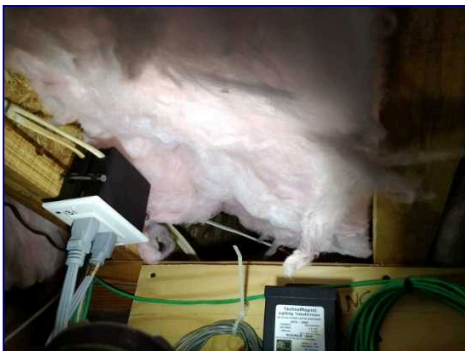
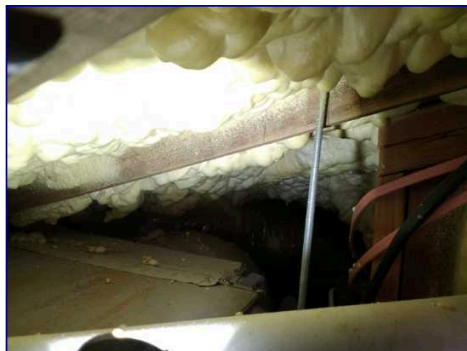
4.1. Insulation is displaced/compressed in the attic. Recommend a professional contractor add and or re-distribute the insulation around the attic.

4.2. Construction debris observed around attic. Recommend that all debris/trash be removed and attic cleaned. Work should be performed by qualified professional.

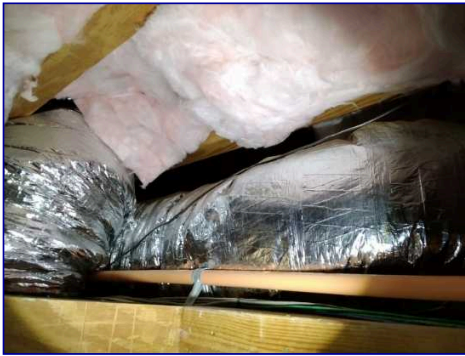
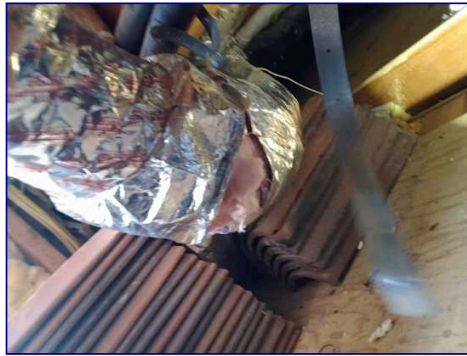
5.1. HVAC ducts within upper attic were torn/frayed, poorly supported. Register connections missing insulation. Duct was crushed, restricted near plenum. Recommend having duct work evaluated and repaired by licensed HVAC technician.

Damage,
