INGRAFFIA  
HOME INSPECTIONS

PROPERTY INSPECTION

July 25, 2026

123 Sample Street  
Corona Del Mar, 92625

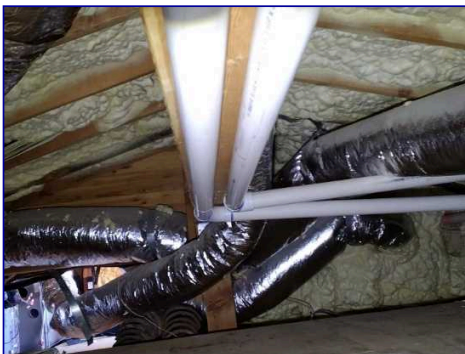
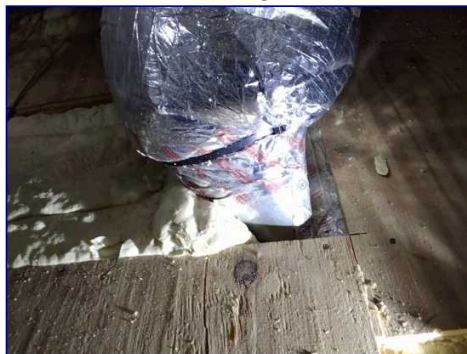
5.1. HVAC ducts within upper attic were torn/frayed, poorly supported. Register connections missing insulation. Duct was crushed, restricted near plenum. Recommend having duct work evaluated and repaired by licensed HVAC technician.

Missing insulation

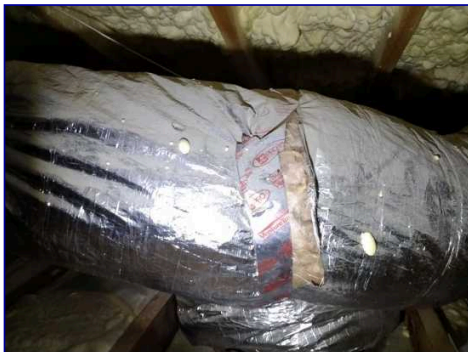
Torn

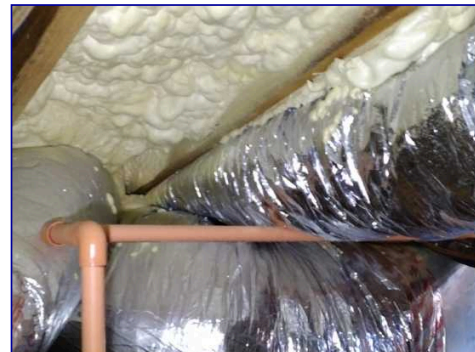
Restricted, crushed

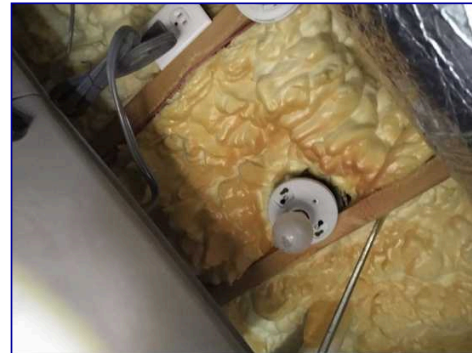
- 6.1. Lower attic junction box missing cover plate. Recommend a licensed electrician repair.
- 6.2. Light not operating within attic. Recommend bulb be replaced and checked for proper operation.

Not operating

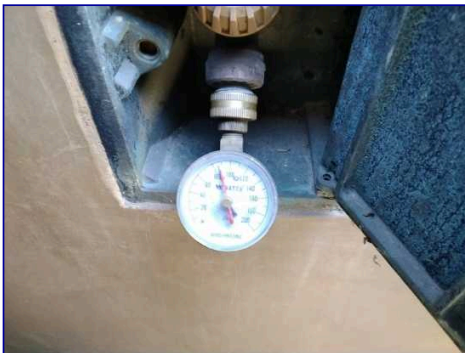
2.1. The water pressure tested over 80 psi at the exterior hose bib, water pressure is to be between 40-80 psi. Recommend that the water pressure be evaluated and adjusted to below 80psi by a licensed plumber.

Psi over 80

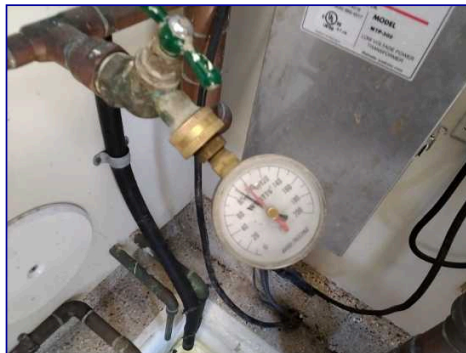
Psi over 80

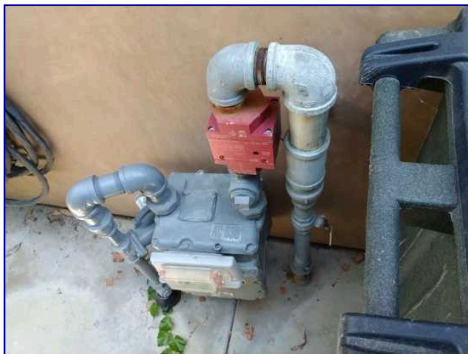
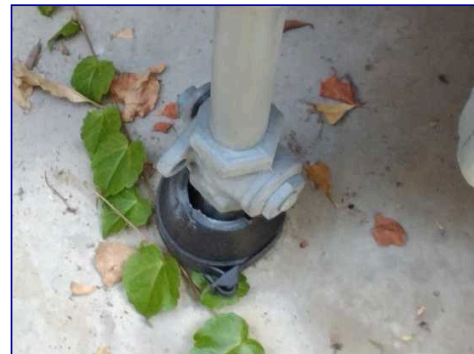
Shut off

4.1. No safety/emergency shut off tool installed/secured near meter. Recommend securing tool/wrench at meter in case of emergency.

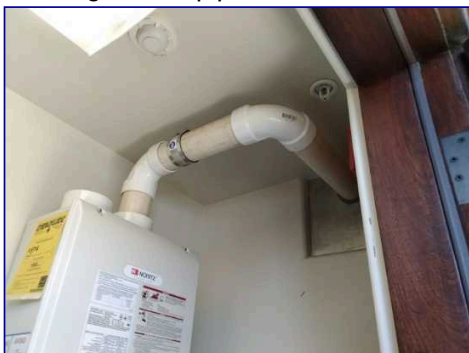
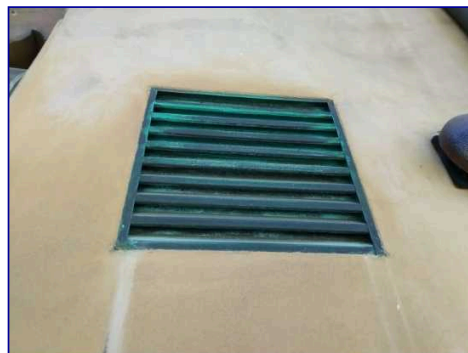
4.1. There is corrosion, rusting on exterior rear vent. Recommend a licensed plumber repair or replace the damaged vent pipe.

Corroded

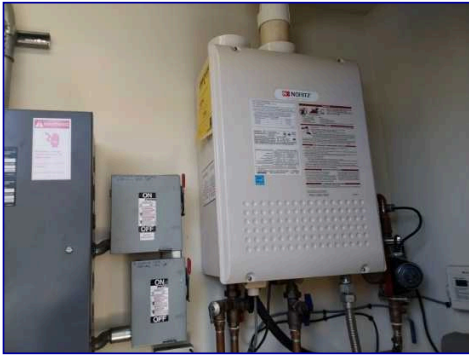
5.3. The water heater water pipes non insulated. Recommend further evaluation from qualified professional.

Pipes non insulated

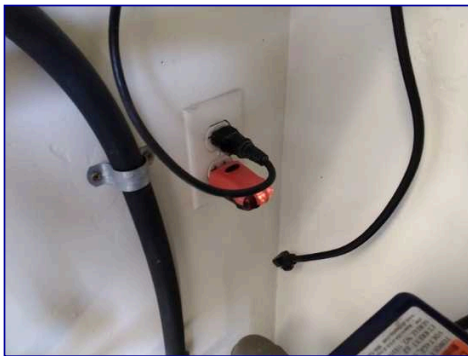
5.4. Exterior right closet no GFCI protection installed. Recommend a licensed electrician repair.

No gfci

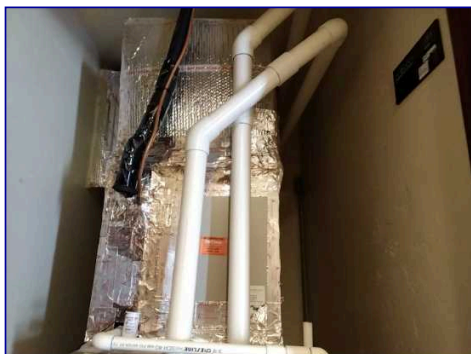
4.1. Vent pipes unsecured within closet, exterior pipes not sealed at house wall. Repair as needed by qualified professional.

Pipes unsecured

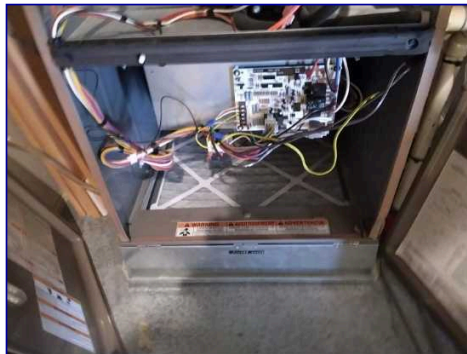
- Standard size
- Filter needs cleaning/replacement

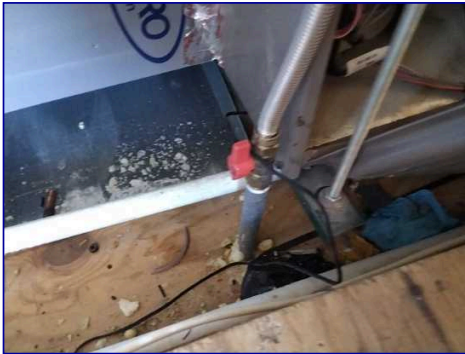
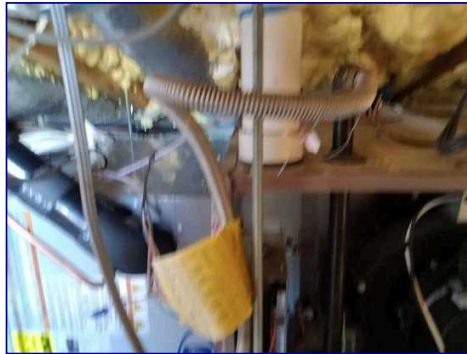
2.1. The furnace gas line was not installed with a sediment trap drip leg which was required since 2009. We recommend a licensed contractor install sediment trap for added safety and convenience.

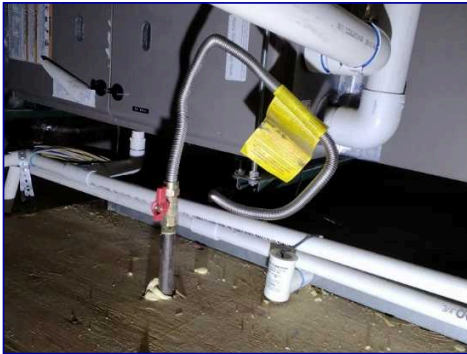
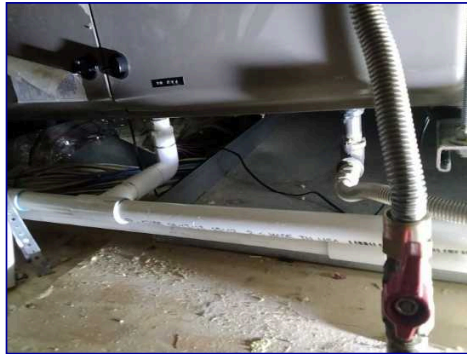
2.1. The furnace gas line was not installed with a sediment trap drip leg which was required since 2009. We recommend a licensed contractor install sediment trap for added safety and convenience.

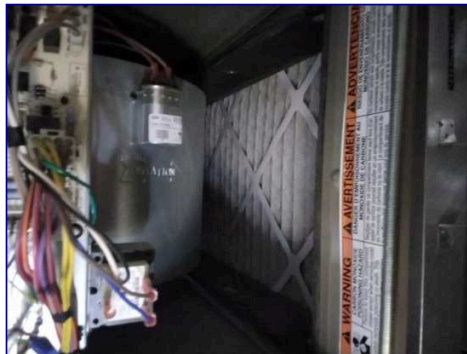
- Standard size
- Filter needs cleaning/replacement

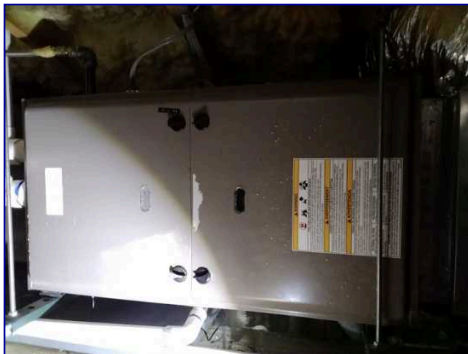
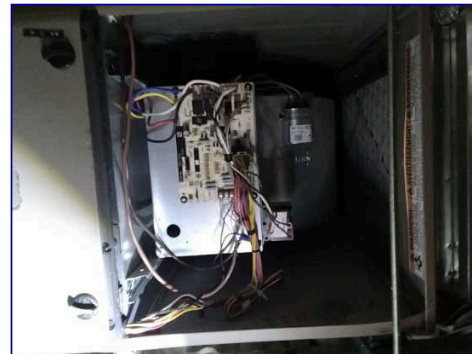
6.1. The furnace is dirty and in need of a routine cleaning by a qualified technician. Recommend the furnace be serviced as part of its regular annual maintenance.

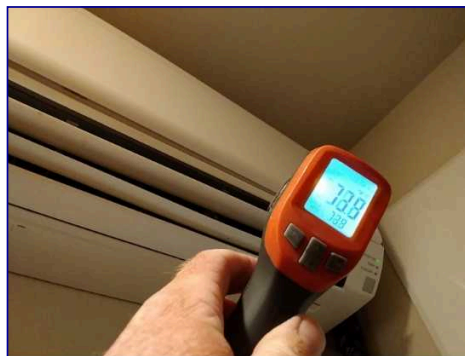
2.1. System should be serviced. Recommend evaluation from licensed HVAC technician.

2.2. The average life expectancy of mini split systems are 15 years. Recommend budgeting for repairs or replacement in near future.

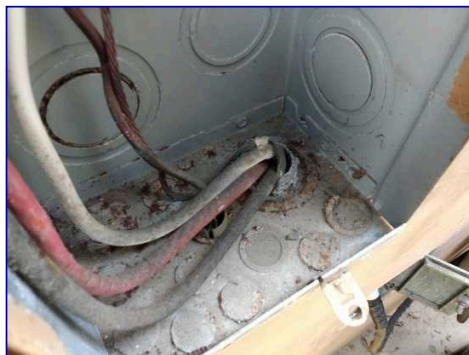
2.1. Bus bar heavy corrosion observed, which is a safety concern. Lower panel enclosure rusting.  
Recommend licensed electrician evaluate and make necessary repairs.

Rusting

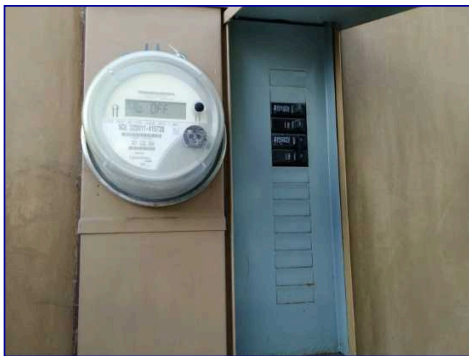
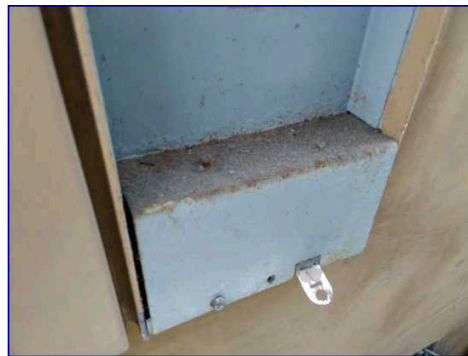
3.1. Apparent rusting observed within panel enclosure. Recommend a licensed electrician evaluate and repair as necessary.

Rusting

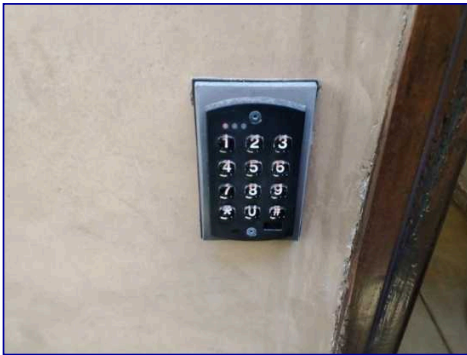
Key pads

• Above listed installed items installed are not evaluated or tested with inspection. Recommend consulting seller regarding ownership and operation.

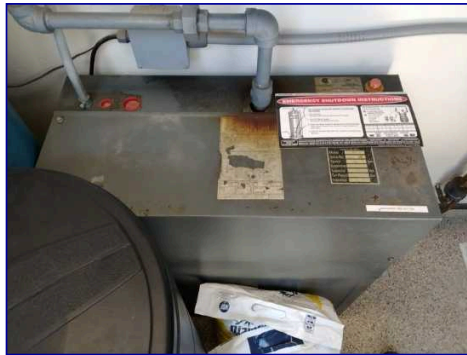
• Elevator installed, not evaluated with inspection, system in need of service. Recommend consulting seller regarding service history, if no completed services were done within last year, recommend consulting licensed elevator service technician.

Elevator

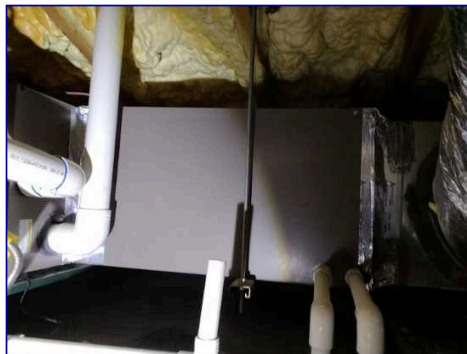
4.1. System in need of service. Recommend evaluation and repairs by licensed HVAC technician.

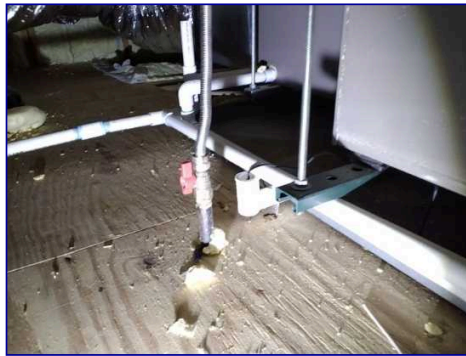
3.1. The condensate drain line was not installed with proper vent trap. Recommend a licensed HVAC contractor to evaluate and repair.
